Technical note about the monitoring of hydromorphological restoration/management of the Maggia River (Switzerland)

Project: HyMoCARES

Deliverable: D.T3.1.1

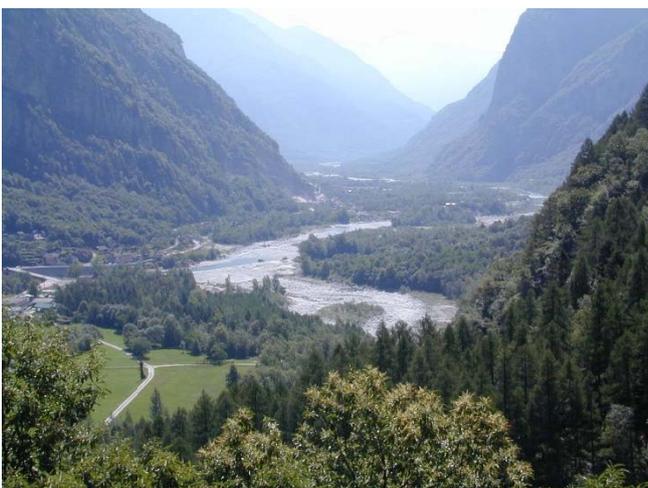
Figure 3: A view of the main valley with its steep hillslopes (©Wolfgang Ruf)

The main valley, located in the lower part of the catchment (section Bignasco-Ponte Brolla) is characterized by steep rocky slopes, resulting in fast responding runoff events, and a relatively well-defined floodplain (Figure 3). After the last period of glaciation, it was filled with deep coarse alluvial material to around 150 m (Ruf et al., 2008).

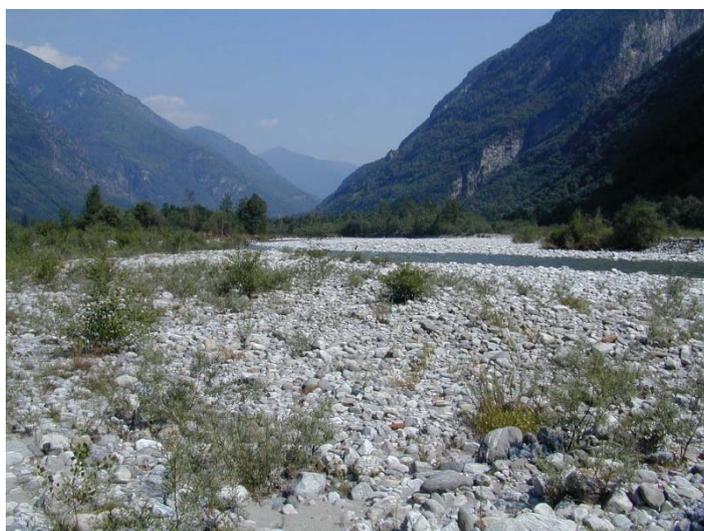
Figure 4: The braided area of the Maggia Valley (©Wolfgang Ruf)

The riverine corridor in the main valley, extending from Bignasco to Ponte Brolla and having approximately a length of 22 km and a width of 500 m, is the concerned river section in this project. The river bed is characterized by strong dynamics and high sediment transport rates. As a result, a braided river morphology with gravel bars and vegetated islands is observed over a length of around 7.5 km near the village of Someo in the central part of the corridor, especially after large flooding events (Figure 4).

Historical references report the wild character of the river Maggia with vast inundations and frequent relocations of the channels (Cerini, 2003). From the natural point of view, this braided area is a very active floodplain with riverine vegetation undergoing its natural dynamics of erosion, seedling, succession, and rejuvenation. The braided area has an average slope ranging from 0.5-1%, while in the upper and lower parts channel slopes reach 2%. The entire floodplain in the main valley consists of coarse material: cobbles, large gravels and sand with a pronounced armouring layer (see Figure 4).

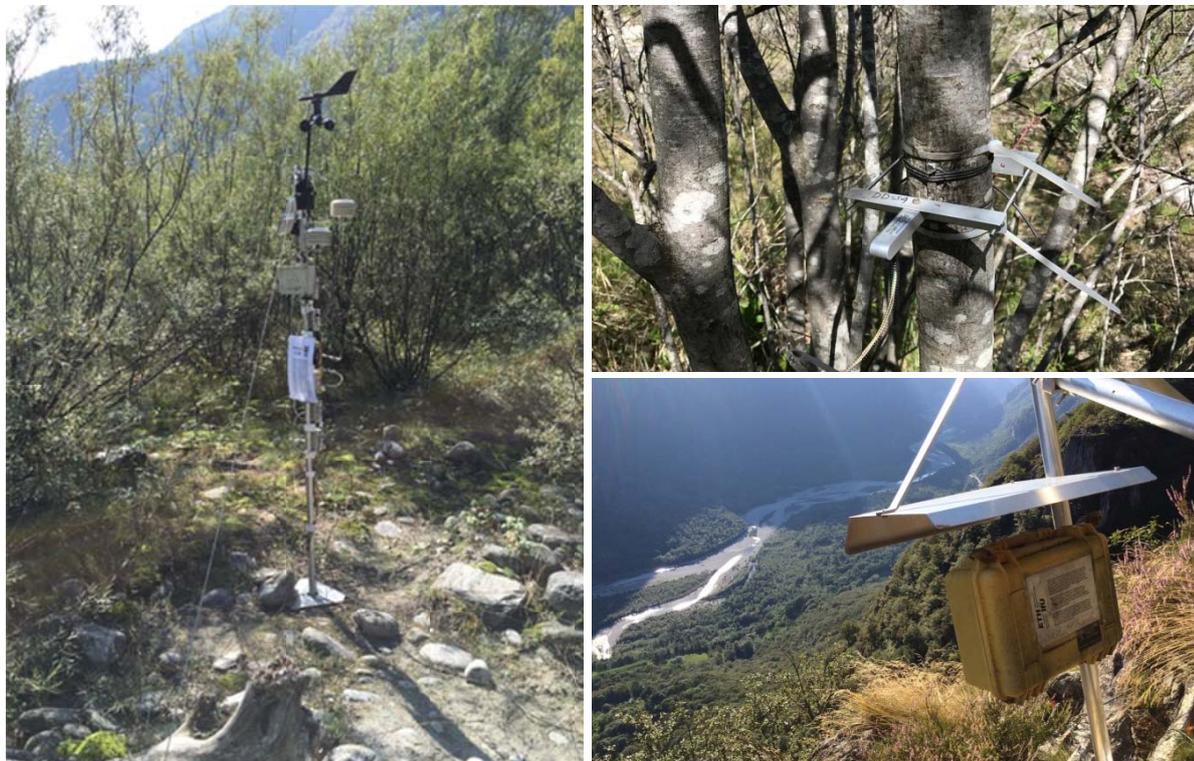
Figure 6: Weather station, dendrometer and camera used for measurements in the main valley (©Gianluca Bergami)

1. Climate and Hydrology. All relevant climatic variables (precipitation, radiation, temperature, wind) are being measured at two SwissMetNet sites in the valley (Cevio) and in the headwaters (Robiei) at a 10 min resolution since 1981. We have added two Sensorscope stations (Figure 6) on a single gravel bar in the central valley near Someo where also soil moisture is measured for the assessment of soil water status. Streamflow is measured at Bignasco (daily since 1932, hourly since 1980) and also at the Lodano station downstream in the valley (high resolution records since 2005). Several boreholes provide long-term intermittent groundwater level measurements. However automatic (hourly) measurements are only available for a short campaign period in 2003-2006 and currently at three wells in the Someo area since 2016.
