FACTSHEET

3. Sediment replenishment of highly altered alpine gravel bed rivers

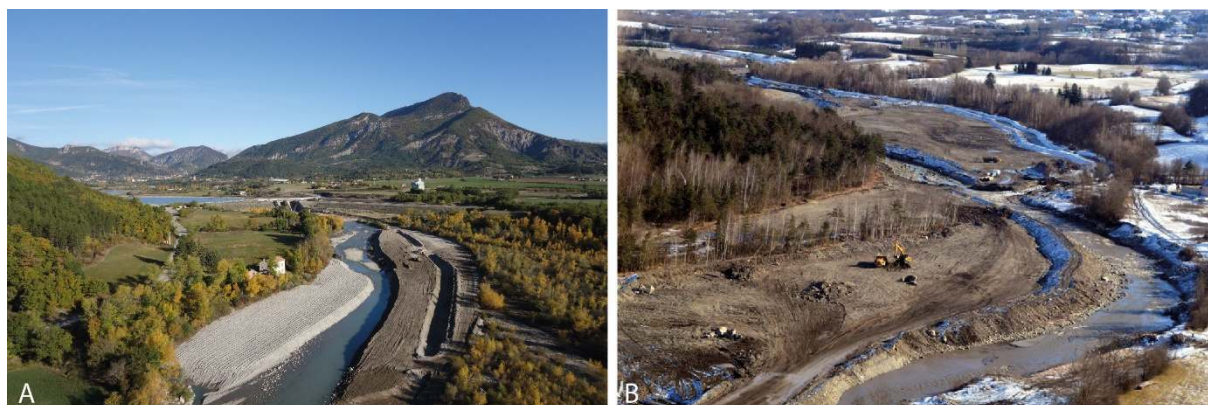
Figure 1. Emblematic recent sediment replenishment operations in French alpine gravel-bed rivers: (A) sediment replenishment downstream of the Saint-Sauveur dam in the Buëch River in 2016 (@EDF); (B) sediment replenishment of the incised Upper-Drac River in 2014 (@CLEDA)

The HyMoCARES project provided the opportunity to assess the morphological effects of two emblematic sediment replenishment operations in the Southern French Alps. In the Buëch River, 40 000 m³ of gravels have been reinjected downstream from a dam (St Sauveur dam) to stop channel incision and to reactivate the altered braided morphology (Fig. 1A). In the Upper Drac River, 400 000 m³ of gravels have been used to recreate a braided channel along a reach where gravel mining induced a dramatic channel incision into lacustrine clay deposits (Fig. 1B).

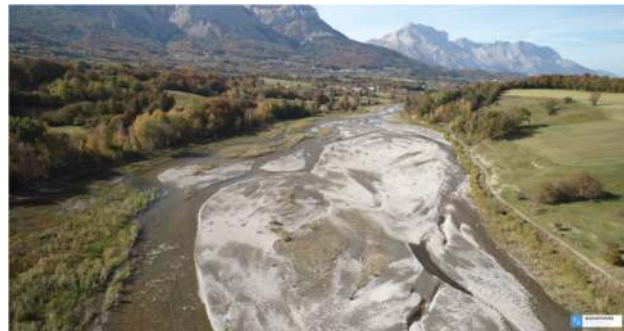
Figure 3. Spontaneous recovery of braided pattern in the Upper Drac restored reach (@Sigosphere)

The monitoring of the morphological restoration of the Upper Drac clearly reveals a very efficient spontaneous recovery of braiding conditions along the 3-km widened and replenished river reach. From a purely aesthetic point of view, this restoration is a real success, as today, the restored reach really looks like a “natural” braided river reach (Fig. 3). The evolution of the morphological signature of the restored reach confirms a rapid recovery to reference conditions (Fig. 4).
