Technical note about the monitoring of hydromorphological restoration/management of the Drau River (Carinthia, Austria)

1. General presentation of the study site

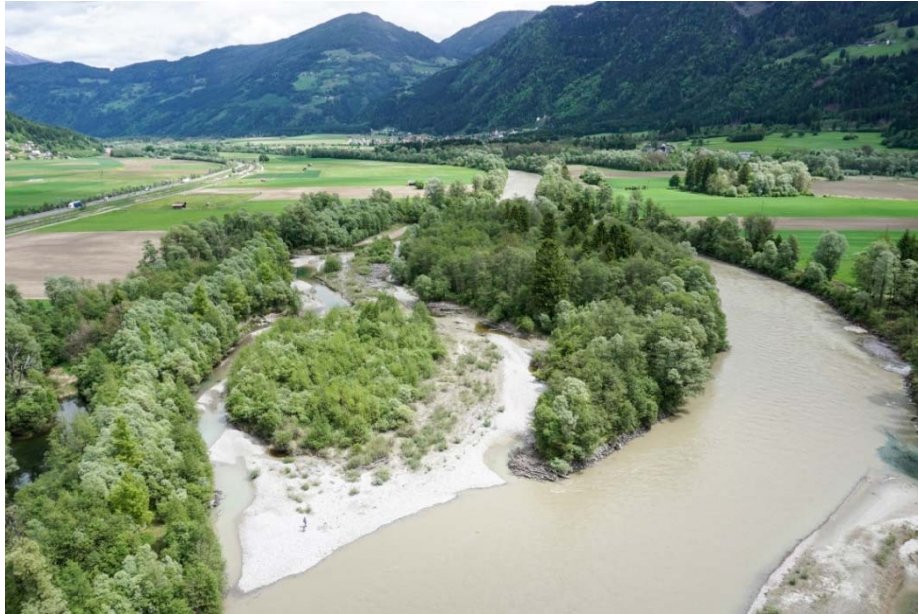
Figure 2: Aerial image taken from a drone of the downstream part of the study site (2017)

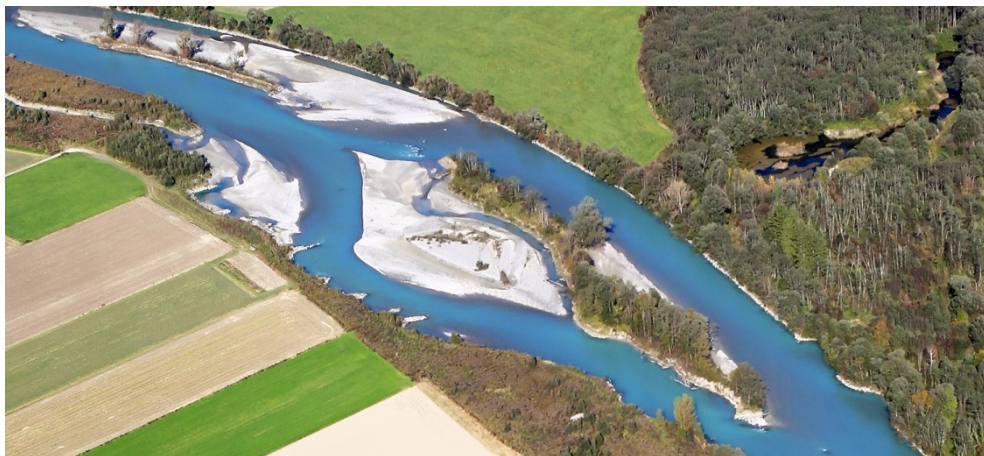
Figure 7. Upstream part of the restored reach near Obergottesfeld in 2017. Massive riverbank erosion required the installation of additional bank protection (groynes) to prevent the erosion of private property. Flow is from right to left (image source: Carinthian government).

Only 5 km downstream of the restored reach of Kleblach, near the village of Obergottesfeld, an even longer reach of the Drau River was restored. The restoration measures included the excavation of two side-channels, one side-channel 1 km in length, one 600 m in length, and were finalised in 2011. Again, groynes were embedded in the floodplain to prevent from erosion of private land. Especially the upstream side-channel quickly widened and triggered massive bank retreat, which required the installation of additional groynes.

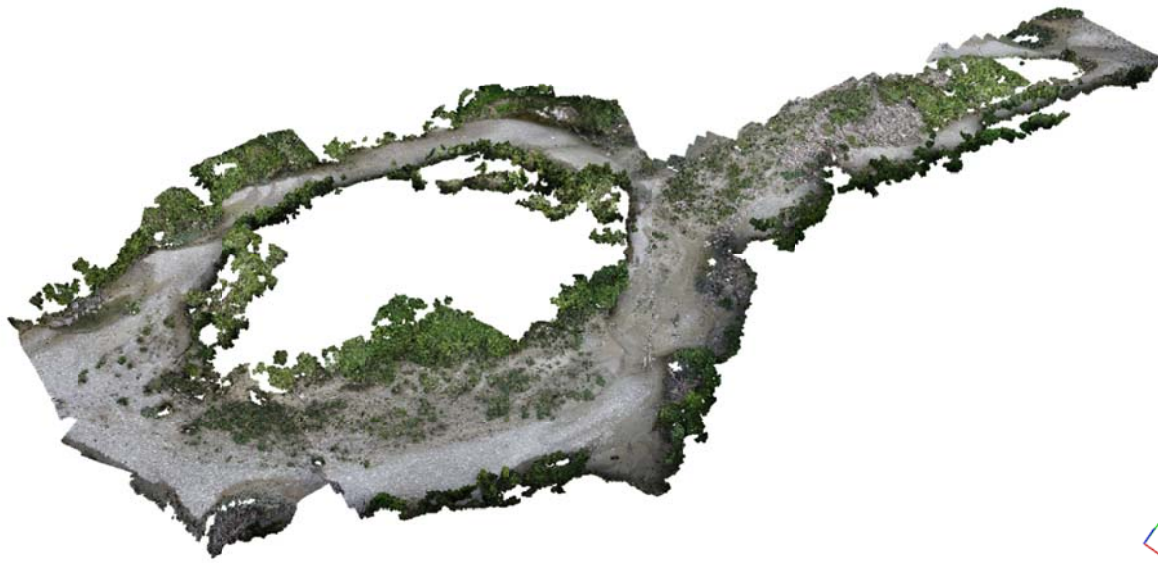
Figure 9: Example of a surface model computed with AgiSoft PhotoScan – side-channel Kleblach-Lind

UAV (unmanned aerial vehicle) surveys will be conducted in the side channel. For that purpose, a drone equipped with a camera is used within HyMoCARES to collect high-res spatial data in April 2017. Figure 9 shows a small part of a UAV based photogrammetric survey. The analysis of UAV-images is conducted with Agisoft photogrammetric software. Areas under water and areas covered by vegetation are additionally investigated by terrestrial surveying using a total station.

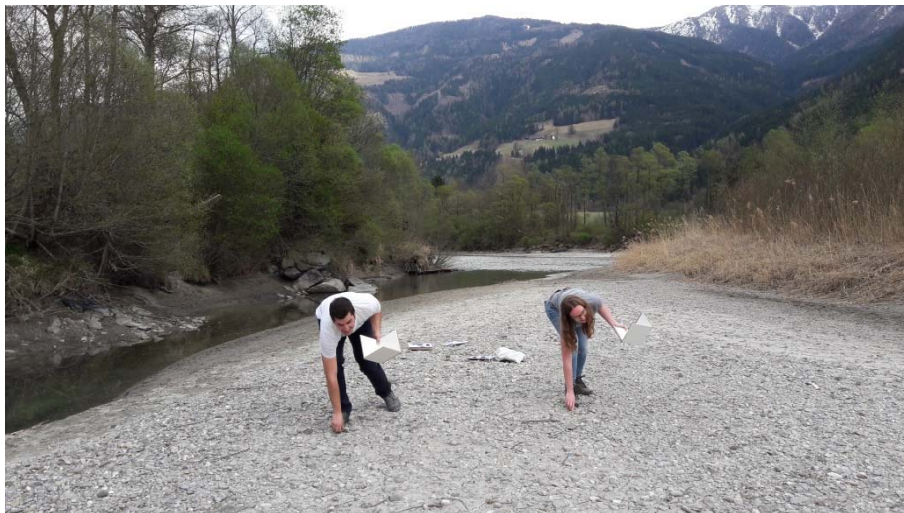
Figure 10: Sediment sampling for grain size analysis based on Wolman pebble counts

The grain sizes at the bed surface are repeatedly measured using the Wolman pebble count technique. We will relate the roughness detected with UAV-surveys to the pebble counts D_{50} to finally get information on all the area of the side channel and then analyse the change of surface sediment.

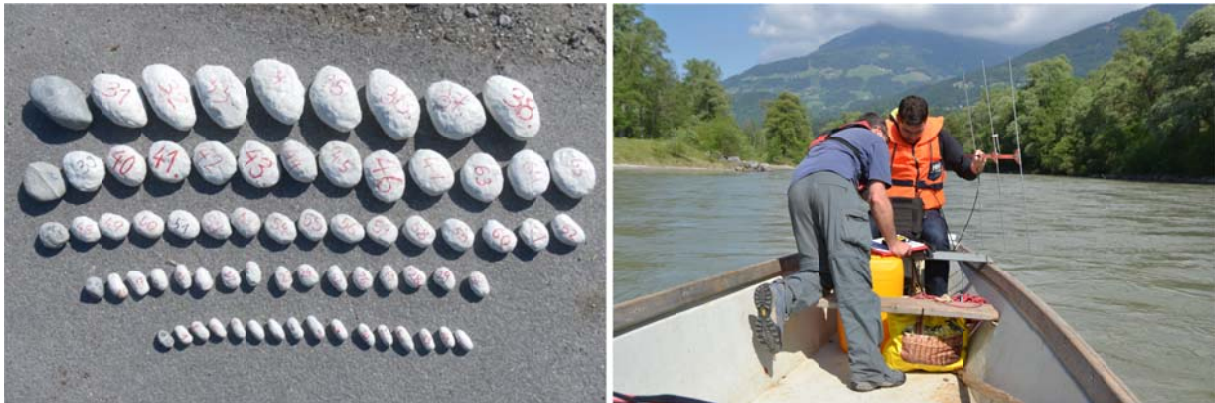
Figure 11: 65 coded radio tracer stones implemented in the Drau River (left) and the process of searching the tracers by boat

Around 20 km upstream of the study site Kleblach a sediment monitoring station of BOKU is located (Dellach im Drautal). 65 coded radio transmitters were used to create artificial stone tracers in 5 size classes using natural stones as templates (Figure 11 left). The stone tracers were put into the Drau River during low flow conditions ($\sim 35 \text{ m}^3/\text{s}$) 5 km upstream of the sediment monitoring station, which is equipped with a permanent

logging antenna to detect the tracers passing by at this cross-section. The monitoring of the tracer positions in the 5 km reach is performed by boat (Figure 11). The data serves as a basis for developing the SedRace tool in WPT2.

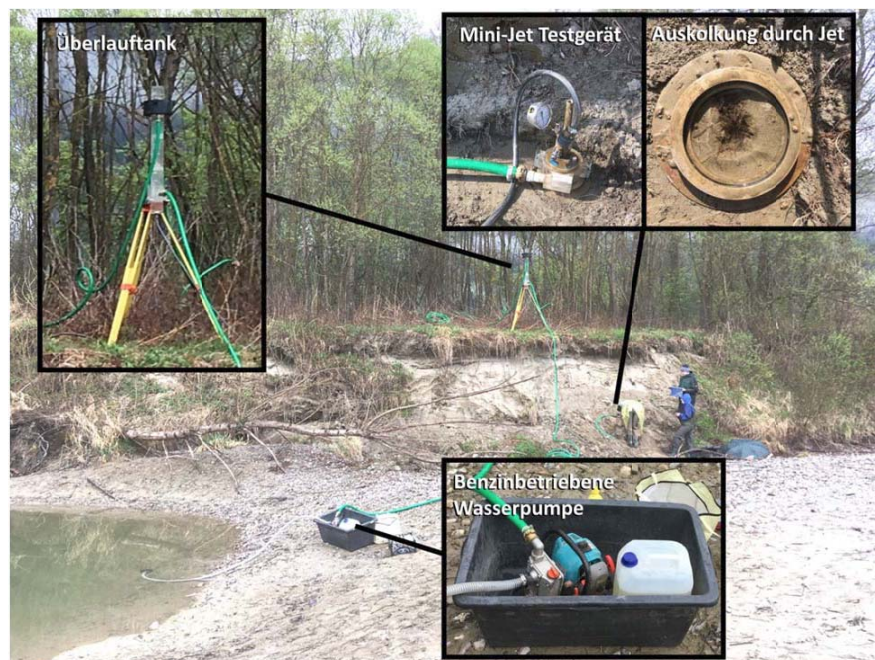
Figure 12: Experimental setup of the jet test

Jet tests are conducted at a characteristic riverbank of the Drau River to assess the erodibility of the cohesive sediment (Figure 12). We additionally assess the grain size distribution of the tested sediment as well as the bulk density.
