# Technical note about the monitoring of hydromorphological restoration/management of the Adige River in Italy

**Project:** HyMoCARES

**Deliverable:** D.T3.1.1. - Technical notes on monitoring protocols implemented on river management/restoration pilot sites

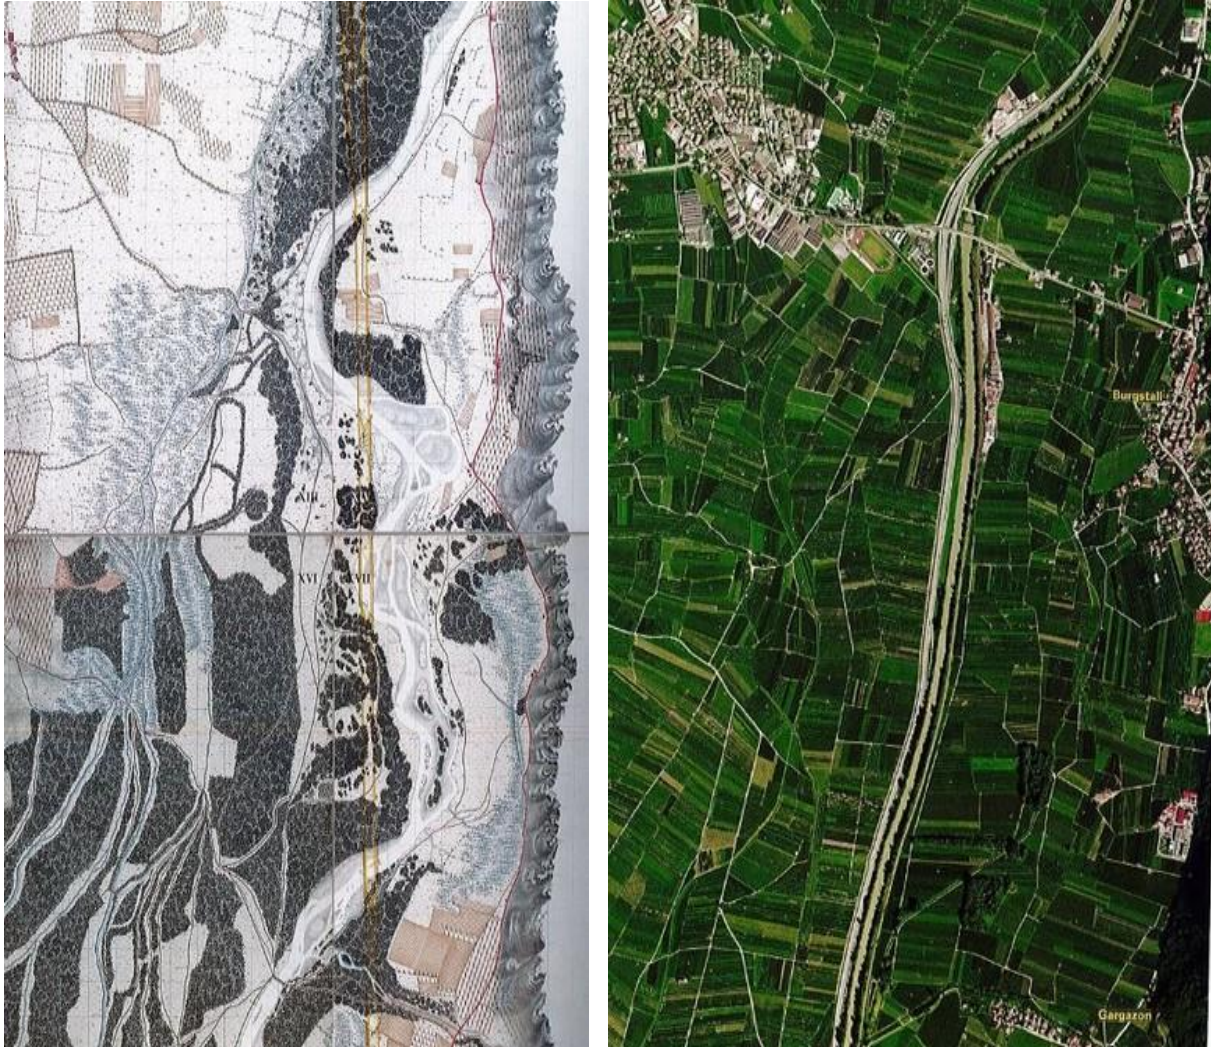
Figure 3 - Adige at Postal (Burgstall in German) at the beginning of 1800 (left) and in the 1998-1999 (right). The yellow lines on the left image indicate the river channelization proposal of the Austrian military engineer Ignaz von Nowack

Similarly to other large rivers in Central Europe, the Adige River was subject to massive channelization works during the 19<sup>th</sup> century, where channel narrowing and straightening was worsened by bank protection and reduction of bars and islands, which led to a loss of the river shapes and features. The consequences, visible in the 21<sup>st</sup> century, are the loss of habitats and species, channel incision due to the limited riverbed and high flow velocity leading to an active channel narrowing, in addition to sediment transport alteration highlighted by the lack of coarse material probably due to past gravel mining and present sediment entrainment. Figure 3 shows the changes of the Adige over time.

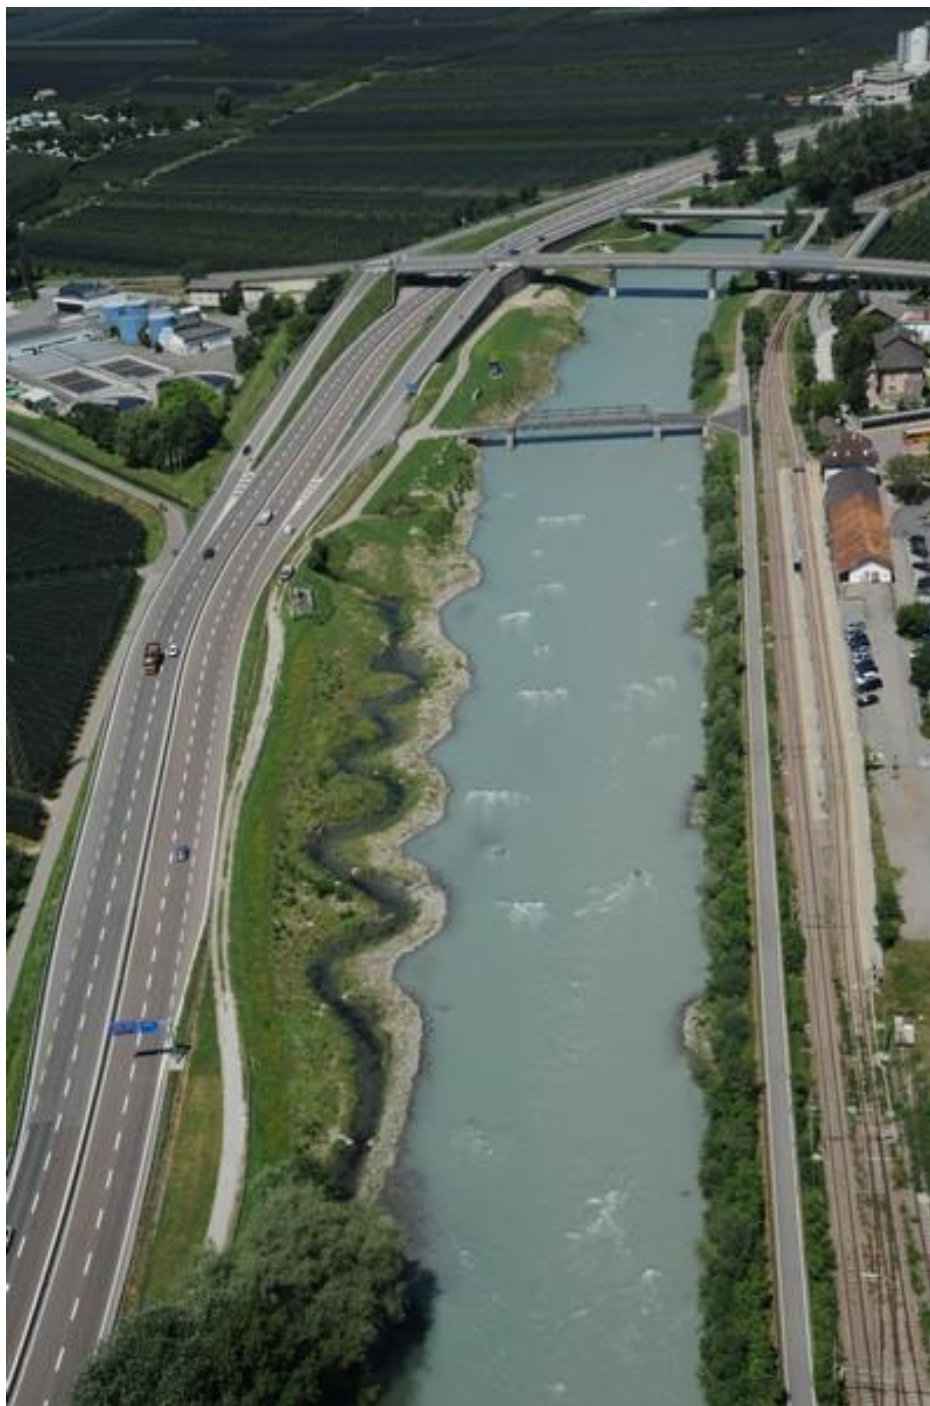
*Figure 4 - Restoration works along the orographic right of the Adige River (2012). Inlets along the reach and boulders distribution on the riverbed. Connection of the lateral ditch with the Adige favoring fish passage and habitat*

- Recreation of macroforms such as flow deflectors, island or inlets (Figure 4) contribute to create reaches and areas where water flows slowly, alternated to areas of faster flow, so that spawning gravel zones for trout reproduction can be re-established and the fish population is expected to grow.

Specifically the restoration in Postal consists in reshaping the orographic right reach, improving the lateral connectivity between the Adige and a later agricultural ditch (Figure 4); in addition large boulder have been placed upstream the restored reach. Along the Sigmundskron section the orographic left reach was reshaped by creating sand bows and inserting large boulder and wood logs (Figure 7).

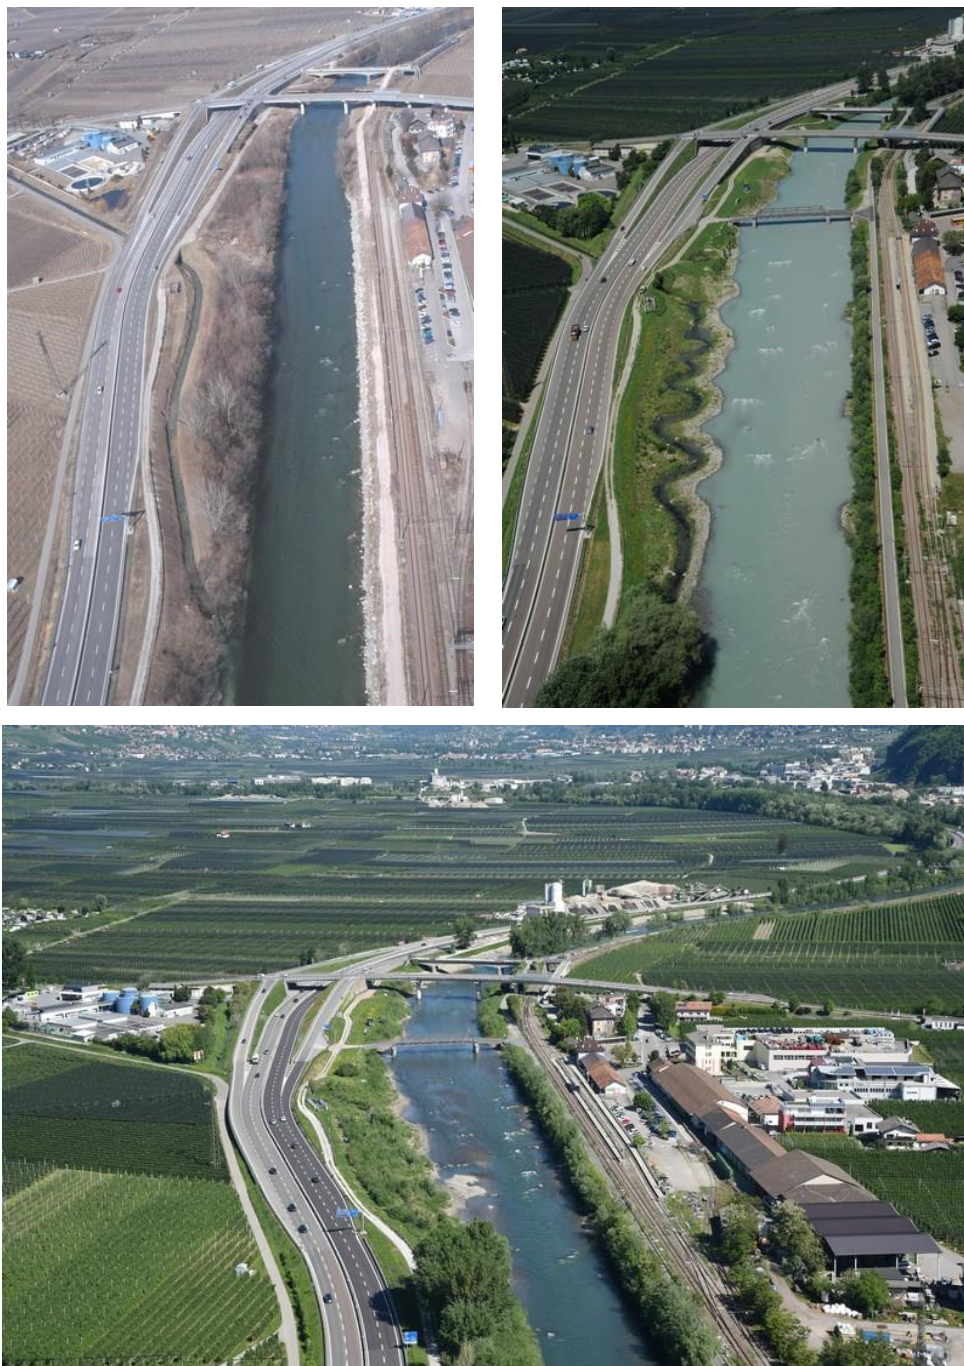
*Figure 6 - Adige River at Postal. River reach before the restoration on the top-left (2009), and after the restoration in 2013 on the top-right and in 2016 on the bottom*

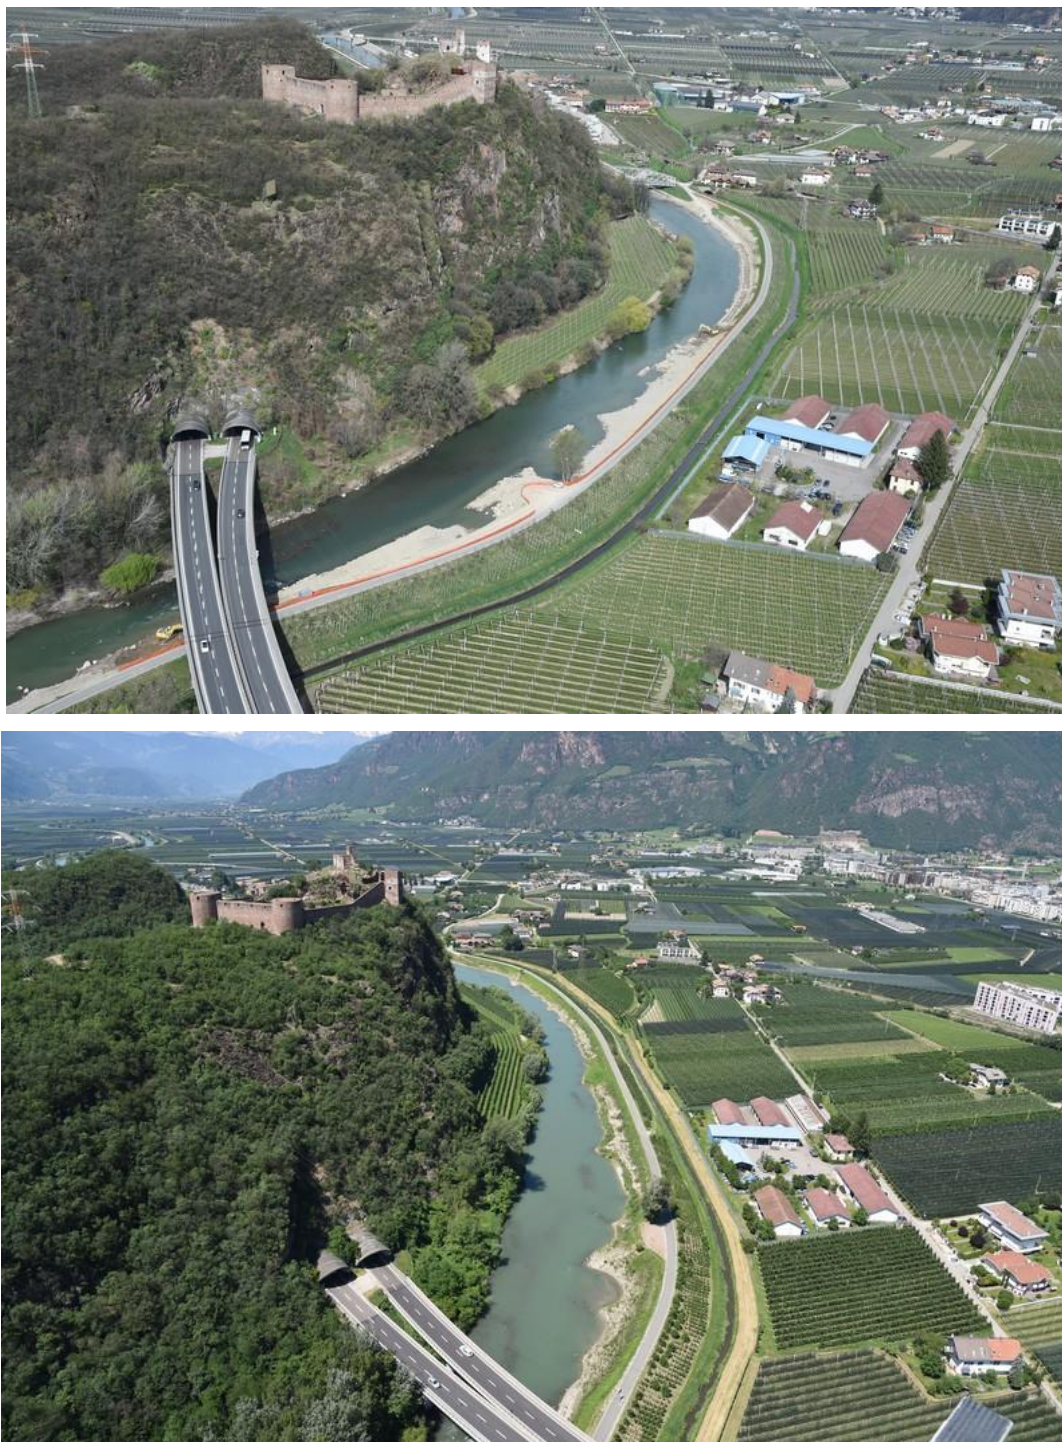
*Figure 7 - Adige River at Ponte Adige in 2015 (top) and 2017 (bottom)*
