HyMoCARES Project

D.T3.3.1 Technical note on the evaluation of physical and ecological effects of river restoration works

Case study: Buëch and Upper Drac rivers, France

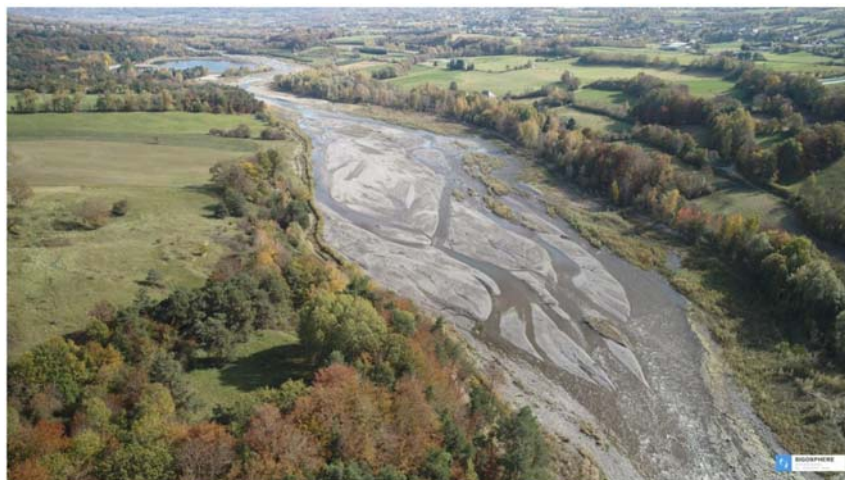
Fig. 14. Drone view of the restored reach of the Upper Drac in 2018, showing the spontaneous recovery of the braided channel morphology (@SIGosphere)

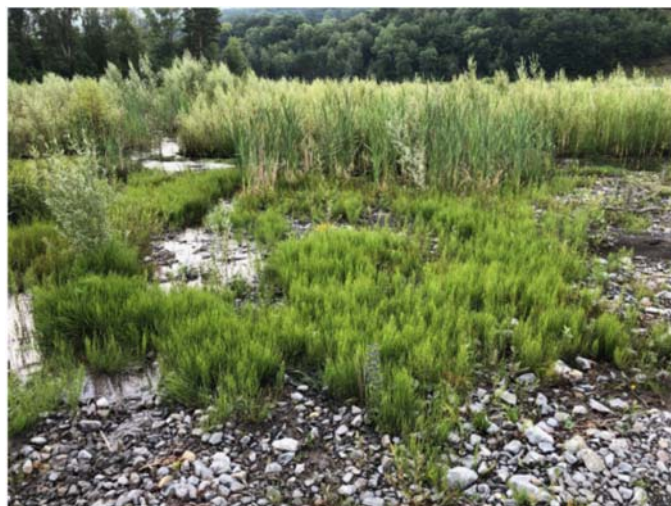
Fig. 24. Illustration of the recovery of the different layers of vegetation
 (©Delphine Gramond, Sorbonne University)

The diachronic analysis of SPOT satellite images over the period 2014-2017 and a field campaign in 2018 made it possible to map and study the evolution of the different functional units of the riverscape (water, bare alluvium, pioneer phase, herbaceous phase, shrub phase, forest phase, riparian area exploited, riparian zone occupied). This work was carried out on the restored sector and a test area upstream of the restoration zone (plain of Chabottes). Following the restoration work, the functional units diversified with the colonization of the unvegetated alluvial banks by pioneer and herbaceous vegetation. A strong spatial dynamic of the hydrological functional unit (water class) is observed: the erosive processes (alluvium naked towards water) are partly compensated by the processes of deposits (water towards alluvium). A functional break is always present between the riparian fringe and the outer woody strip. Intermediate strata (herbaceous and shrubby) do not provide (yet?) the successional relay (Gramond, 2018).
