HyMoCARES Project

D.T3.3.1 Technical note on the evaluation of physical and ecological effects of river restoration works

Case study: Wertach and Lech River, Germany

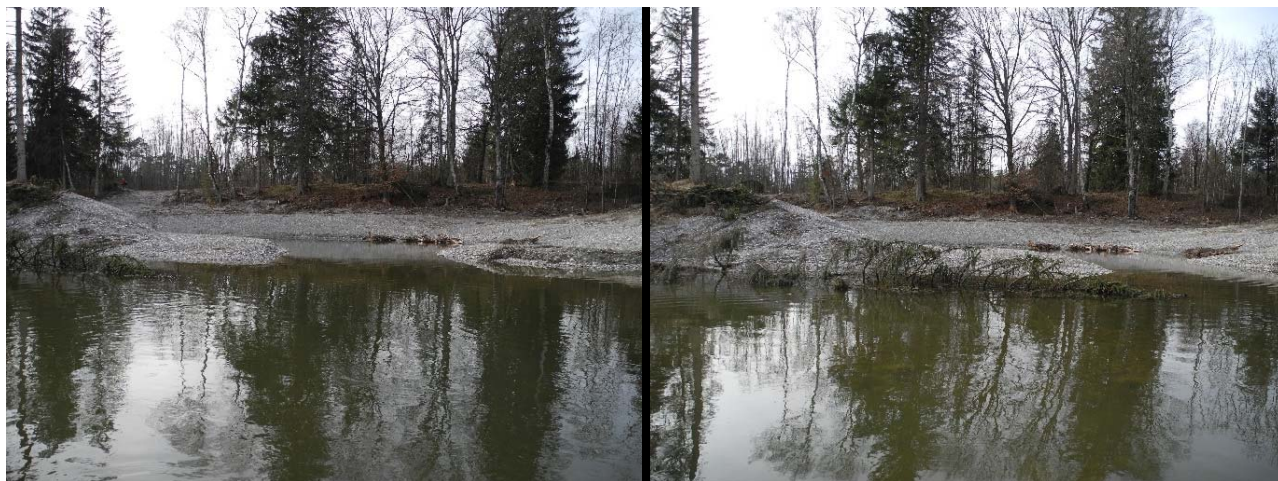
Figure 4 Pictures of the oxbow.

At the Lech river case study an oxbow was newly built (Figure 3, Figure 4 and Figure 5), because of the large structural deficits natural recruitment of rheophilic fish was not very likely.

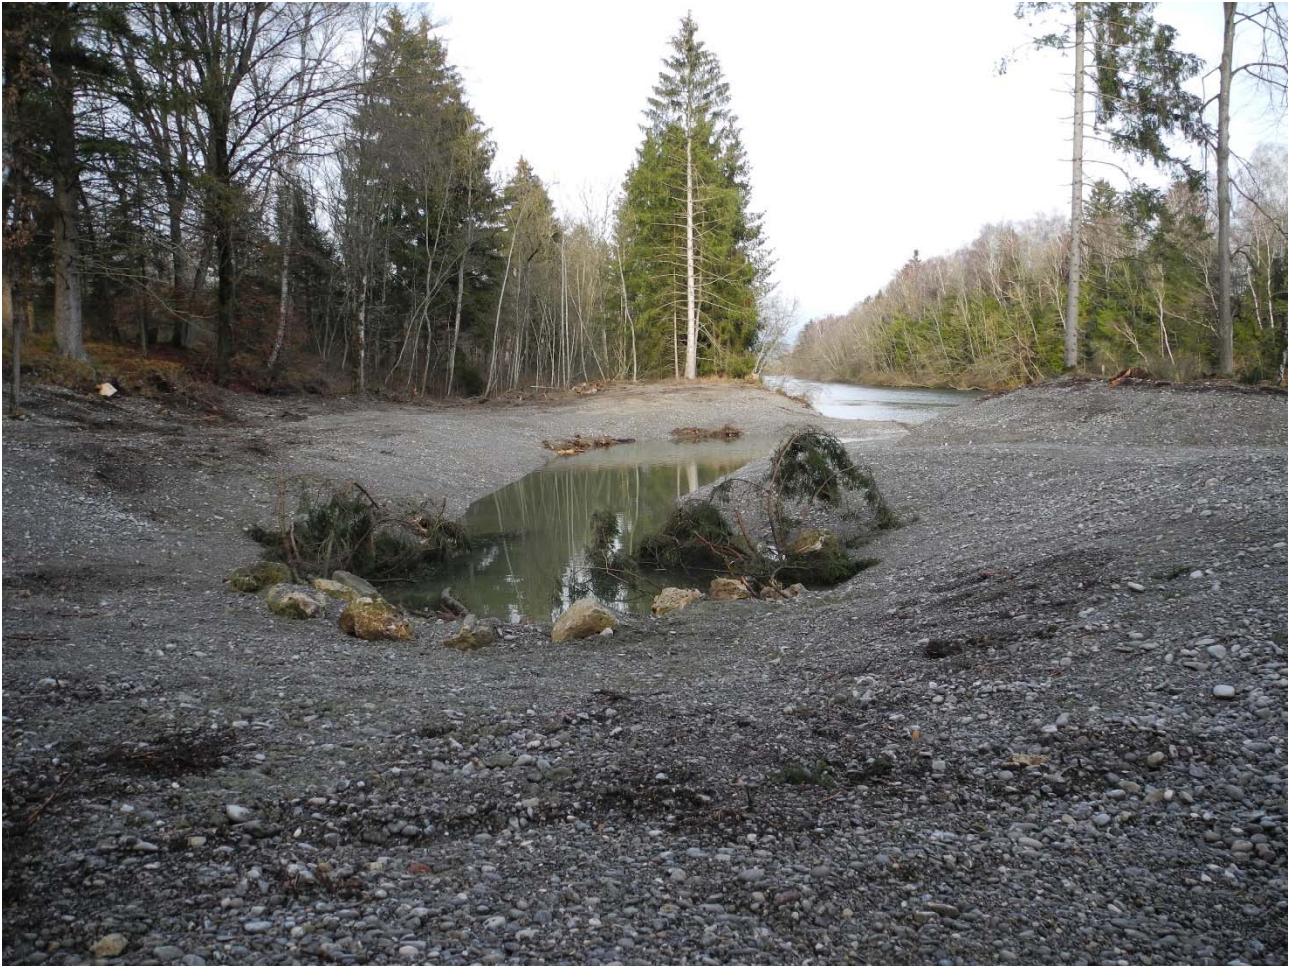
Figure 5 Oxbow view from the bank after the end of the project.

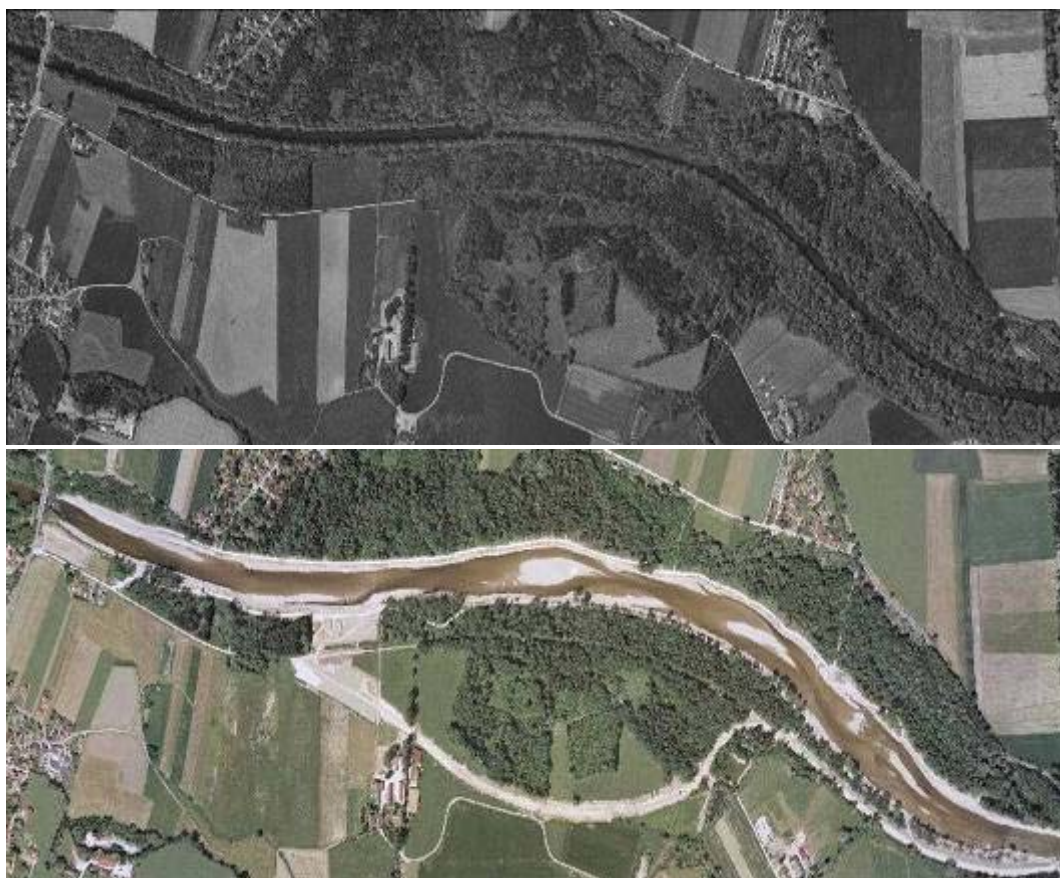
Figure 7 Wertach River case study pre and post restoration

At the Wertach River case study, a channel widening and a reshaping of the river cross-section have been realized (Figure 7, Figure 8 and Figure 9).

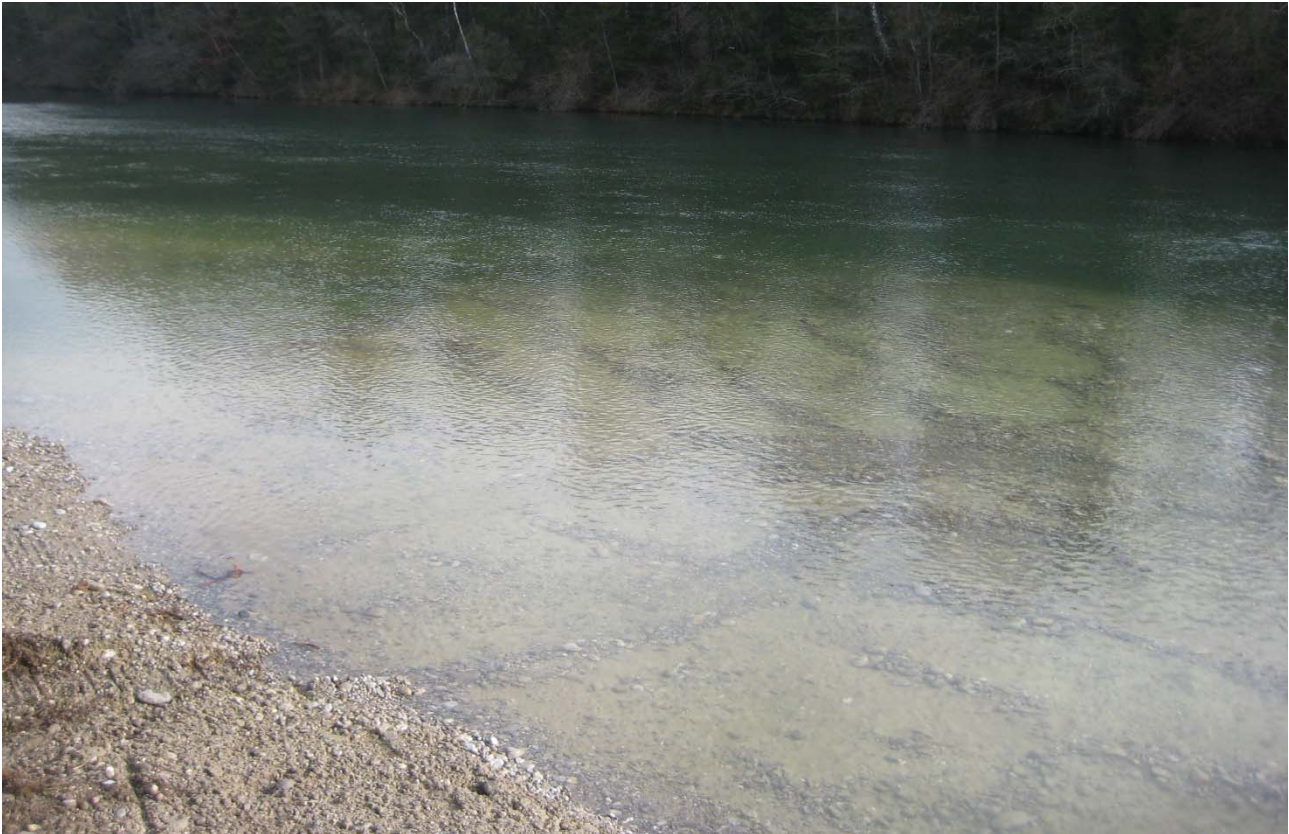
Figure 12 Artificial gravel bar in the Lech River.
