HyMoCARES Project

D.T3.3.1 Technical note on the evaluation of physical and ecological effects of river restoration works

Case study: Ischiello (Adige river) - Italy

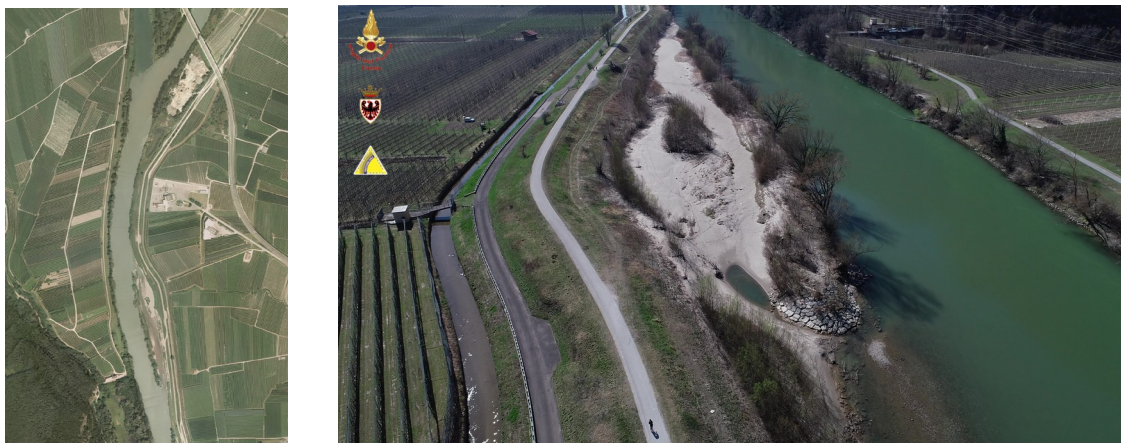
Fig. 1: Adige river restoration site

In 2011 the Autonomous Province of Trento carried out a river restoration project on the Adige River, downstream from the Noce confluence, in an area belonging to the biotope "Foci dell'Avisio". The restoration project was aimed at widening the active channel area in order to partially restore the portion of floodplain lost after the past river rectification and embankment operations. The area of the restoration intervention was identified based on a compromise between technical feasibility and land availability.

The project consisted of two different interventions. The removal of part of the existent embankment of the river with contextual remodeling of the floodplain along a 500 m long river reach. A sediment volume of about 70'000 m³ was removed from the study site in order to create a secondary channel, which activates in presence of consistent flow conditions. The resulting sediment volume was used for landfill capping operations. Almost 500 meters upstream, near the Noce confluence, a second part of the restoration project was aimed at creating an artificial riparian area 100 m long and 30 m wide with a pond directly connected to the main course of the Adige River.
