## ***HyMoCARES Project***

### ***D.T3.3.1 Technical note on the evaluation of physical and ecological effects of river restoration works***

#### **CASE STUDY: TALVERA RIVER (ITALY)**

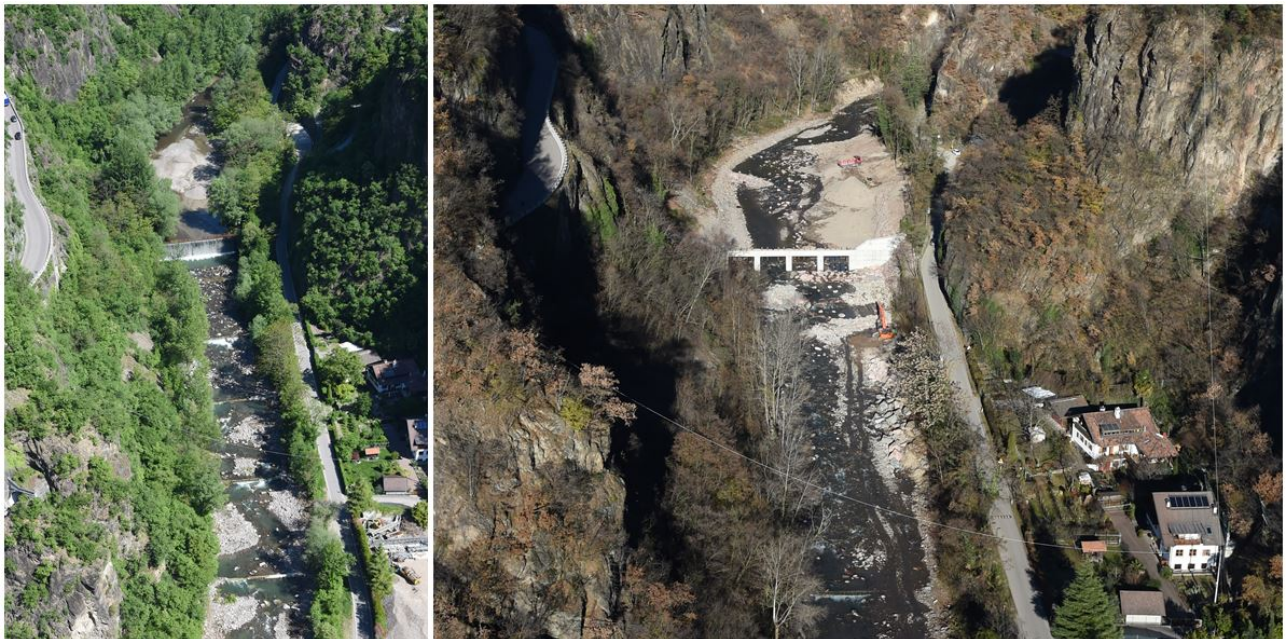
Figure 4: Consolidation check dam previously on site (left) and lately substituted by a retention check dam (right)

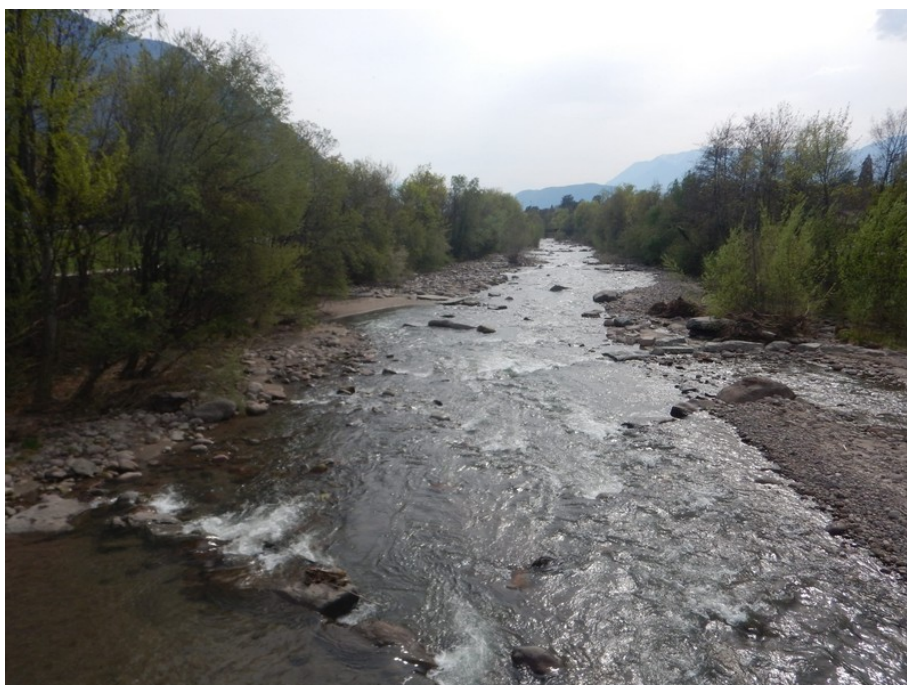
Figure 21: Reach T4, upstream view. Detail of a flow deflector in the foreground

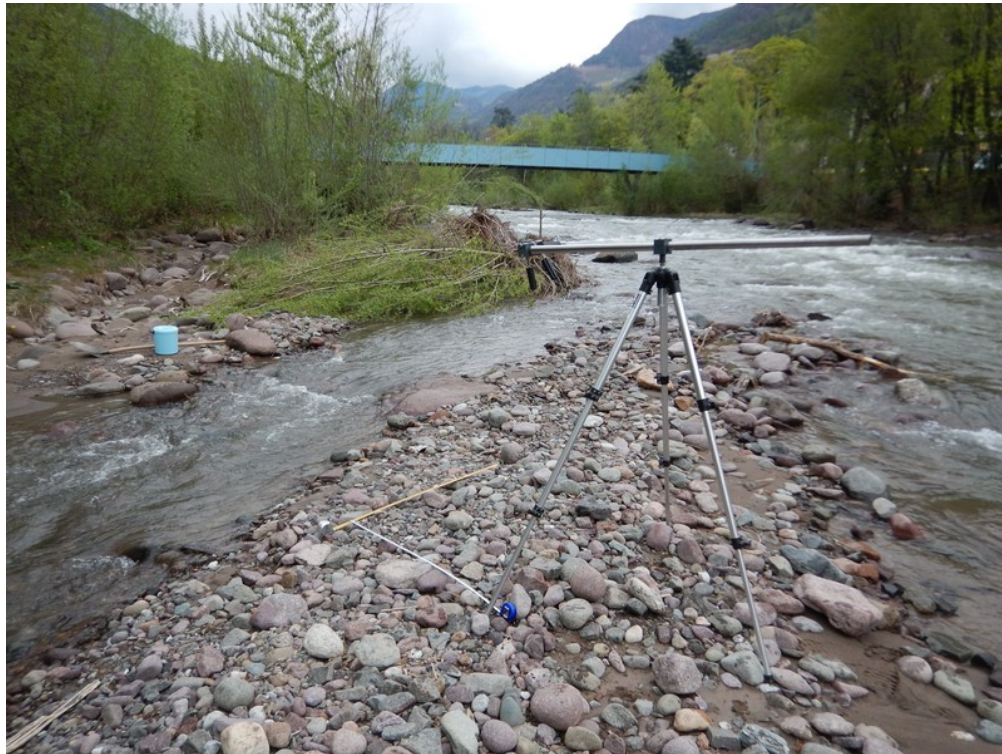
(a) Identification of the sampling area and positioning of the mount supporting the camera

Figure 22: Field survey based on photos and grain size measurements

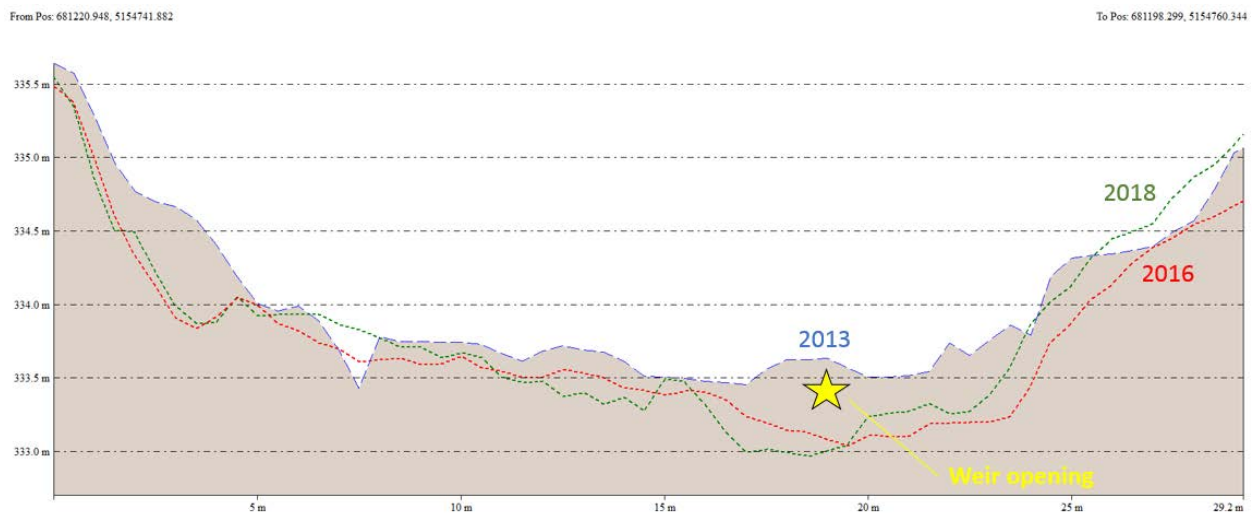
(b) Cross-section 2 showing the profile on the weir

Figure 30: Cross-sections profile over time. Cross-section 1 and 2 are identified in the planimetric view in the Figures 28 and 29

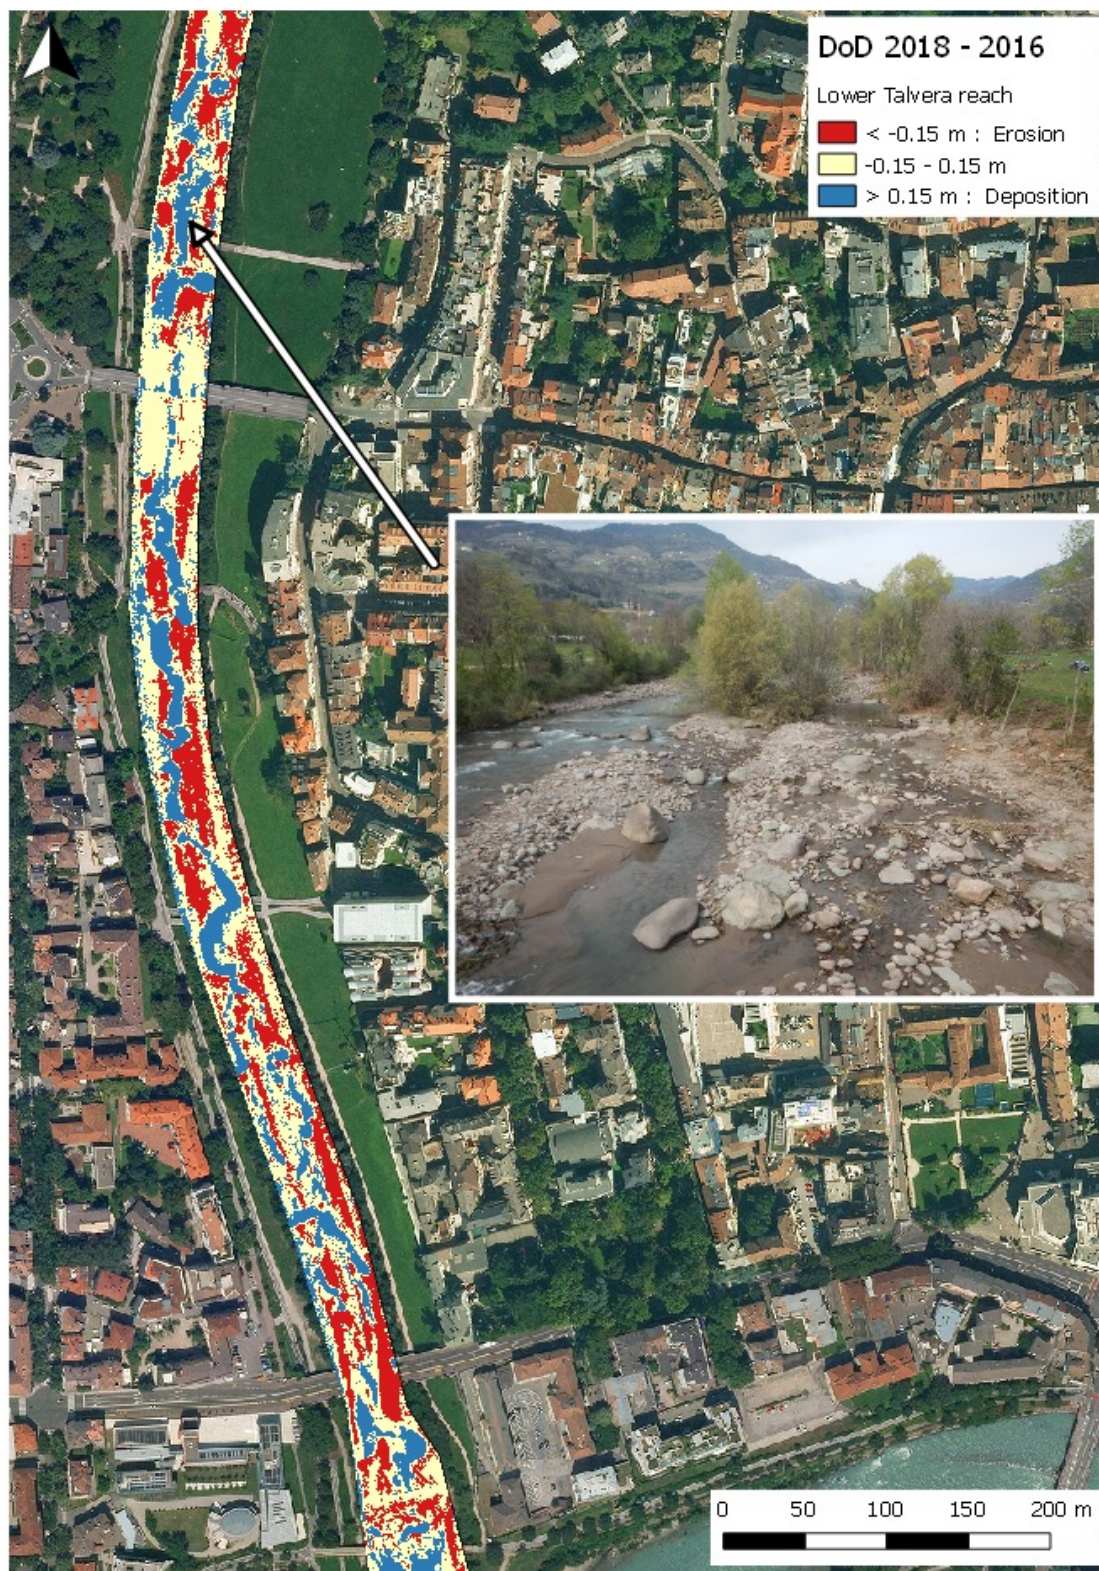
Figure 31: DoD 2018-2016 of the low study reach of the Talvera Torrent with a picture showing a deposition area

brought by the flood provided an unusual supply. Figures 29, 31 and 32 show a significant difference in aggradation-deposition pattern between the upstream and the downstream portion of the study reach. In particular, the reach upstream from the Talvera bridge exhibits a non clear pattern (Figure 29) due to the high energy of the flow (the mean bed slope is 2%); on the contrary the reach downstream the same bridge presents a deposition-erosion pattern which becomes more clear toward the confluence (compare Figures 31 and 32). In this reach the mean bed slope is around 1.2 %. The meandering deposition patterns downstream the Talvera bridge can be explained by the mean slope between alternated weir partial openings being milder than the mean bed slope. The post-event-morphology characterized by meanders is not natural for channelized water courses and it might depend on the strong anthropization of the Talvera. The difference between the eroded and deposited sediment volume (2018 - 2016) amounts to 5500 m<sup>3</sup> of eroded sediment, which might be a good indicator for higher longitudinal sediment dynamics. The removal of one large consolidation check dam in the upper part of the study reach, triggered sediment transport, which was enhanced by the flood occurred on October 2018, which eventually determined a net sediment loss. Finally, Figure 33 shows the downstream effect of the check dam removal in terms of depositional pattern (blue area) and of excavated area upstream the check dam (red area). The picture refers to the upstream area in which material has been excavated to build the retention check dam and its retention basin.

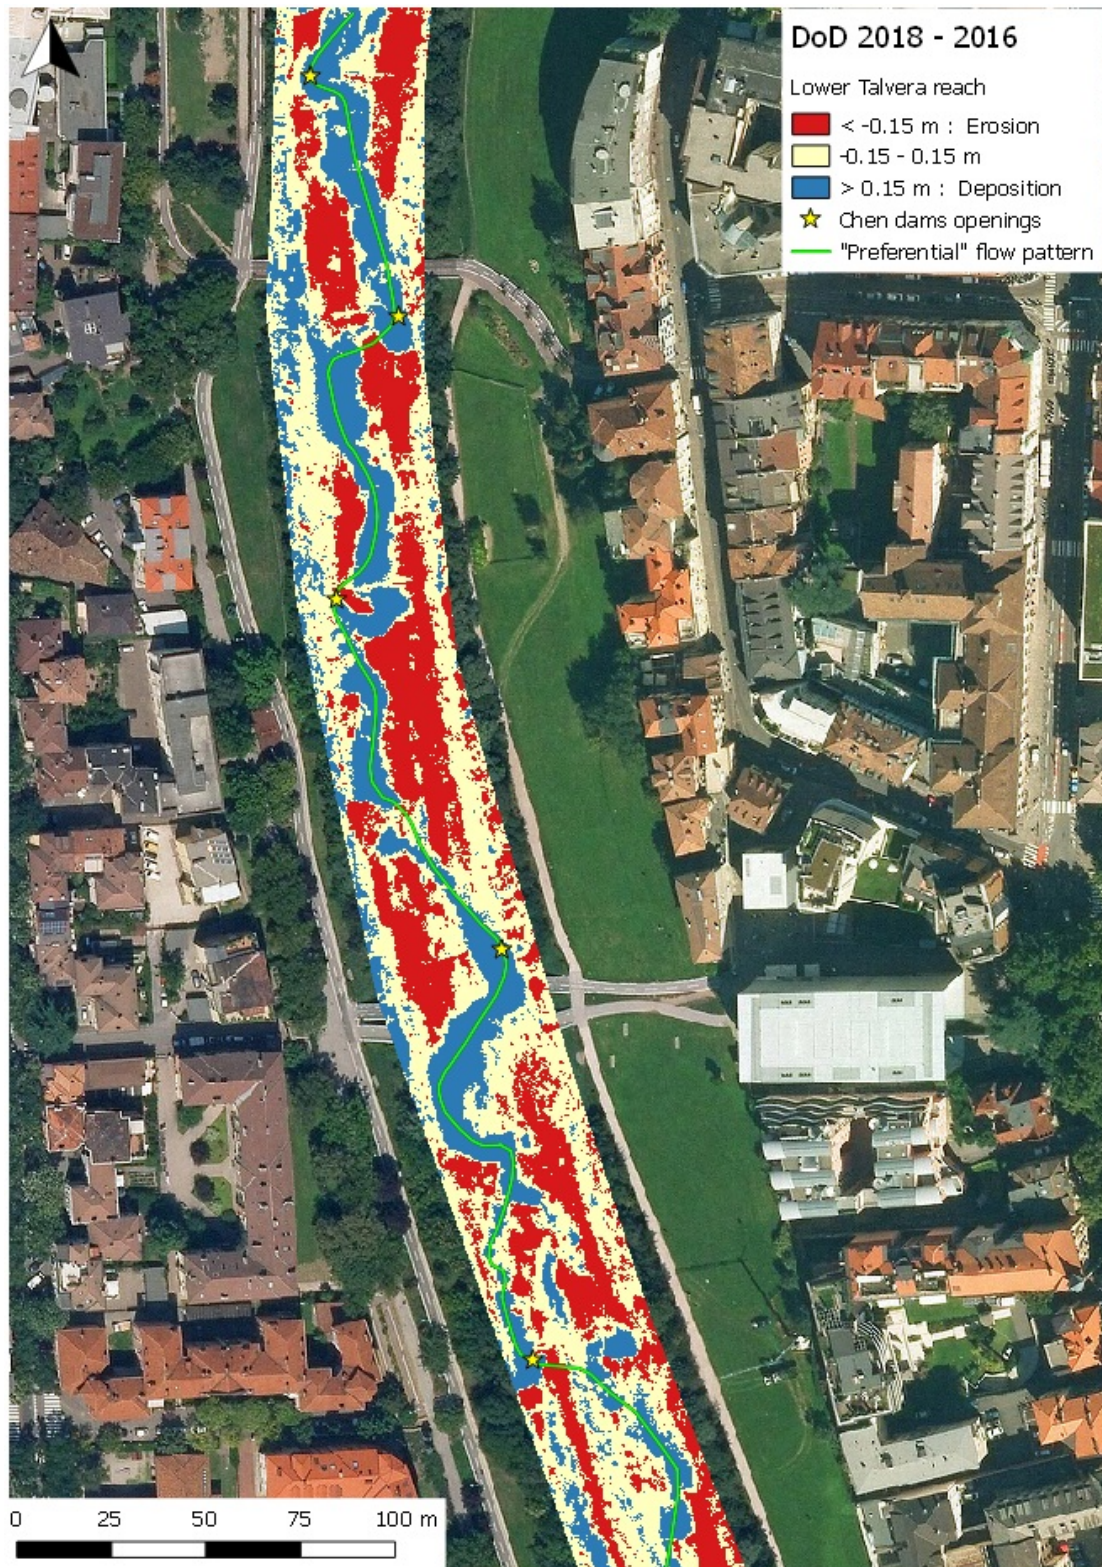
Figure 32: DoD 2018-2016 of the low study reach of the Talvera Torrent showing the depositional pattern determined by the weir openings

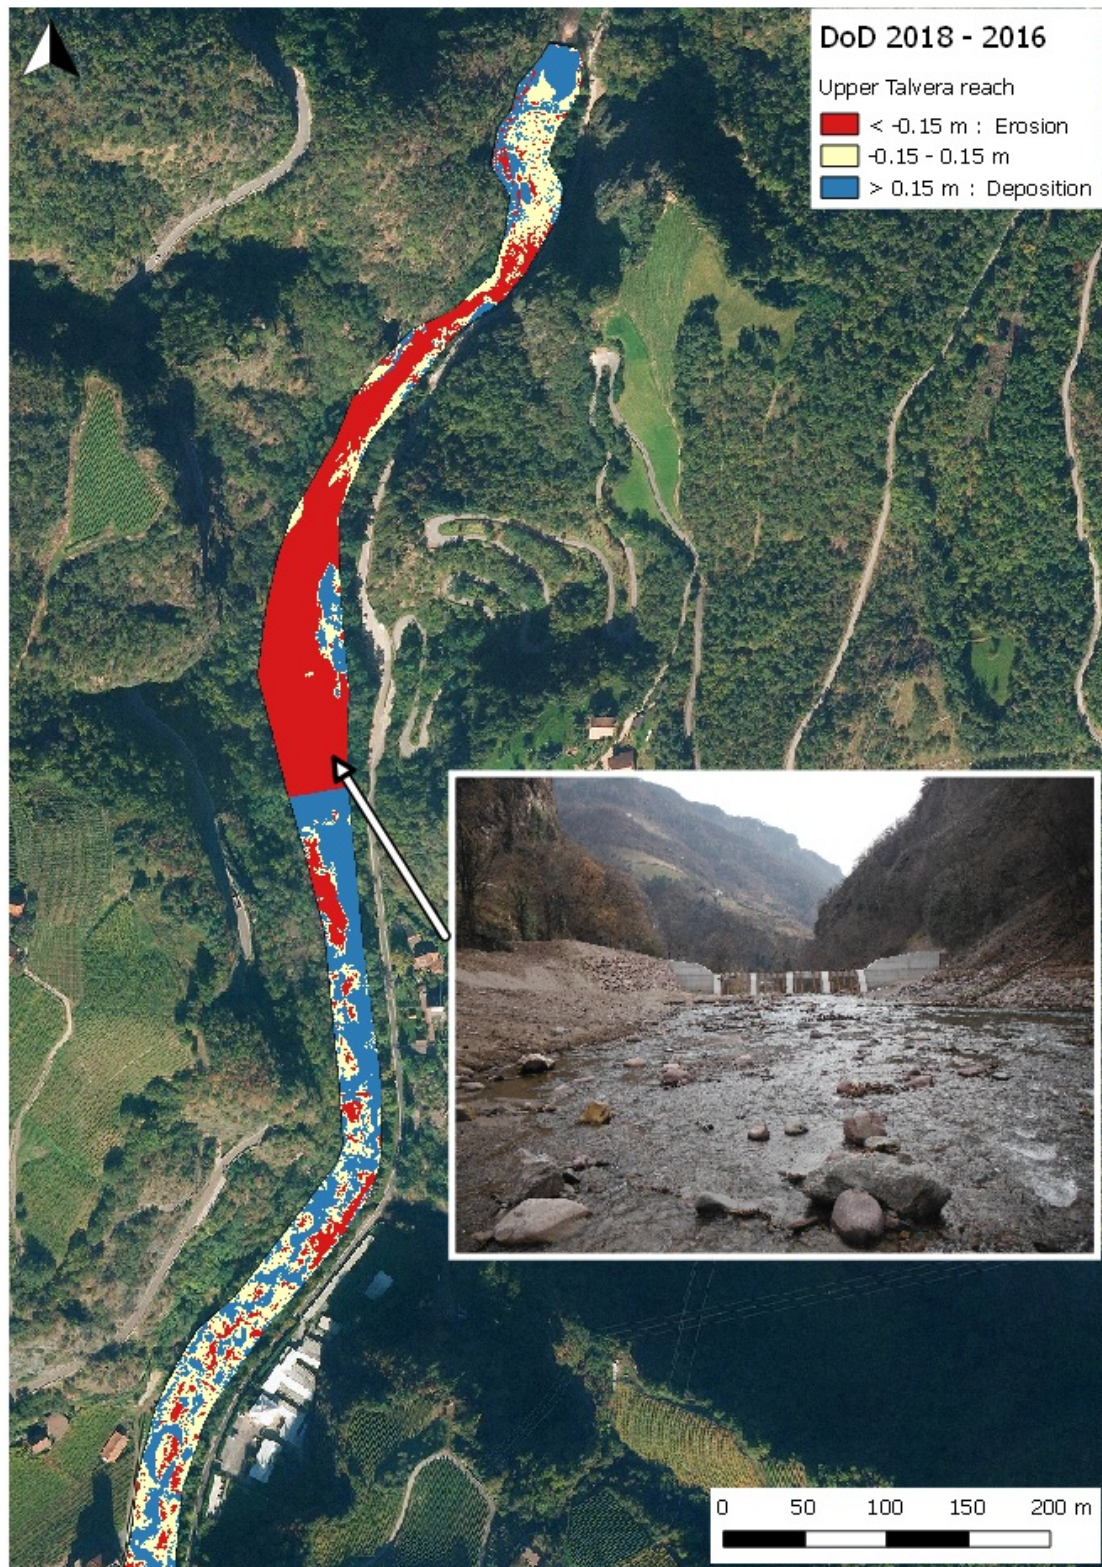
Figure 33: DoD 2018-2016 of the upper study reach of the Talvera Torrent with a picture showing erosion and deposition areas as a consequence of the check dam removal

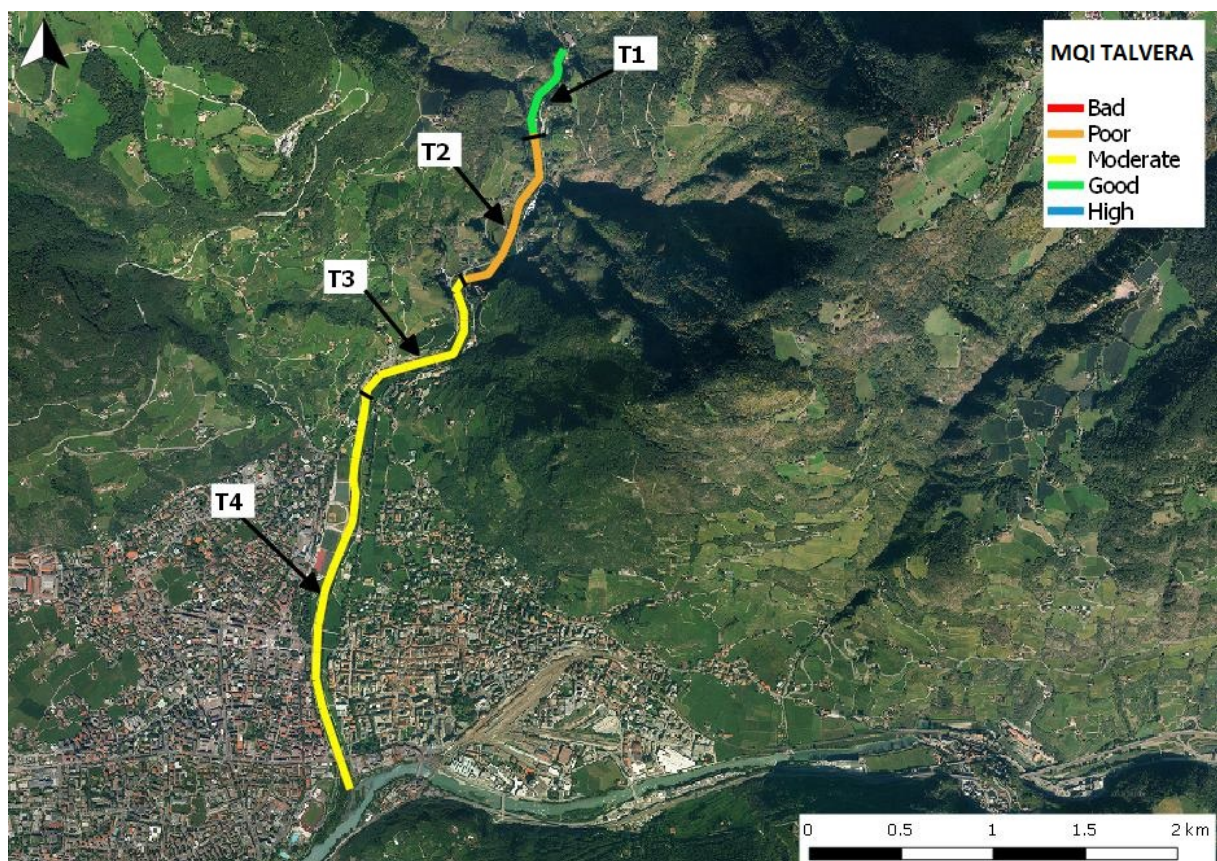
Figure 35: Final judgment on the MQI classes for each analysed reach

The application of the Morphological Quality Index resulted in a different classification according to the river reach. In particular, for the upper Talvera reach, subject to less anthropization compared to the others, the morphological quality has been classified as *Good*. The MQI for the reach T2 has been classified as *Poor*, while for the reaches T3 and T4 as *Moderate*. Figure 35 shows the MQI classification by colors for each study reach.

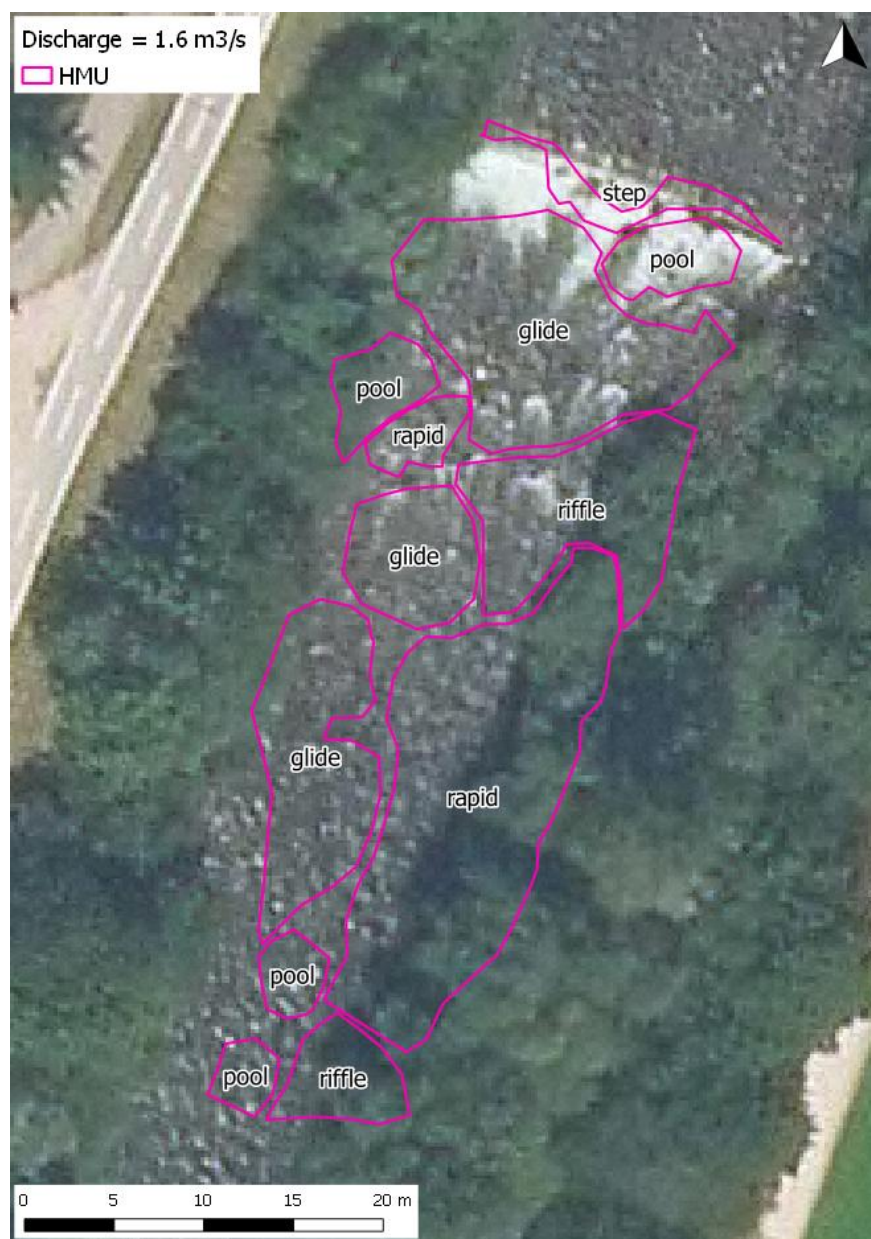
Figure 50: HMUs associated to a discharge of 1.6 m<sup>3</sup>/s

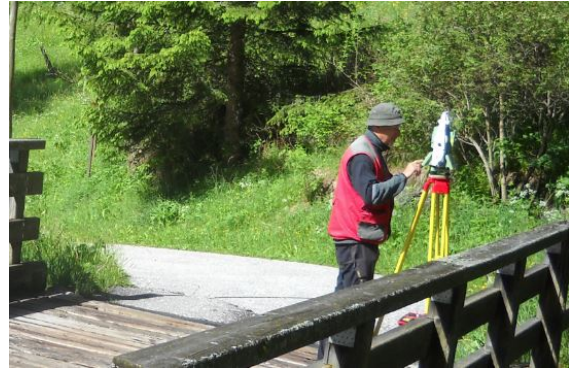
(b) TS used for collecting topographic data

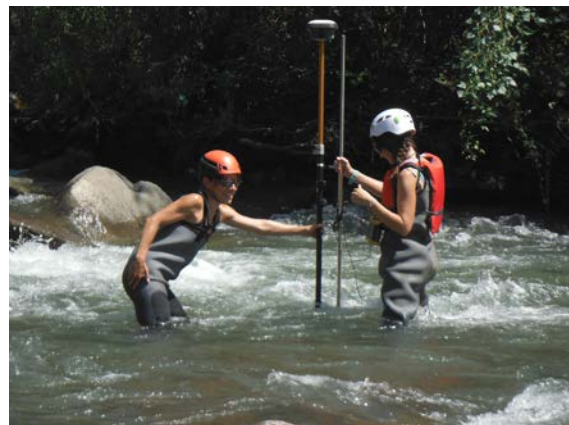
(d) Flow depth and velocity measurements

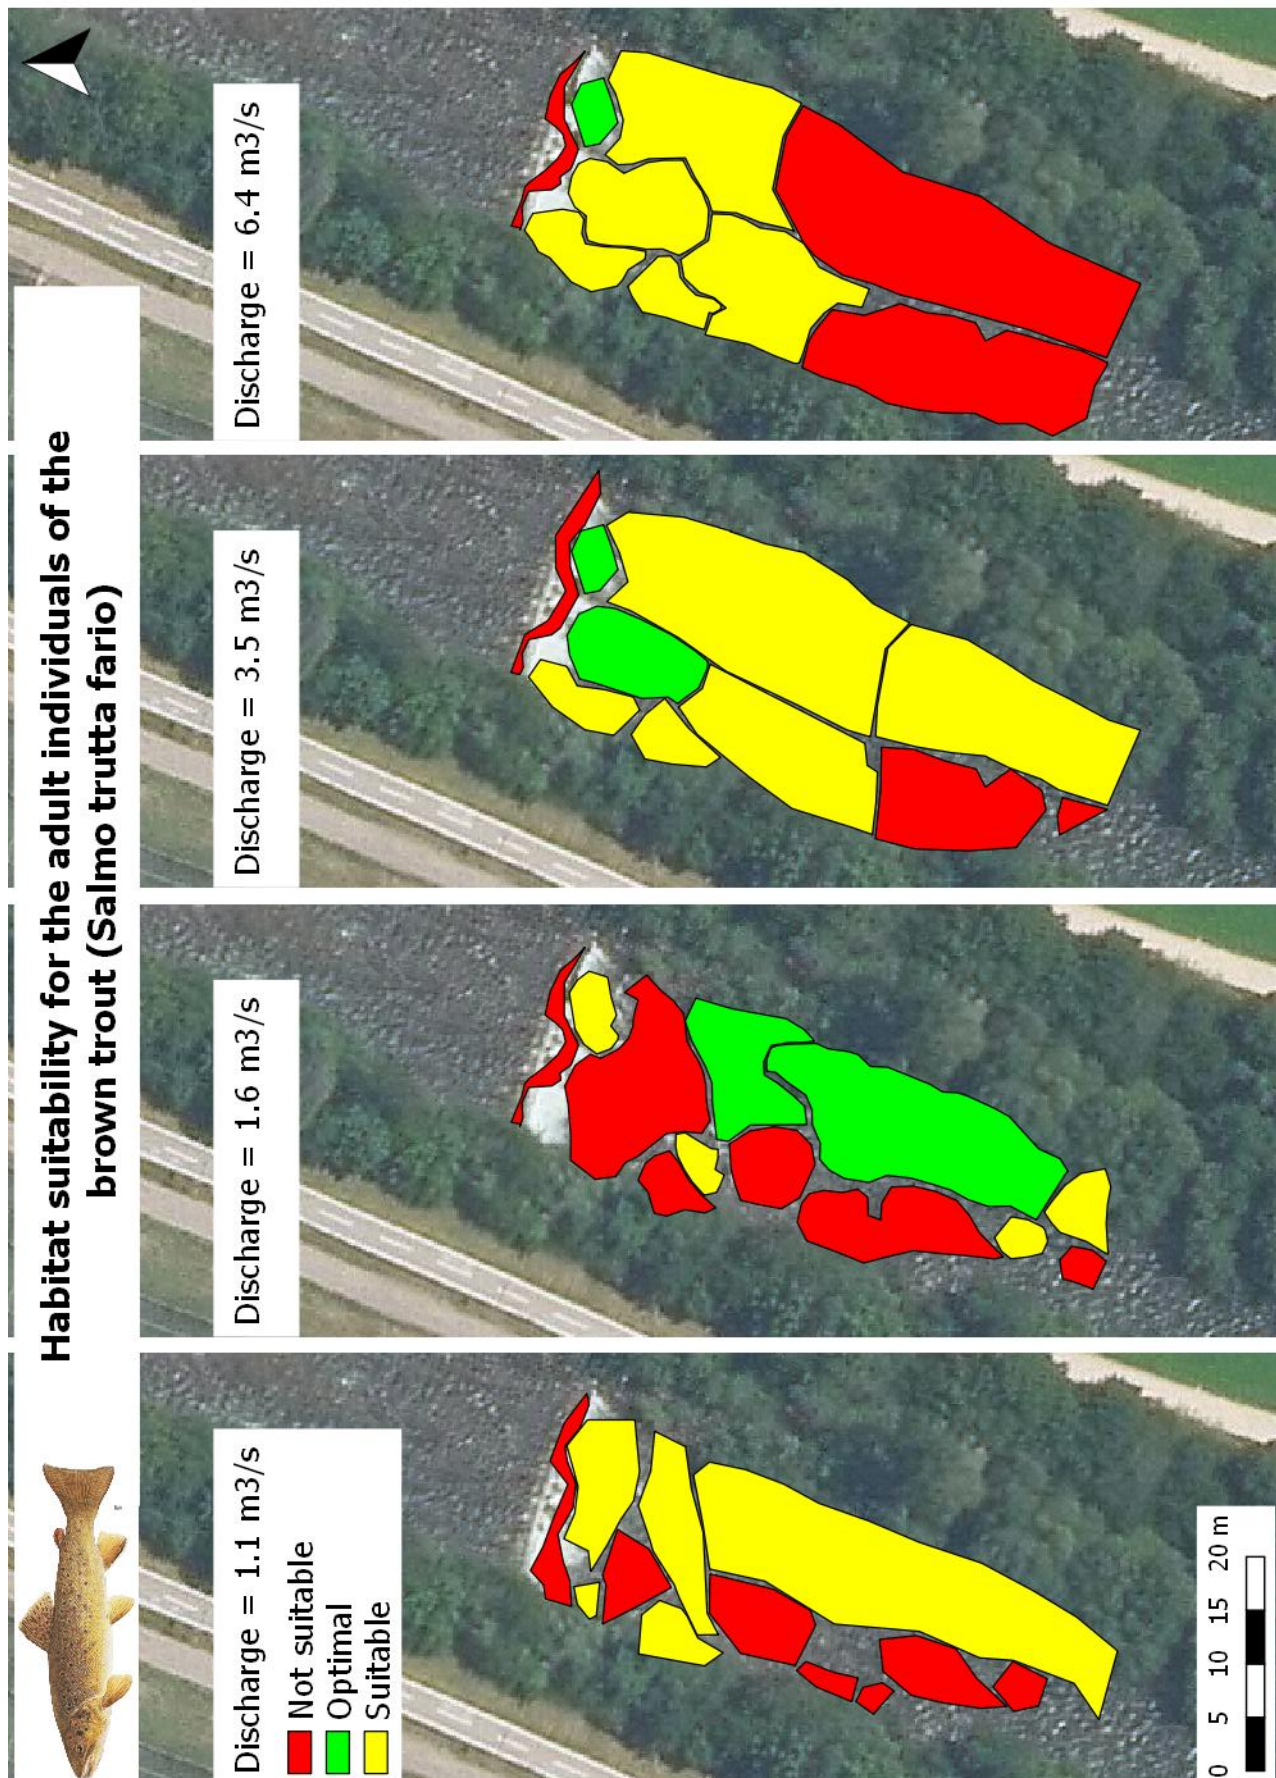
Figure 52: Maps of habitat suitability for the brown trout species depending on different simulated discharges

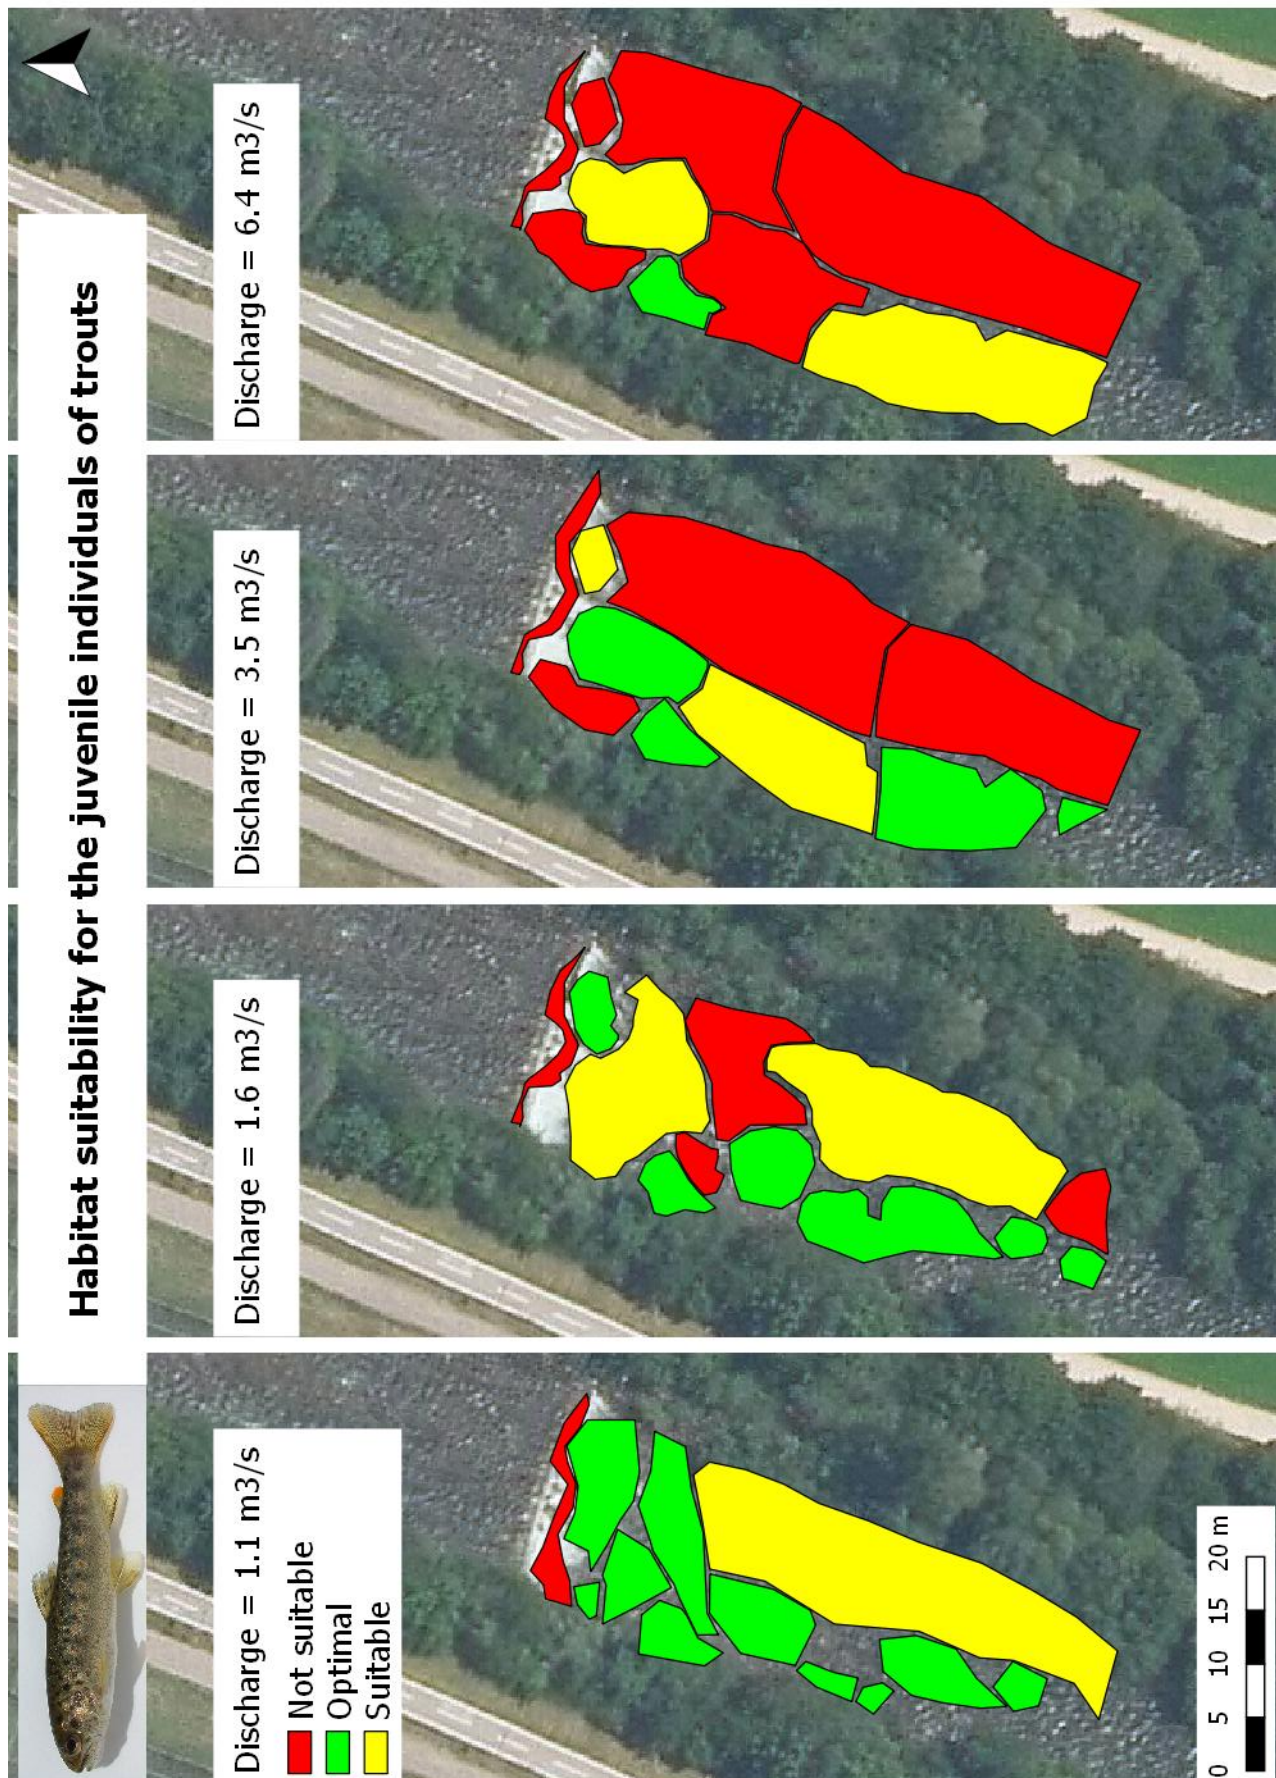
Figure 54: Maps of habitat suitability for the juvenile trout species depending on different simulated discharges

- Juvenile trouts: the suitable condition occurs at a discharge of  $1.1 \text{ m}^3/\text{s}$  and then the available habitat decreases monotonically with the discharge;
