HyMoCARES Project

D.T3.3.1 Technical note on the evaluation of physical and ecological effects of river restoration works

Case studies: Drau, Mur, Salzach (Austria)

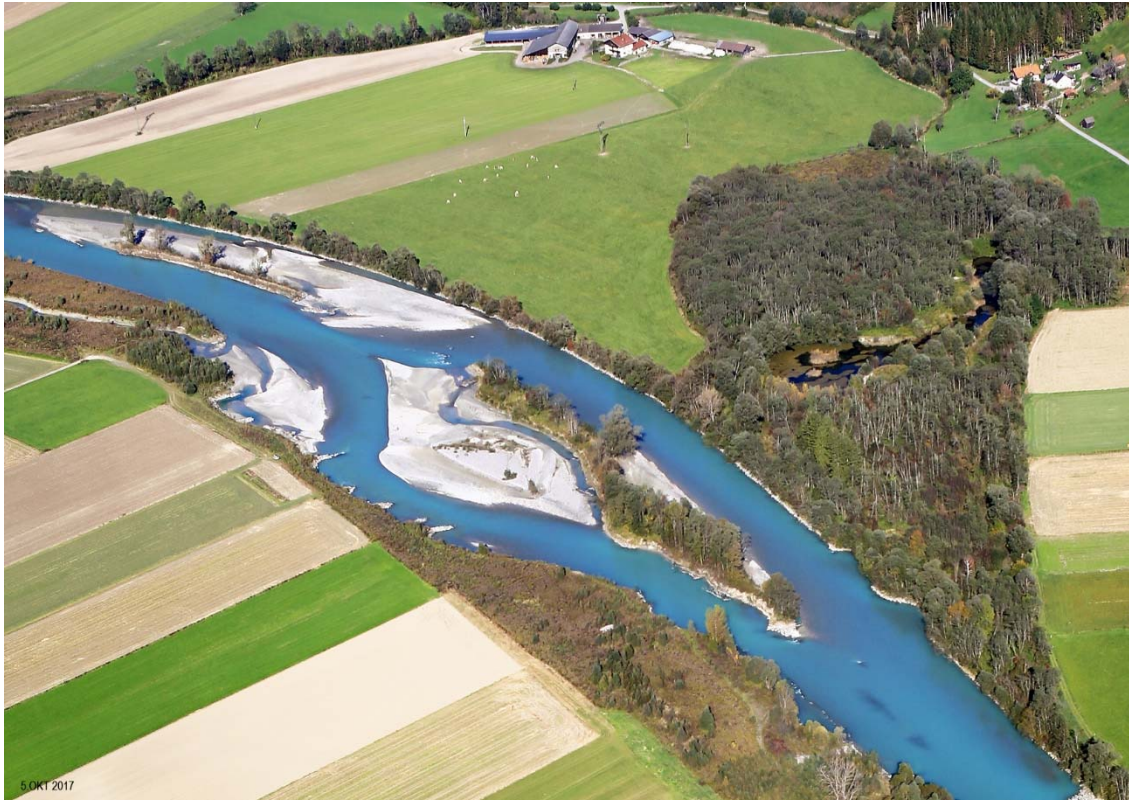
Figure 2. Emergence and enlargement of a mid-channel bar at a restored site of the Drau River, accompanied by excessive widening which required an expansion of bank protection (groynes) to prevent erosion of land outside of the provided corridor (source: Carinthian government).

5 km downstream of Kleblach, near the village Obergottesfeld, another reach was restored. The restoration measures included the excavation of two side-channels, one 1 km in length, the other 600 m in length, and again an embedment of groynes. Finished in 2011, the upstream side-channel quickly widened and triggered massive bank retreat, which required the installation of additional groynes.

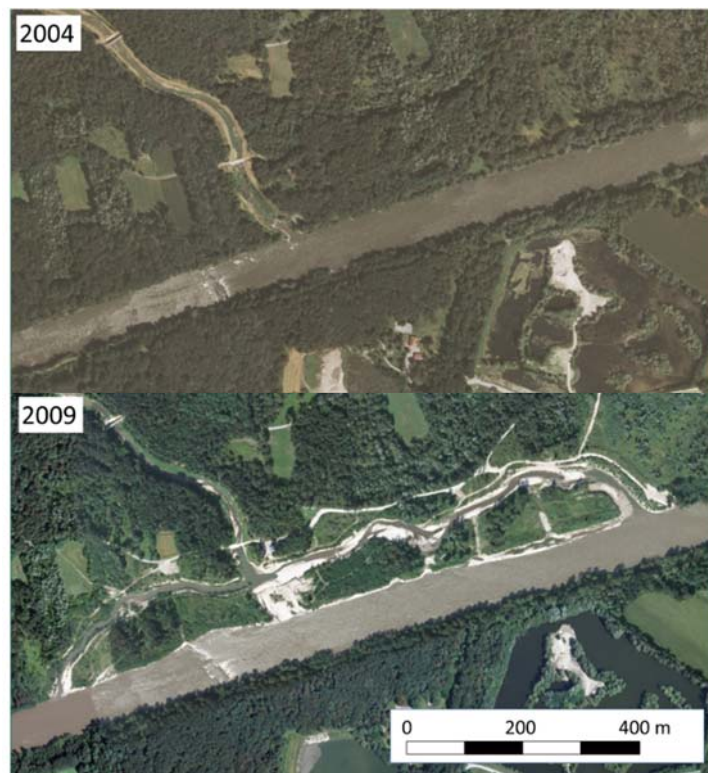
Figure 4. Mur River before (2004) and after (2009) restoration (image source: google earth)

Figure 4 displays satellite images from the channelized (2004) and restored Mur section at Gosdorf.

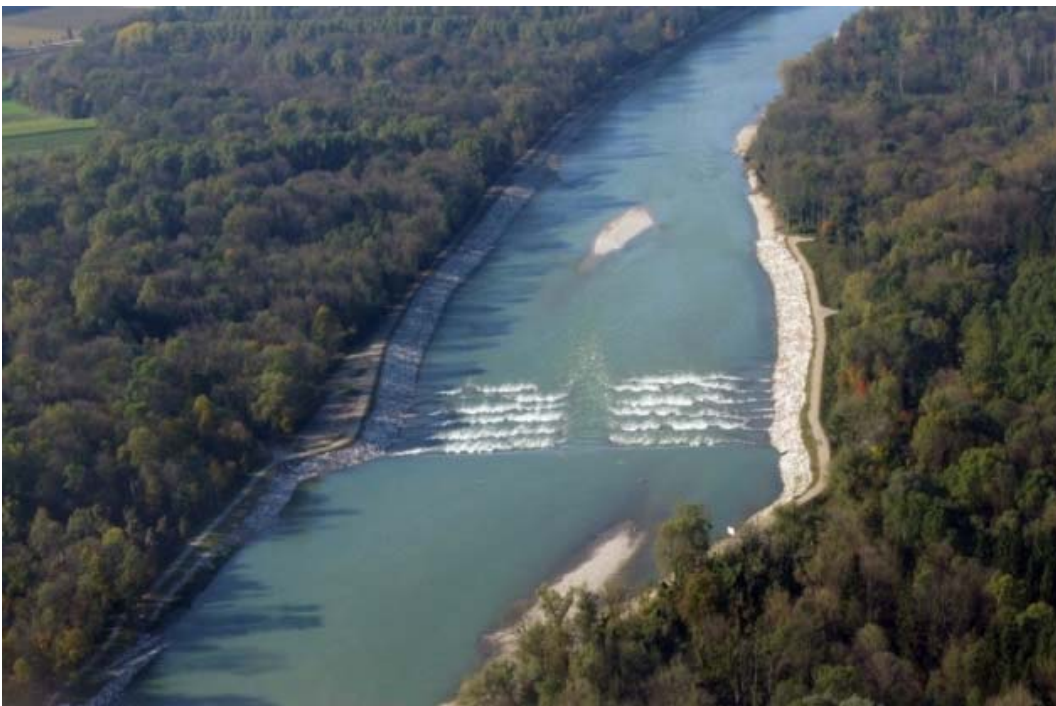
Figure 5. Step-pool ramp constructed in the year 2010 in the Salzach River to rise the bed level upstream. Removal of bank protection downstream intended to compensate the bedload deficit which resulted from sediment trapping upstream of the reservoir.

In 2010, a ramp was constructed at river-kilometer 51.9 to rise the bed level upstream (Figure 5). The ramp decreased the channel slope upstream and temporarily caused a trapping of the supplied sediment. To compensate the resulting temporary bedload deficit in the downstream section, the bank protection structures were removed in the downstream section. The gravel which enters the riverbed from bank erosion should compensate the deficit from upstream.

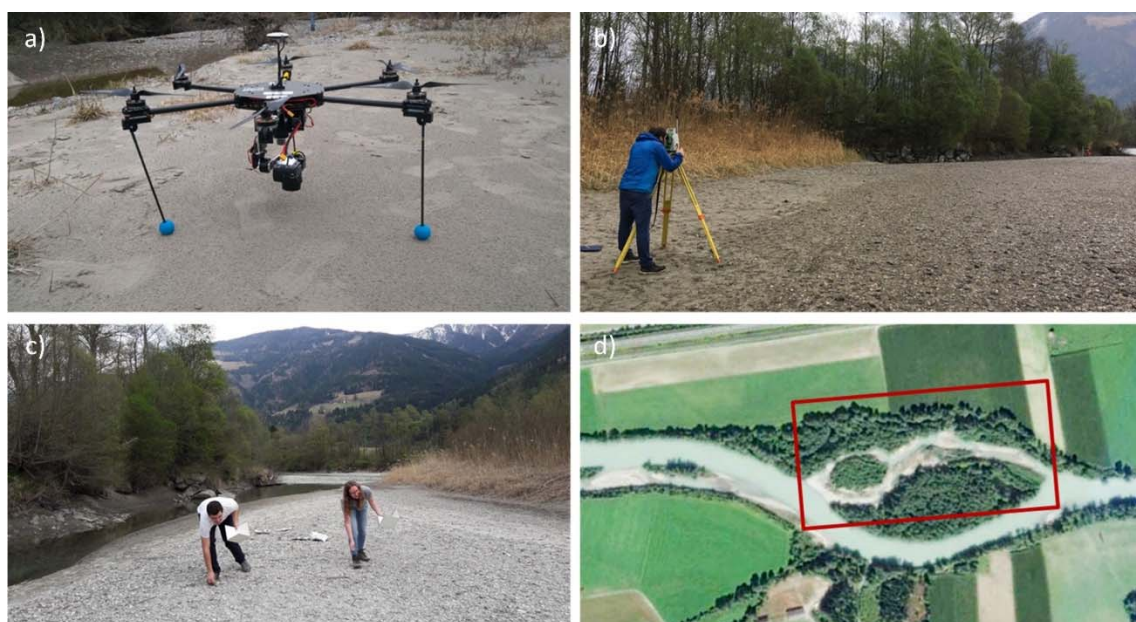
Figure 6. Morphological monitoring at the Drau River (Austria) - a) used drone for the structure from motion (SfM) photogrammetry, b) terrestrial survey, c) Wolman pebble counts for grain size analysis, d) location of the survey

Side channel survey - Within the physical monitoring at the Drau River in Austria repeated UAV (unmanned aerial vehicle) surveys were conducted in the side channel (Figure 6d). For that purpose, a drone (Figure 6a) equipped with a camera was used to collect high-resolution spatial data in April 2017, April 2018 and March 2019. Structure from Motion (SfM) photogrammetry was applied to extract dense and accurate three-dimensional point clouds. The analysis of UAV-images was conducted with Agisoft PhotoScan Professional photogrammetric software. Submerged areas and areas covered by vegetation were additionally investigated by terrestrial surveying using a total station (Figure 6b). The data sets from the terrestrial survey and the drone survey were finally merged and Digital Elevation Models (DEM) for both measurement campaigns were derived and used to produce difference maps. The development of the elevation and the morphology respectively is crucial for the assessment of hydromorphological restoration measures.

Wolman pebble counts - To characterize the grain sizes in the monitored reach samples were taken using the Wolman pebble count technique (Wolman, 1954) (Figure 6c) in April 2017. A data set of 11 Wolman pebble counts was taken exposed and representative gravel bars. Each pebble count consisted of 100 grains collected along two lines. To minimize bias, all the grains were selected by the same person. A Pebble box (Bunte & Abt, 2001) was used to measure the b-axis of grains.

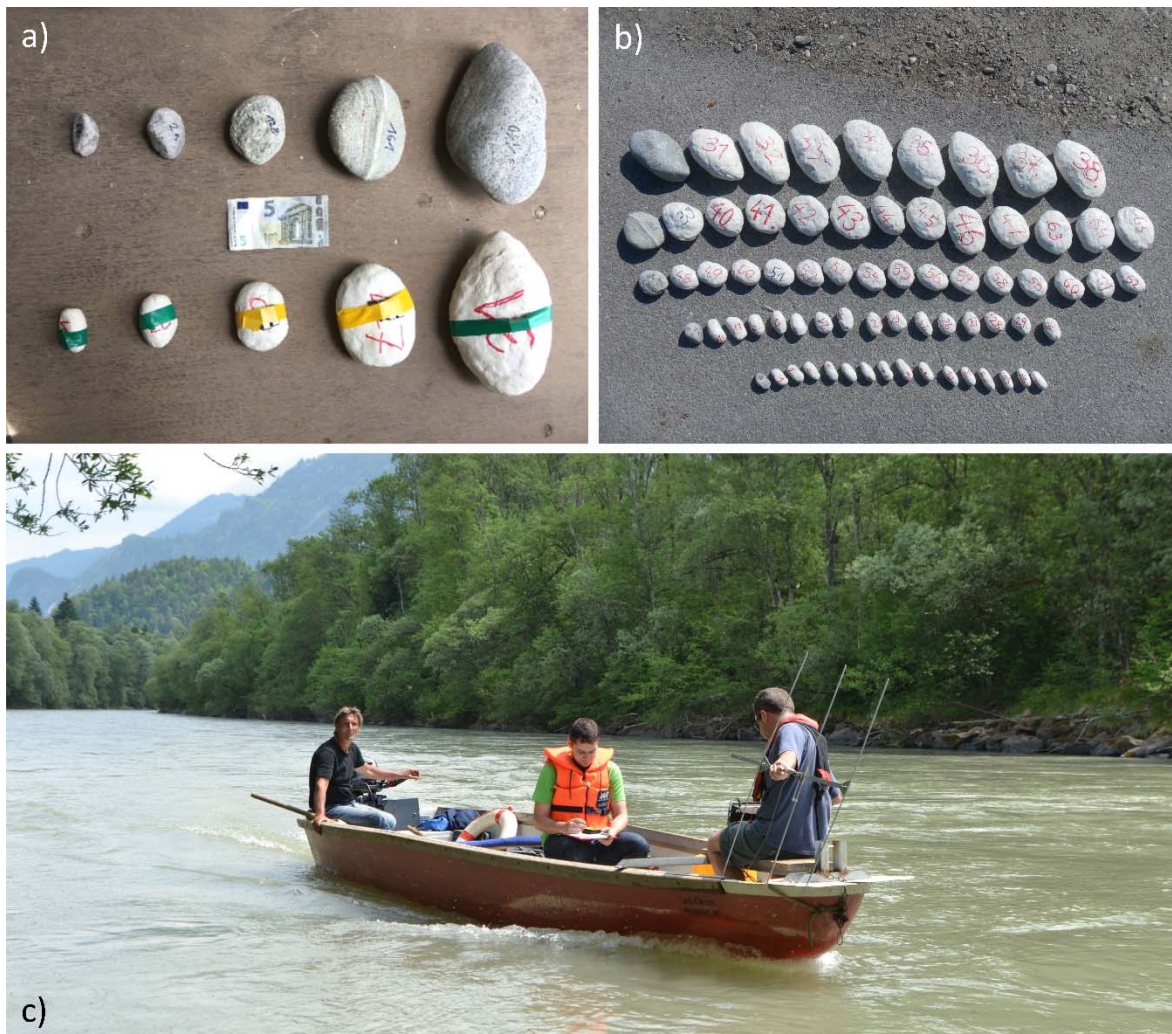
Figure 8. a) Original stones and tracer replications, b) All 65 coded radio tracer stones positioned next to the originals before insertion into the Drau River, and c) the process of searching the tracers by boat.

create artificial stone tracers in 5 size classes using natural stones as templates (Figure 8a and Figure 8b). The artificial stones were selected based on a statistical analysis of the lengths of their three axes to identify stones with average axis relations. Around 20 km upstream of the study site Kleblach a sediment monitoring station of BOKU is located (Dellach im Drautal), which was equipped with a permanent logging antenna to detect the tracers passing by at this cross-section. The location of the antenna marked the downstream end of the investigated section and was installed to avoid the introduction of bias into the data analysis (following recommendations from Chapuis et al., 2014). The stone tracers were put into the Drau River during low flow conditions ($\sim 35 \text{ m}^3/\text{s}$) 5 km upstream of the antenna, assuming that this distance was sufficiently long for a monitoring duration of one year, so that most of the tracers remained in this section and that only a small part was transported further downstream crossing the antenna section. The survey of the tracer positions was performed from boat using a GPS-handheld, a receiver and an antenna (Figure 8c).

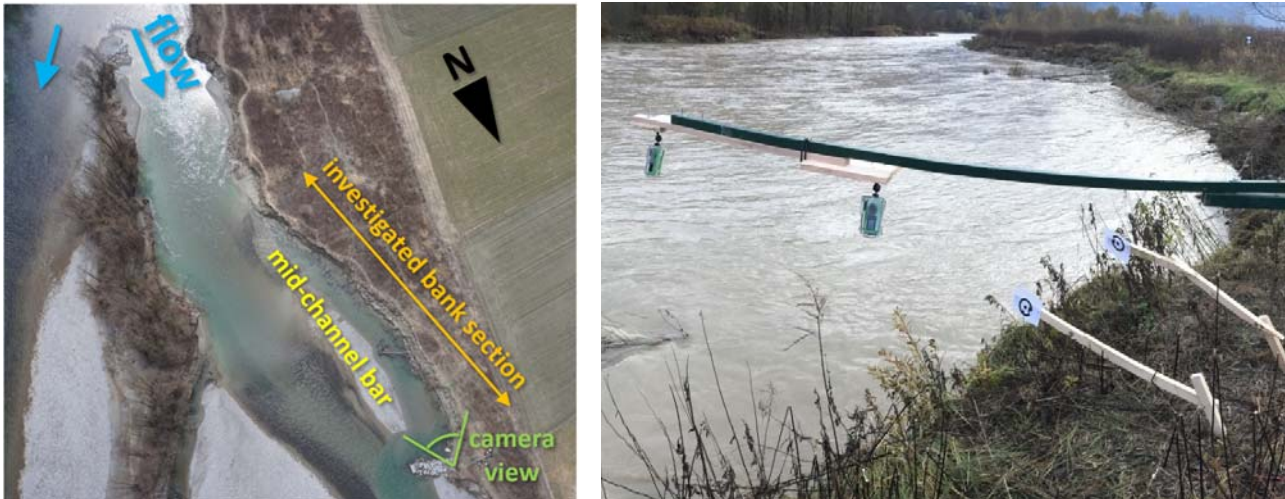
Figure 9. Left: Localisation of the investigated riverbank and mid-channel bar section including direction of the cameras' view, right: Time-lapse cameras mounted on the Drau riverbank to continuously observe the occurring bank retreat

In the widened section near the village of Obergottesfeld time-lapse cameras were mounted (Figure 9) to assess the bank erosion which followed a major flood event (10 years return interval), to understand the processes leading to excessive widenings which occurred especially in this widened section.

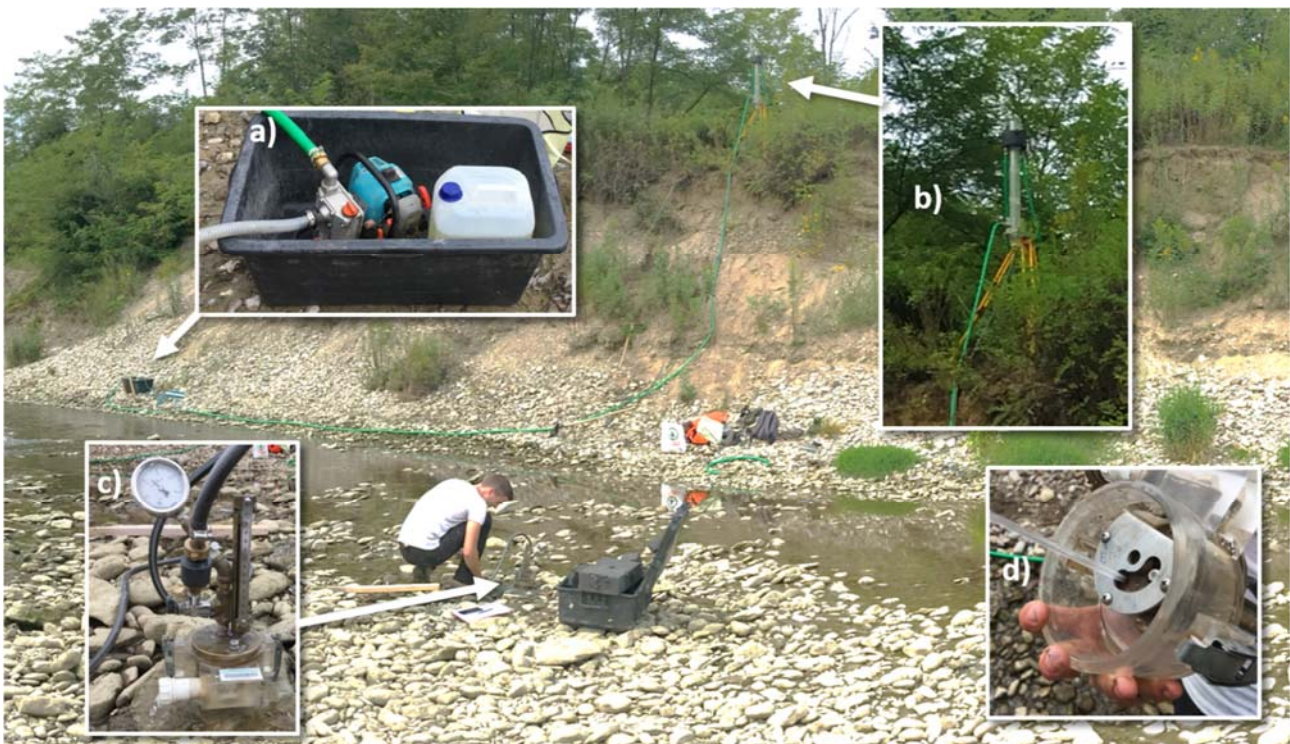
Figure 10. Instrument setup at the Mur River for deploying the Jet-test device. a) Pump continuously delivering river water to the head tank, b) head tank with continuous overflow to ensure constant water pressure at the Jet-Test instrument, c) Jet-Test device mounted on the tertiary sediment, d) Jet exiting the nozzle (submerged in water during the experiment). The Jet-test device was provided by the U.S. Department of Agriculture, National Sedimentation Laboratory, Oxford, Mississippi.

where τ is the shear stress, τ_c is the critical shear stress and k_d is the erodibility coefficient. The formula parameters τ_c and k_d were determined with the Jet-Test device (Figure 8), which applies a known shear stress at the sediment surface and allows repeated measurement of the resulting scour depth. The jet is submerged in water, so that the jet diameter increases and the shear stress decreases with distance to the jet nozzle.

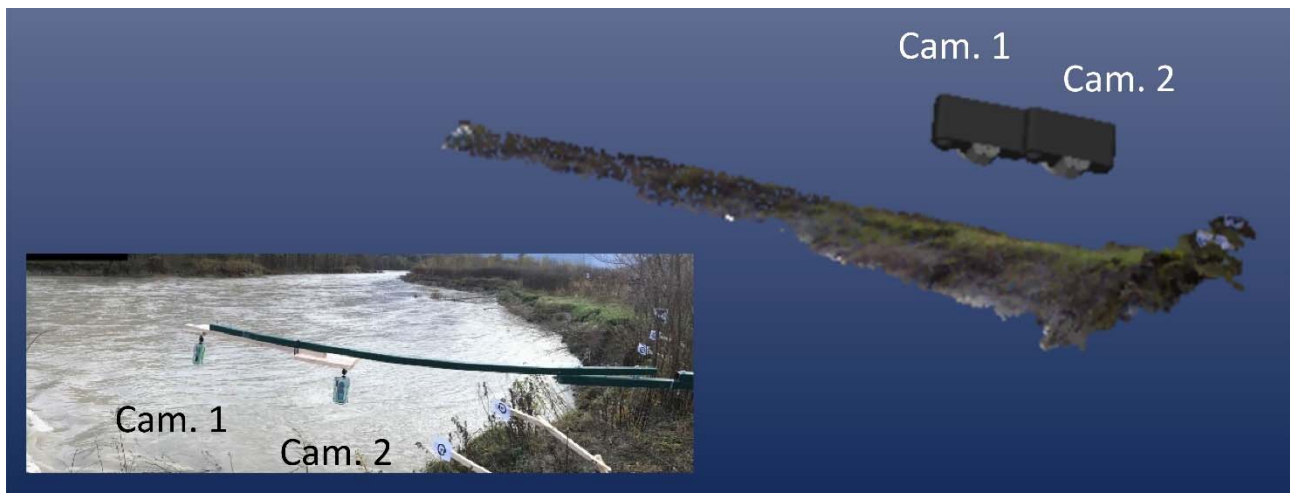
Figure 30. Test of using two time-lapse cameras for continuous monitoring of riverbank geometry.

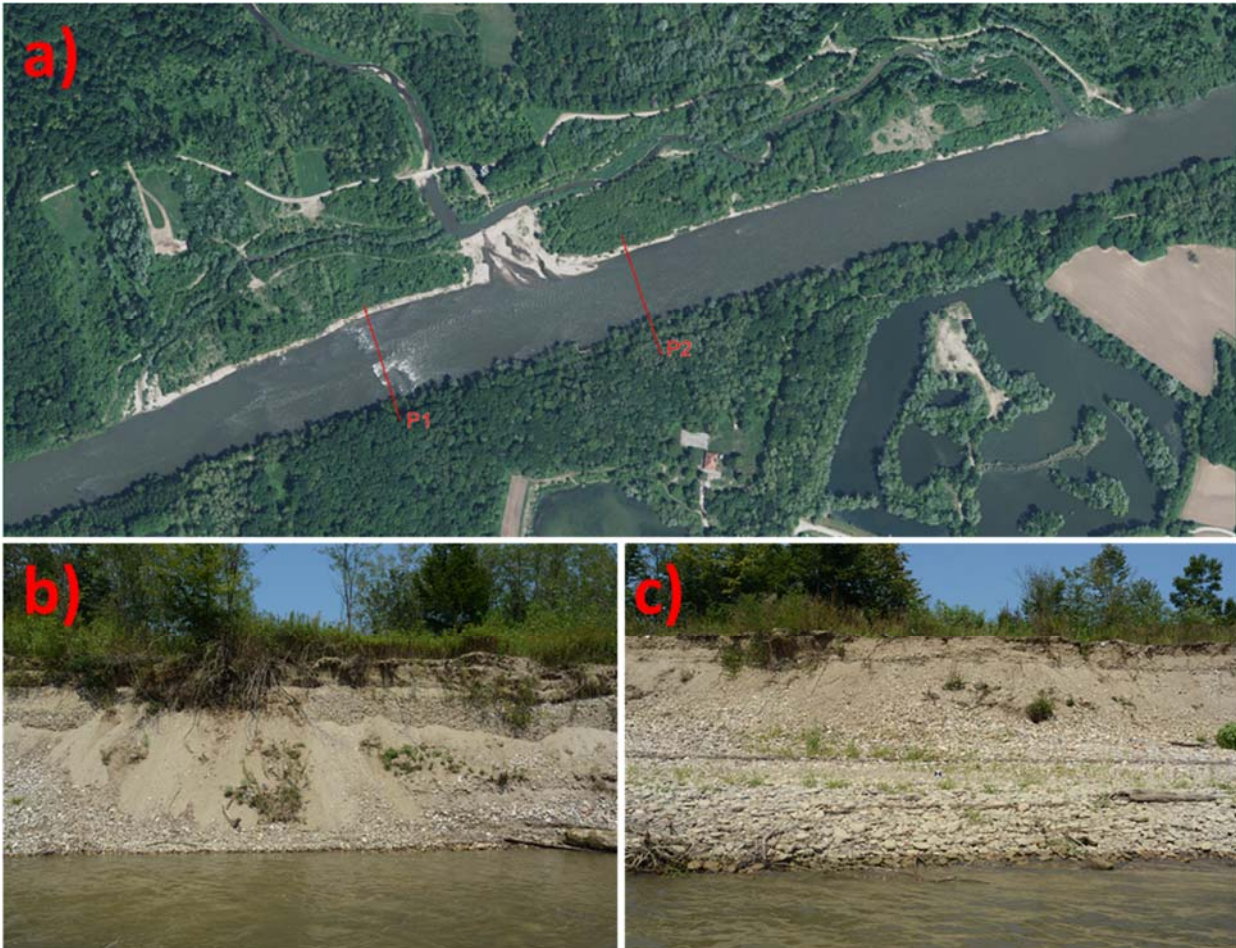
Figure 31. a) Mur river case study site near Gosdorf with surveyed cross-sections, b) left bank of cross-section P1, c) left bank of cross-section P2.

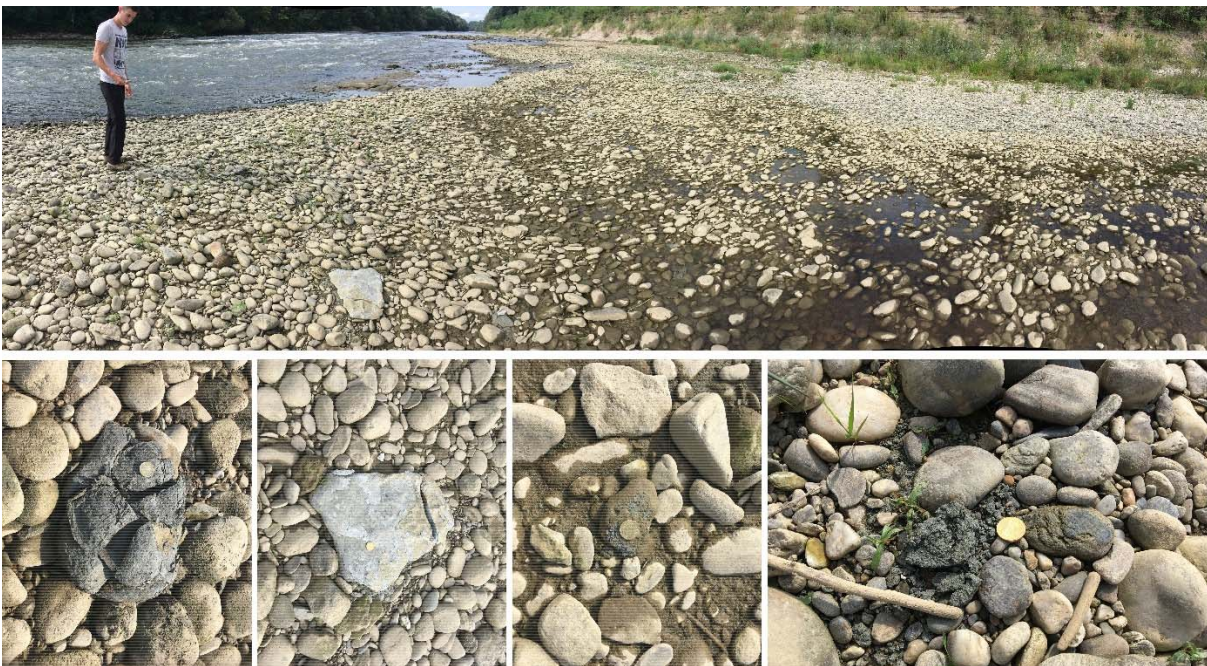
Figure 33. Deposits of transported tertiary sediment on a bar downstream of a large tertiary outcrop. A Fifty Euro Cent coin is used as a scale.

During a period of low flow in August 2019, the Mur site was visited to analyse the condition of the riverbed and the erodibility of the tertiary sediment. Tertiary outcrops were visible at several places of the riverbed. The tertiary sediment, which was detected, did not consist of loose fine grains such as sand or silt, but was compacted, appearing like sandstones. On a plane bar downstream of the large outcrop which crosses the entire river, several deposits of transported tertiary sediment could be detected (Figure 33).
