## ***HyMoCARES Project***

### ***D.T3.3.1 Technical note on the evaluation of physical and ecological effects of river restoration works***

#### **CASE STUDY: ISARCO RIVER (ITALY)**

**Date:** 30-10-2019

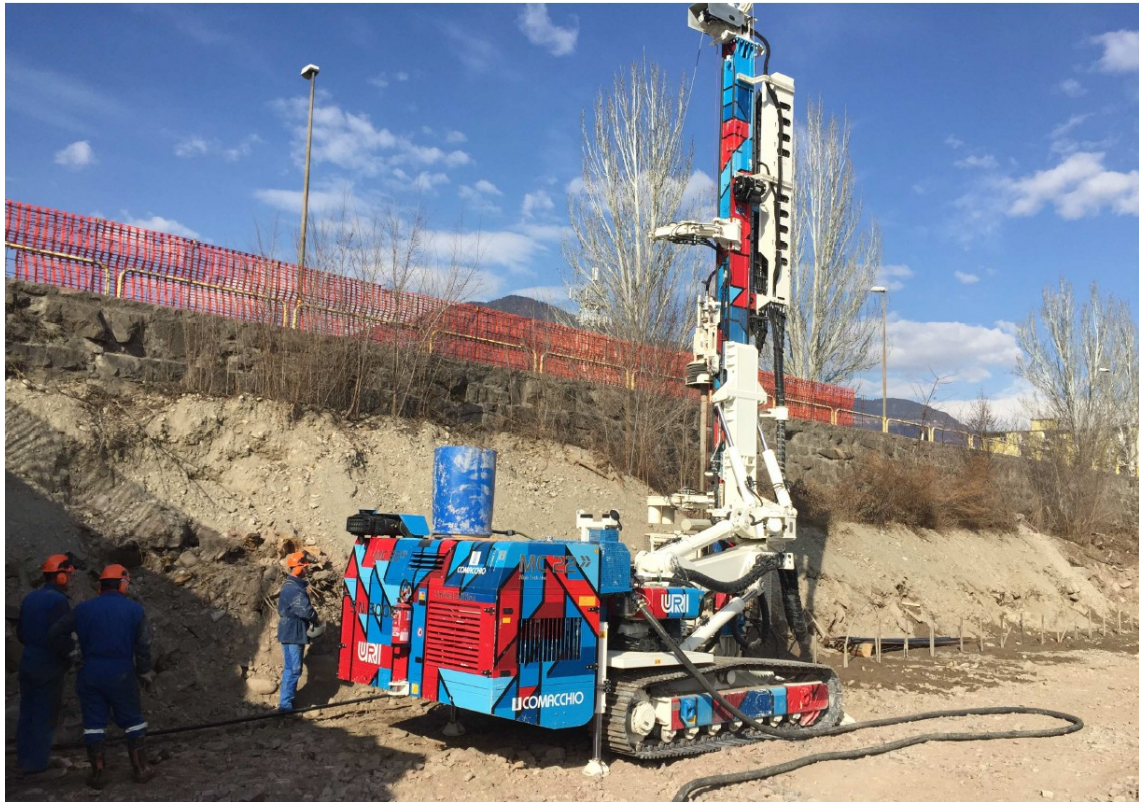
Figure 2: Construction of micropile bulkhead and reinforced concrete kerb to support the bank defences

kerb on micropiles to ensure wall stability and flood protection (Figure 2).

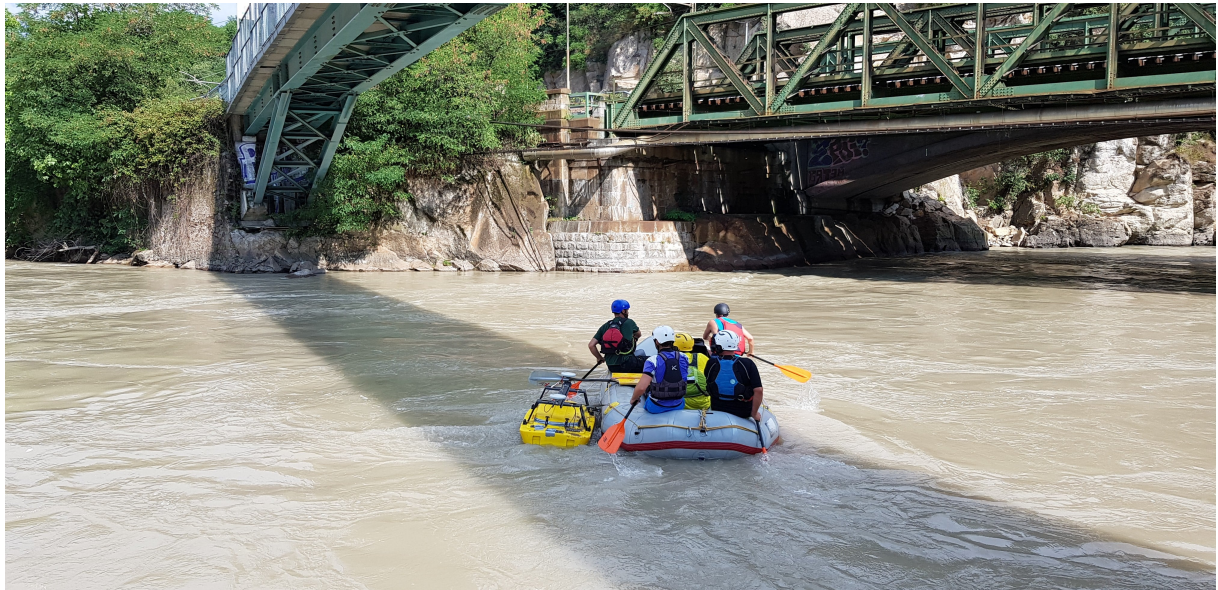
Figure 8: Picture showing the bathymetric survey along the Isarco River

- 2009 bathymetric and topographic survey, commissioned by the Civil Protection Agency of the Autonomous Province of Bolzano. A DEM (Digital Elevation Model) characterized by a resolution of 25 cm was created by interpolating the recorded points, which store elevation information.
- 2016 bathymetric and topographic survey performed by the Austrian company AHM (AirborneHydroMapping) GmbH, which uses a water penetrating laser beam at high resolution to get the river bed elevation with an accuracy under water around 5 cm (in clear water conditions and up to a depth of 2 m). Data collected by this technology consists of a point cloud with elevation values, which was later interpolated into a DEM.

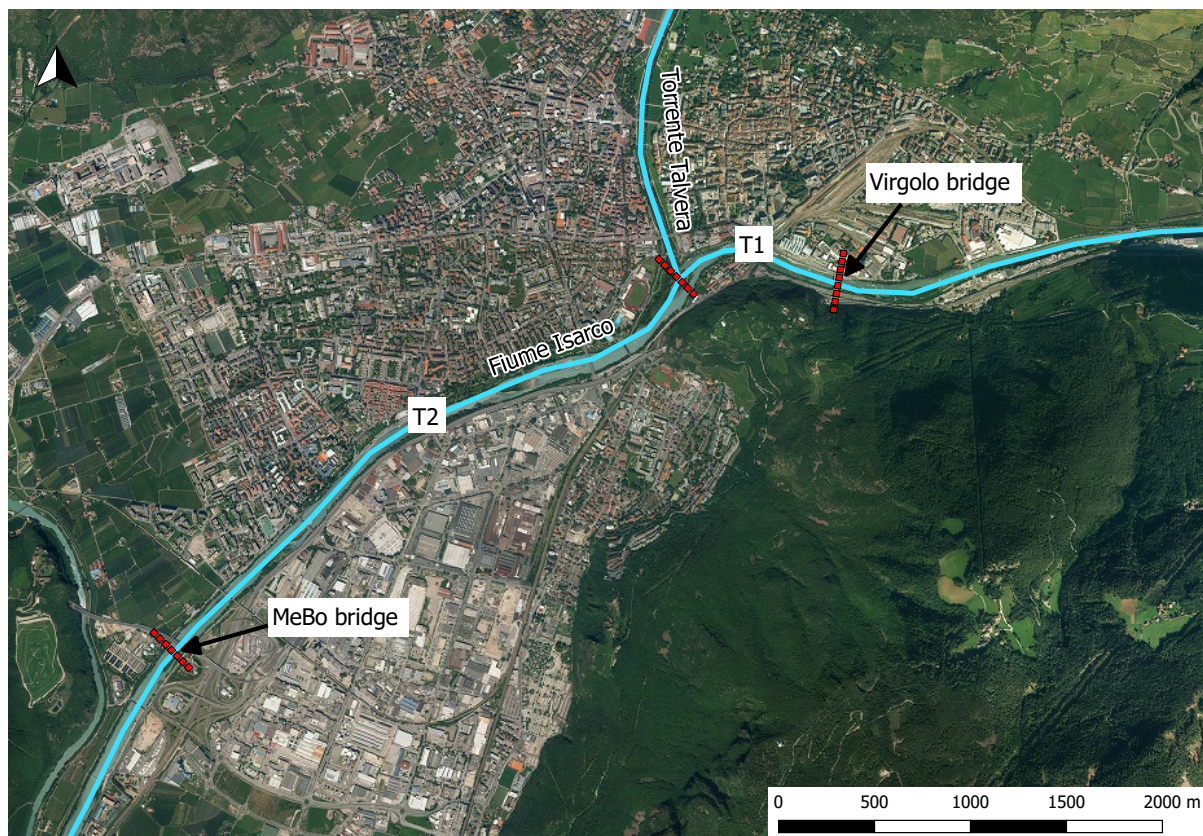
Figure 10: Sub-reaches identification along the Isarco River. T1 extends from Virgolo bridge to the confluence, while T2 stretches from the end of T1 until the MeBo bridge

Table 5: Macroscopic characteristics of the two sub-reaches. Conf. stands for confinement. The acronyms SC, NC indicate the type of confinement: semi-confined and non-confined. L is the length of the sub-reaches,  $\alpha$  is the average slope, EU and ED are respectively the upstream elevation and the downstream elevation

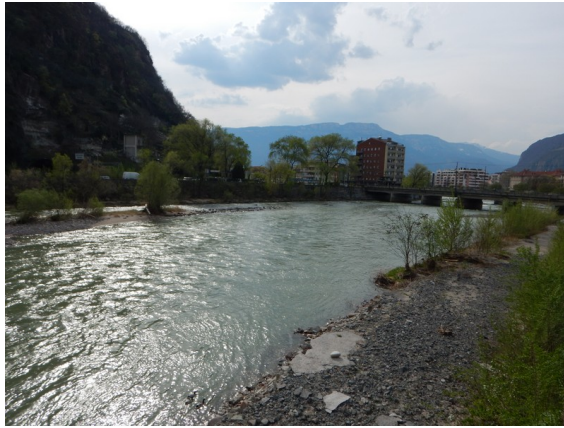
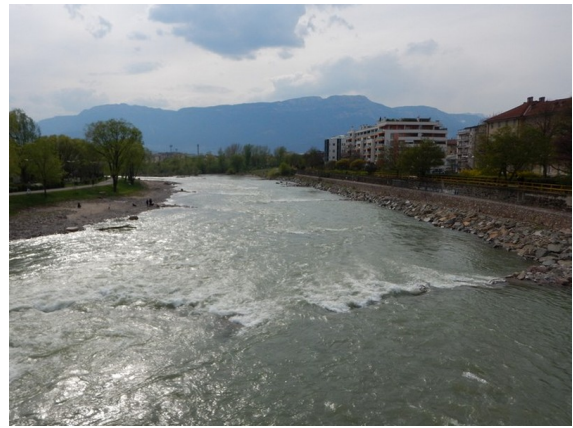
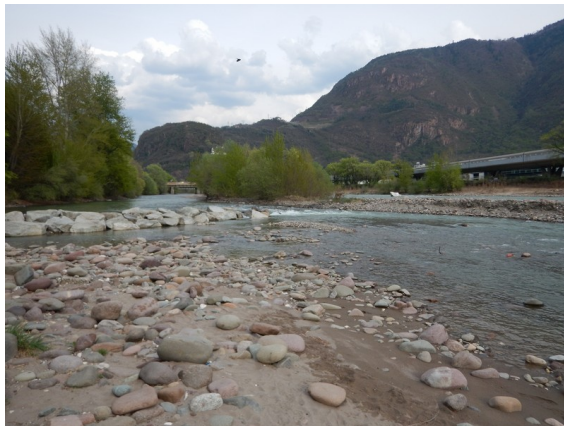
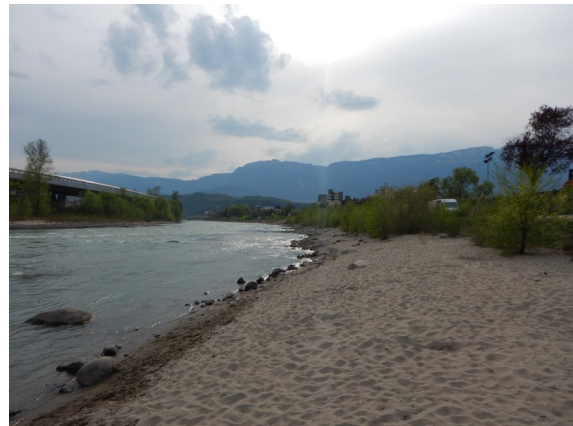
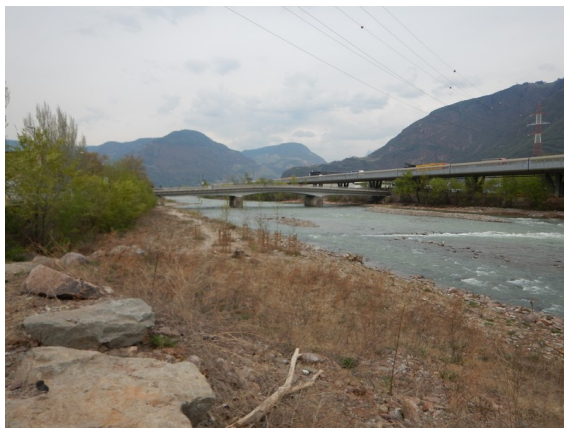
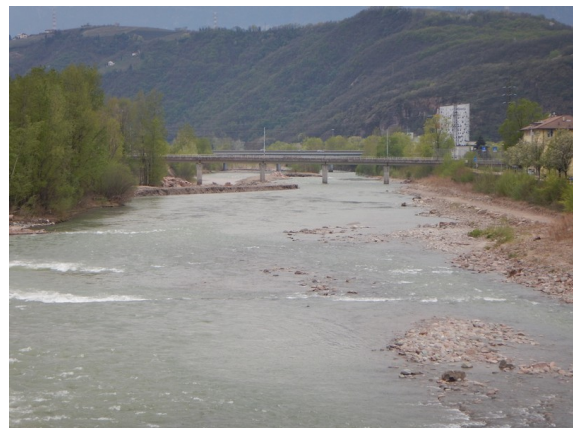
Figure 11: Views of two sub-reaches

(a) T1 reach. Downstream view from Virgolo bridge towards Loreto bridge

(b) T1 reach. Downstream view from Loreto bridge

(c) T2 reach. Upstream view towards Roma bridge

(d) T2 reach. Downstream view from Palermo bridge

(e) T2 reach. Upstream view towards Resia bridge

(f) T2 reach. Downstream view towards the railway bridge and MeBo bridge

The upstream reach (T1) stretches between the Virgolo bridge and the Talvera confluence to the Isarco River (Figure 10). Despite the upstream part was not subject to restoration, it was included in the T1 reach to correctly apply the IDRAIM methodology. Indeed, every sub-reach must have a linear extension of at least 10-20 times its average width. More in detail, T1 presents a semi-confined riverbeds, an average width of about 70 m with a sinuous course and a morphology which is associable to a flat bed, where the dominant sediments are pebbles.

The T2 reach runs from the Talvera confluence to the Isarco River until the MeBo bridge (Figure 10). T2 is characterized by an unconfined riverbeds with an average width of 75 m. It is channelized, straight and presents a flat-bed morphology. The dominant sediments are pebbles. Many restoration works along this reach had a linear extension.

Figure 11 shows the reaches just described, whose main features are summarized in Table 5.

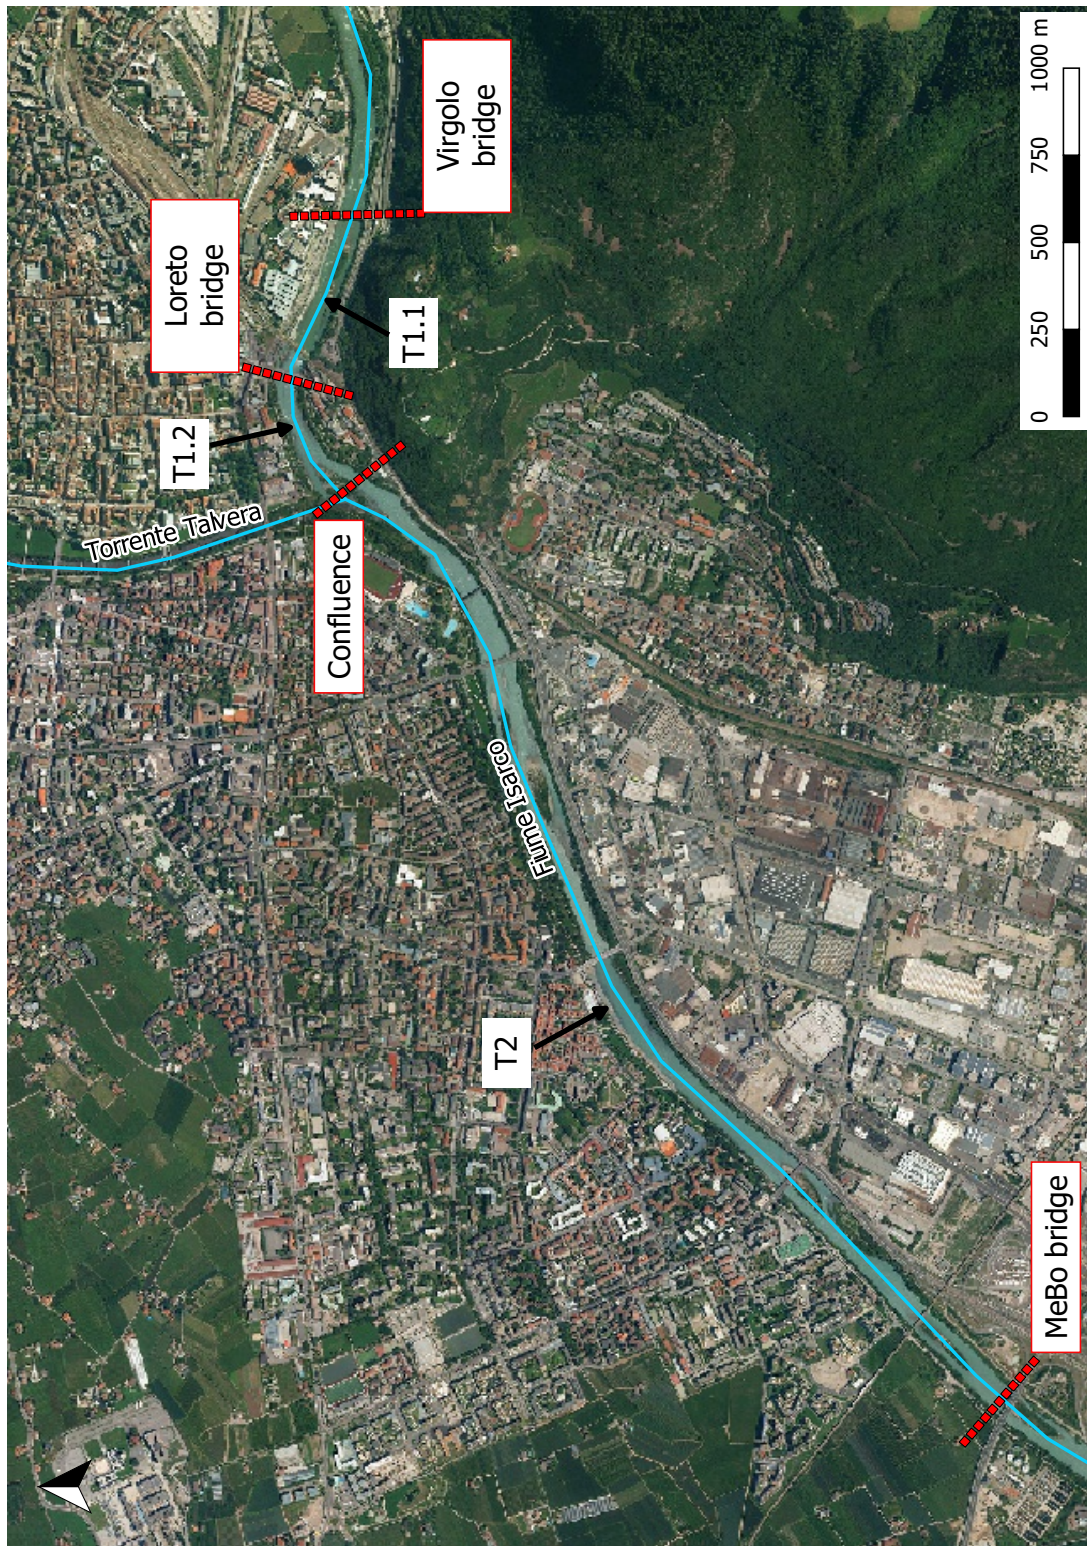
Figure 12: Sub-reaches identification along the Isarco River. T1.1 extends from Virgolo bridge to the Loreto bridge, T1.2 goes from the Loreto bridge to the confluence and T2 stretches from the confluence to the MeBo bridge

The river reaches used for the analysis are the same as the MQI, however the T1 reach has been divided into two sub-reaches (T1.1 and T1.2). This choice is due to the different restoration works carried out within these two stretches. The identification of the sub-reaches used for the MQIm analysis is shown in Figure 12.

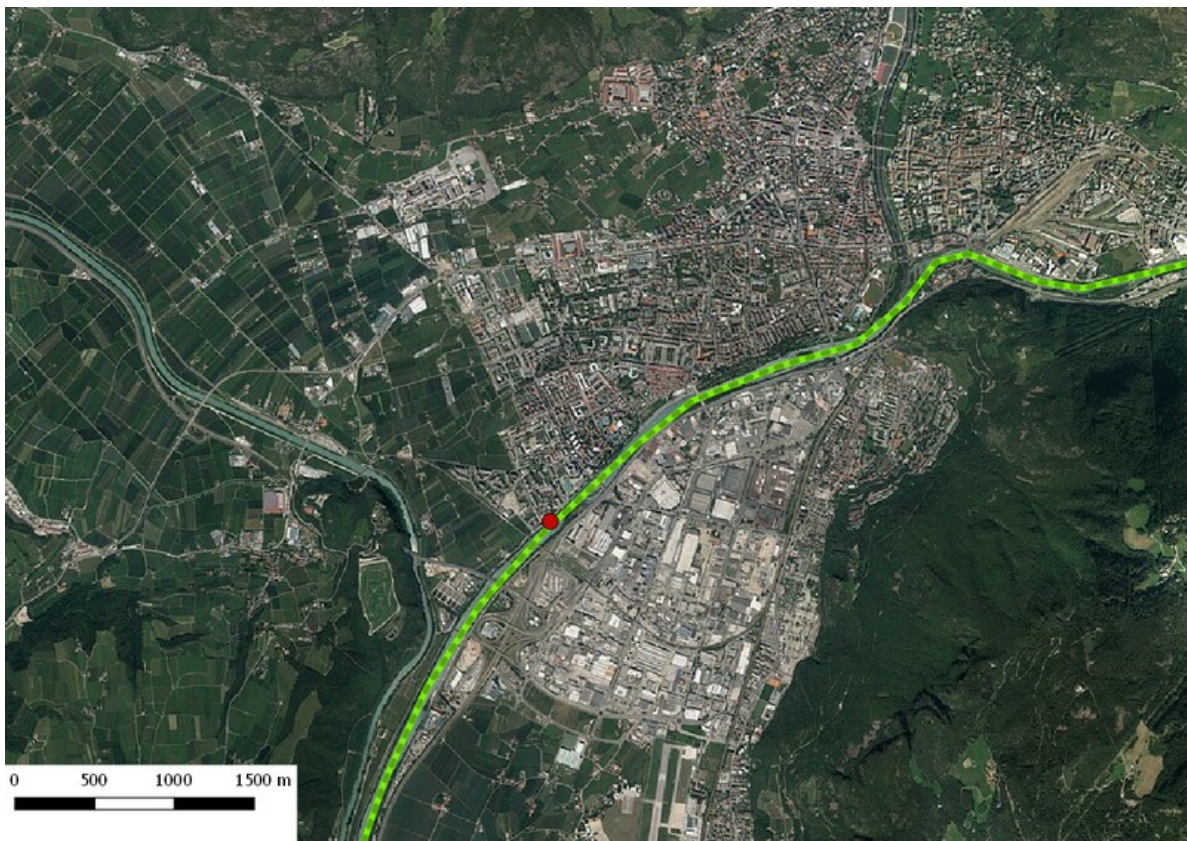
Figure 13: Map showing the monitoring station (red dot); the green line is the stretch where different restoration actions have been performed from 2013 to 2019

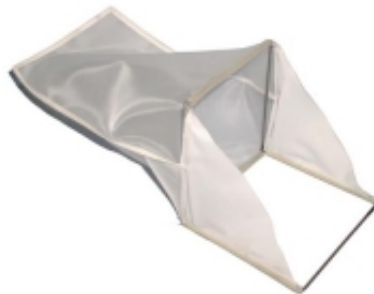
Figure 14: *Example of a Surber sampler used for collecting macroinvertebrates*

Generally, the sampling method is based on a multi-habitat design, where major habitats are sampled according to their proportional distribution within a sampling reach. Macroinvertebrates are collected systematically from all available in-stream habitats. A total of 10 sub-samples is taken from all major habitat types in the reach (approx. 1 m<sup>2</sup> of habitat). Assuming that a given habitat is characterised by a certain substrate, if the substrate in the sampling reach consists of 60 % sand and 40 % gravel, then 6 sub-samples must be taken in sand and 4 sub-samples in gravel. The habitats are then categorised according to the site protocol. The sampling starts at the downstream end of the reach and proceeds upstream. Each of the 10 sub-samples is taken by positioning a net and distributing the substrate in an area that equals the square of the frame width upstream of the net (0.32 m x 0.32 m). Therefore, either a hand-net/shovel sampler or a Surber sampler with a frame of 0.25 m width and at least 0.25 m height can be used (Figure 14). The mesh size of the net is 0.5 mm. More details on the sampling protocol can be found on ISPRA (2014).

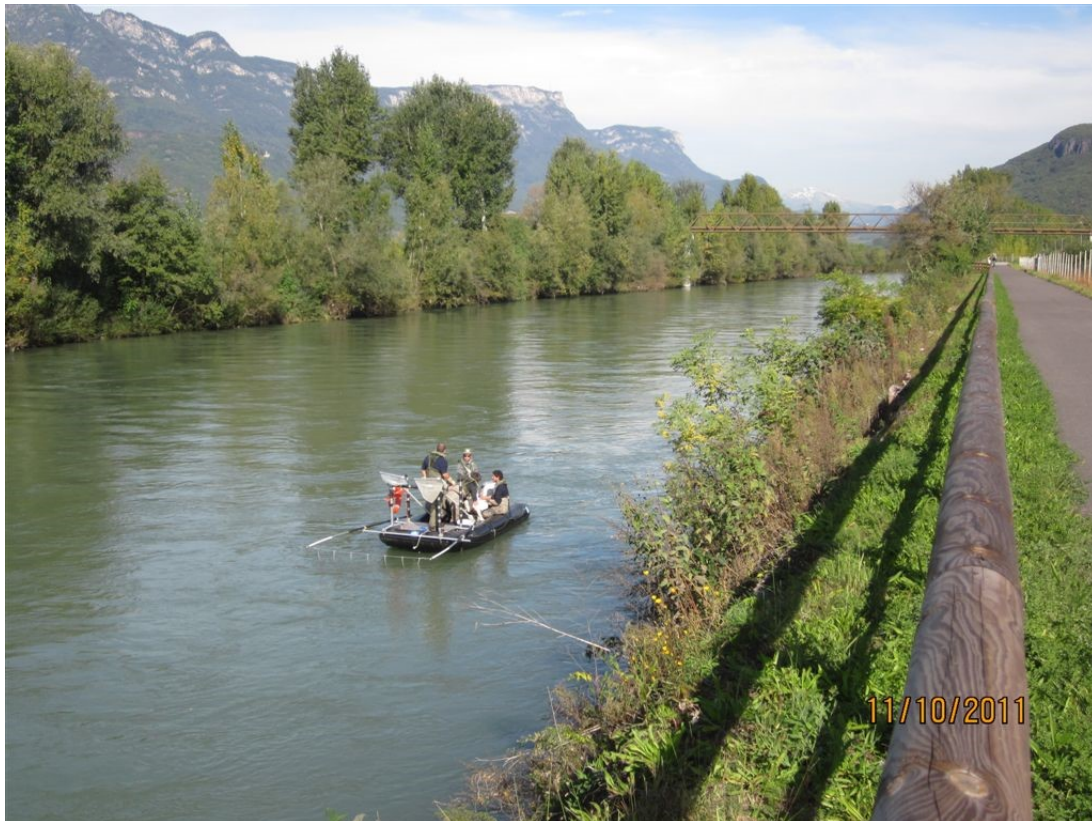
Figure 16: *Electro-boat used to estimate fish stocks*

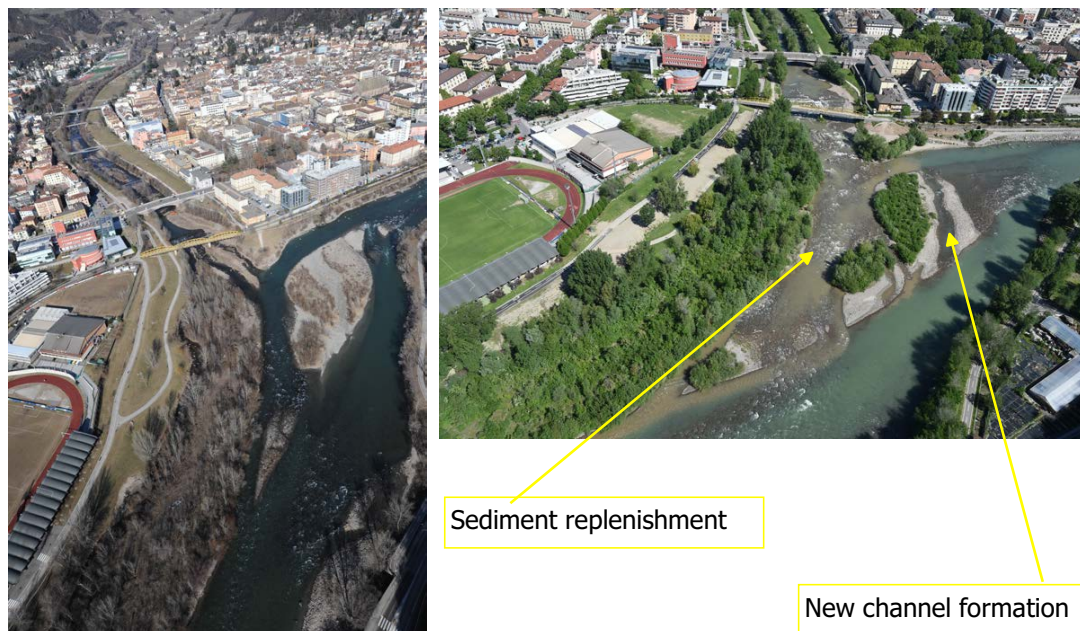
Figure 17:  $DoD_{2016-2009}$  computed for the study reach at the Talvera confluence to the Isarco River. The restoration work of sediment replenishment can be observed as deposits (blue). This probably caused a shift of the flow towards the center and the orographic left of the riverbed, causing the middle channel formation and erosion on the left-hand side

The  $\text{DoD}_{2016-2009}$  (Figure 17) shows the effects of the restoration works occurred at the Talvera confluence to the Isarco River. The main measure consisted of sediment replenishment, which can be associated to the deposits (blue) present in the map. As a consequence of this restoration action, the flow has probably migrated on the left-hand side, partially eroding the island in the middle of the river bed and later the Isarco left river bank. In order to reduce the river bank erosion, in 2018 flow deflectors were built along the left- and right-hand side of the river with the aim of forcing the flow towards the middle of the channel. The 2019-survey allows to assess whether and to which extent the restoration measure achieves the expected results. The  $\text{DoD}_{2019-2016}$  (Figure 18) shows that the flow deflectors, placed both on the right and on the left river sites, convey the flow towards the middle. As a consequence, the slow flow characterizing the river banks tends to deposit while erosion is more pronounced at the center of the channel. In addition, sediment deposition might also have been influenced by a dam flushing (ca 50 km upstream) occurred in May 2019. It is also important to emphasize that the weir removal performed along the Talvera Torrent contributed to re-establish the sediment continuity between Talvera and Isarco. On a larger scale, an higher sediment supply, together with the Isarco's transport capacity, can bring benefits to the ecosystems further downstream, along the Adige South of Verona and to the seashore. In the first case, the combination between a lack of sediment and riverbed erosion brings about a deepening of the aquifer, while in the second severe seashore erosion can be observed. The lack of sediment in these ecosystems is caused by the upstream hydraulic works holding the material.

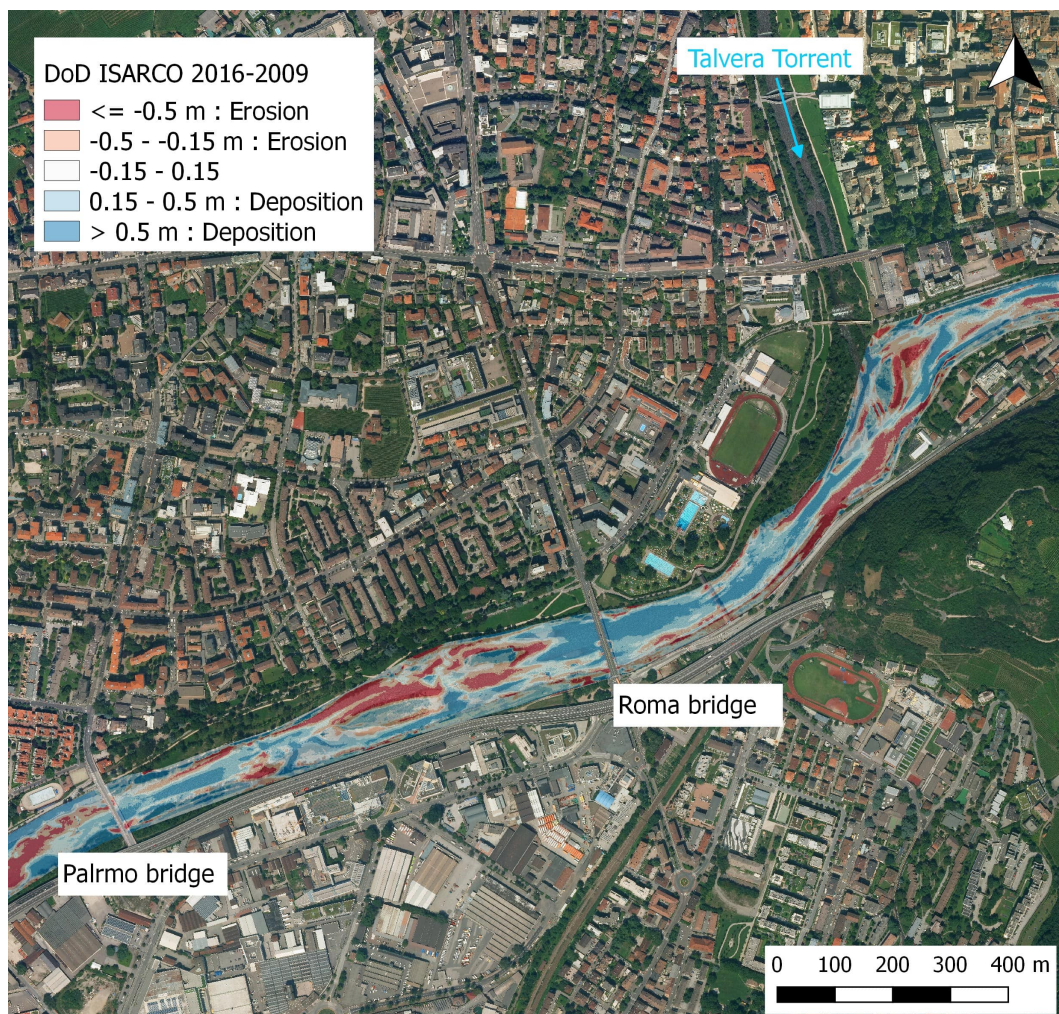
Figure 19: Overview of the DoD<sub>2016–2009</sub> computed for the study reach at Roma bridge; water flows from right to left

Figure 19 displays the DoD<sub>2016–2009</sub> of the upper part of the study reach, downstream the confluence. When zooming it in, around the Roma bridge, an evident depositional area can be observed under the bridge (Figure 20). Downstream these deposits an interesting dynamic of bar migration can be observed (yellow circle). The red color shows where the bar used to be (in 2009), while the blue color indicates the recent sediment aggradation (in 2016). From 2016 to 2019 the bar that was present under the Roma bridge has moved (Figure 21), while the two bars downstream the bridge are still on place, despite the storm event of October 2018 (the neutral color indicates that no changes occurred). This remarks that flow deflectors cause the flow to slow down and therefore sediment deposition, which can be detected upstream each deflector (yellow circles).

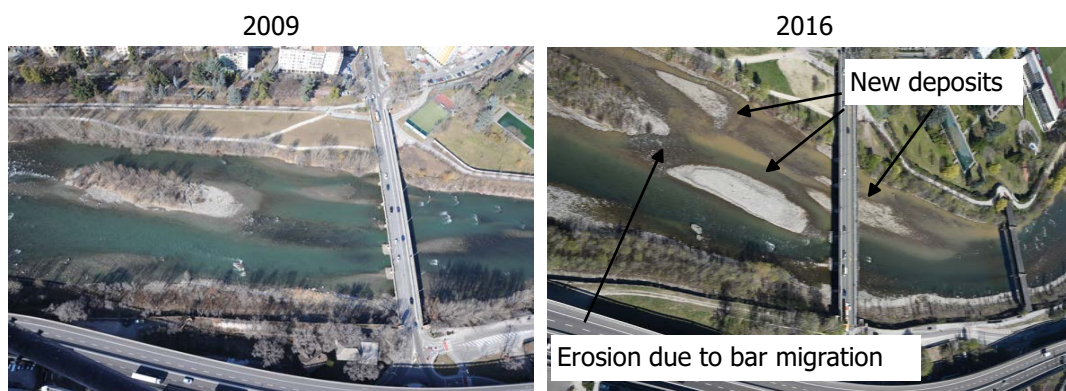
Figure 20: DoD 2016 - 2009 computed for the study reach at Roma bridge; water flows from right to left

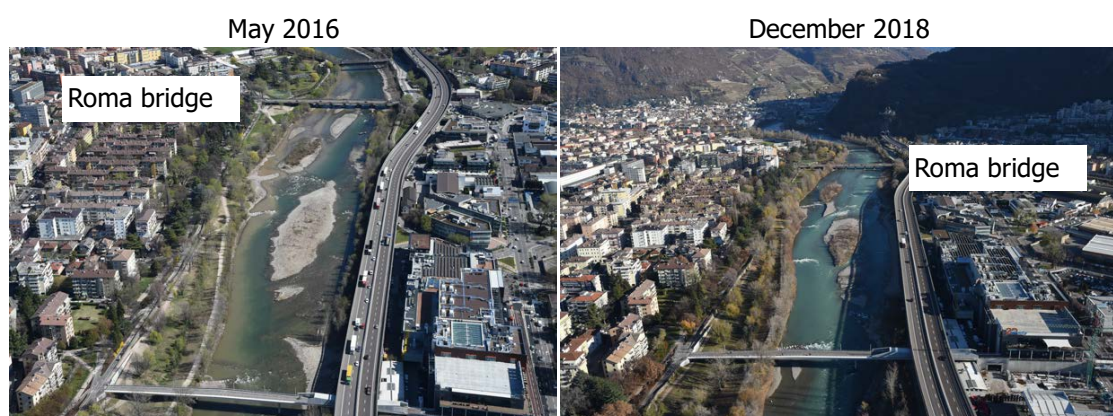
Figure 21: DoD 2019 - 2016 computed for the study reach at Roma bridge; water flows from right to left

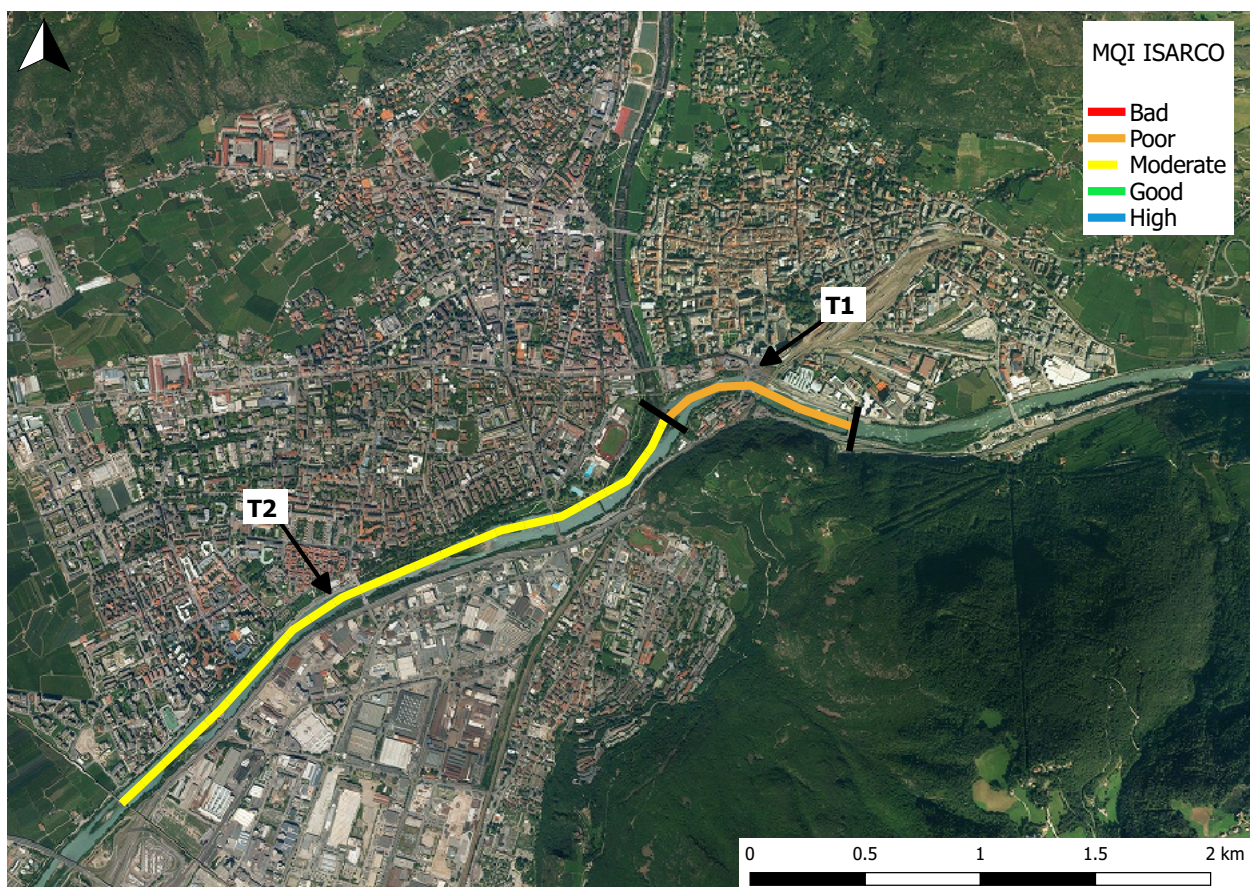
Figure 25: MQI classification for each analysed sub-reach

The MQI was applied to both sub-reaches yielding different values; in particular, a *Poor* morphological quality (MQI = 0.31) has been assigned to the upper Isarco sub-reach. Instead, the MQI for T2 has been classified as *Moderate* (MQI = 0.64). Figure 25 shows the MQI classification by colors for each sub-reach. A detailed analysis on each MQI parameter has been computed to understand whether the restoration works have brought improvements on the river morphological quality and particularly on which aspect. The pre-restoration evaluation from Patscheider-Partner (2015) was considered as a reference for a comparison to the 2019-MQI assessment for the T2 sub-reach; indeed T1 is not directly comparable since its length differs from the ones chosen in 2015.
