I-SWAMP

# Deliverable 1.4.1: Conservation report

This document represents the **Deliverable 1.4.1: Conservation Report** of I-SWAMP (Integrated Small Wetlands of the Alps Monitoring and Protection). The project is co-funded by the European Union in the frame of Interreg Alpine Space.

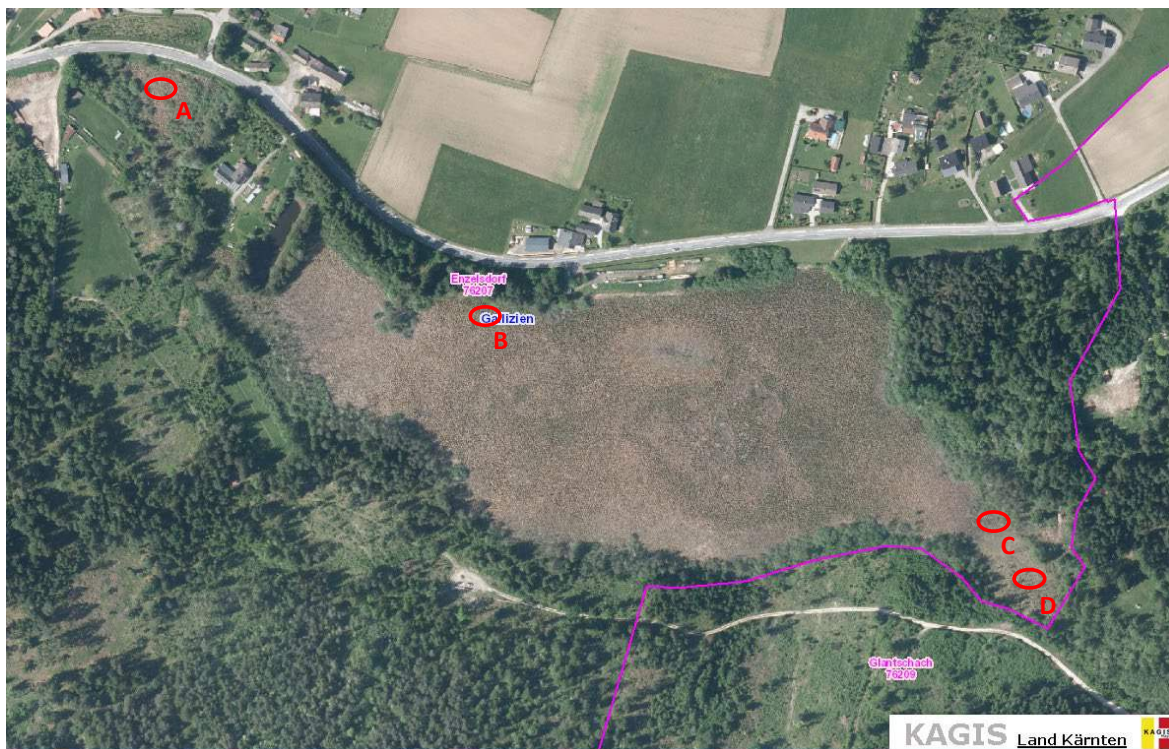
**Figure 1.2:** Establishment of spawning ponds for amphibians. Place options: A, B, C and D, removal of trees and bushes and removal of bushes

In the southern part of the area, the fir and spruces that are causing increasing overgrowth should be removed. The overgrowth leads to shading areas, which can significantly impact the flora and fauna.

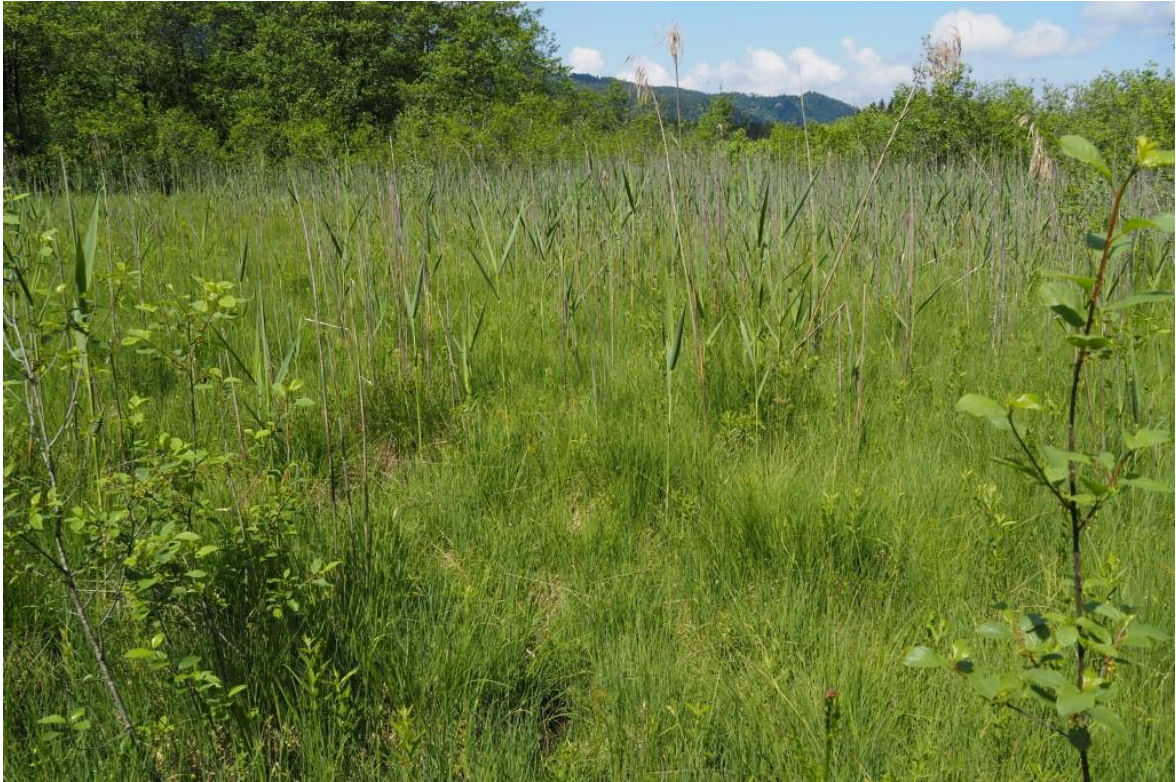
**Figure 1.3:** Eastern part of Wildenstein Fen 07.06.2023, Karina Smole-Wiener

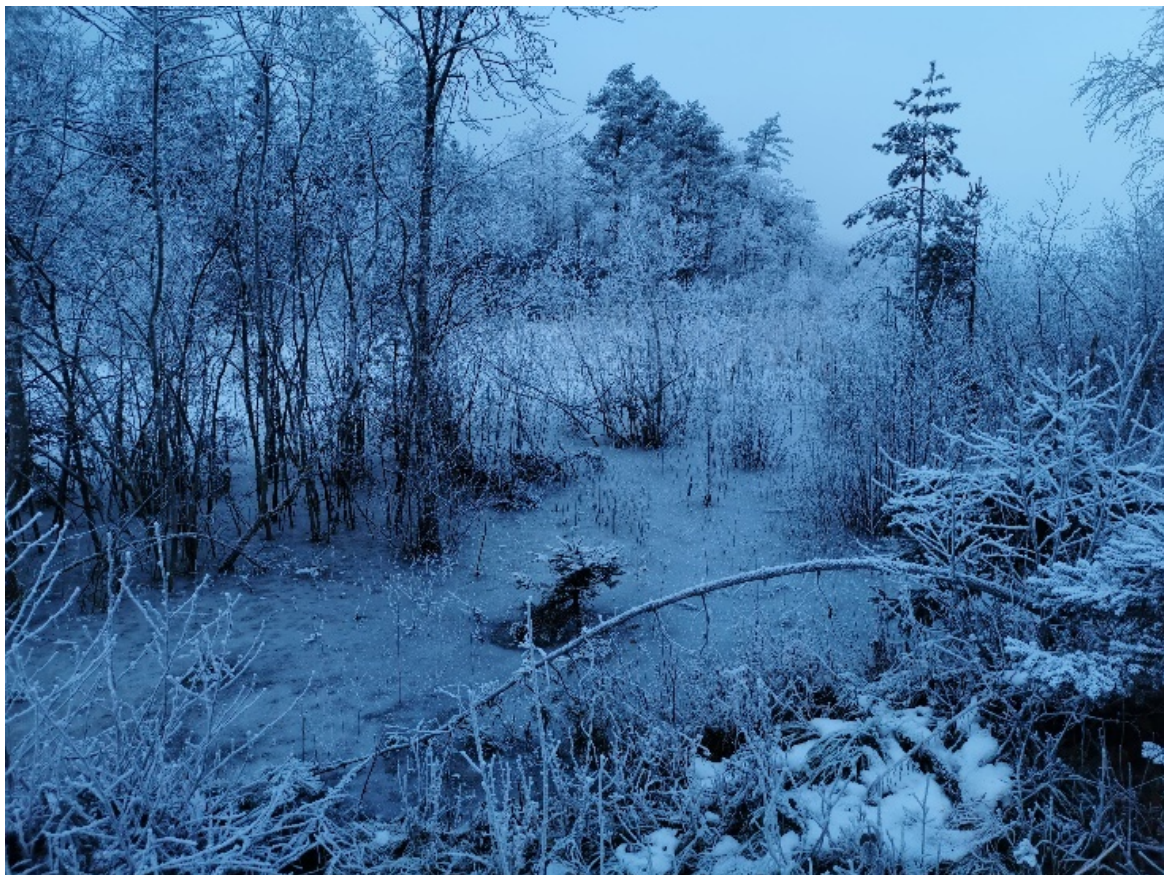
**Figure 1.4:** The area where ponds are proposed was filled with water (ice) in January 2024.

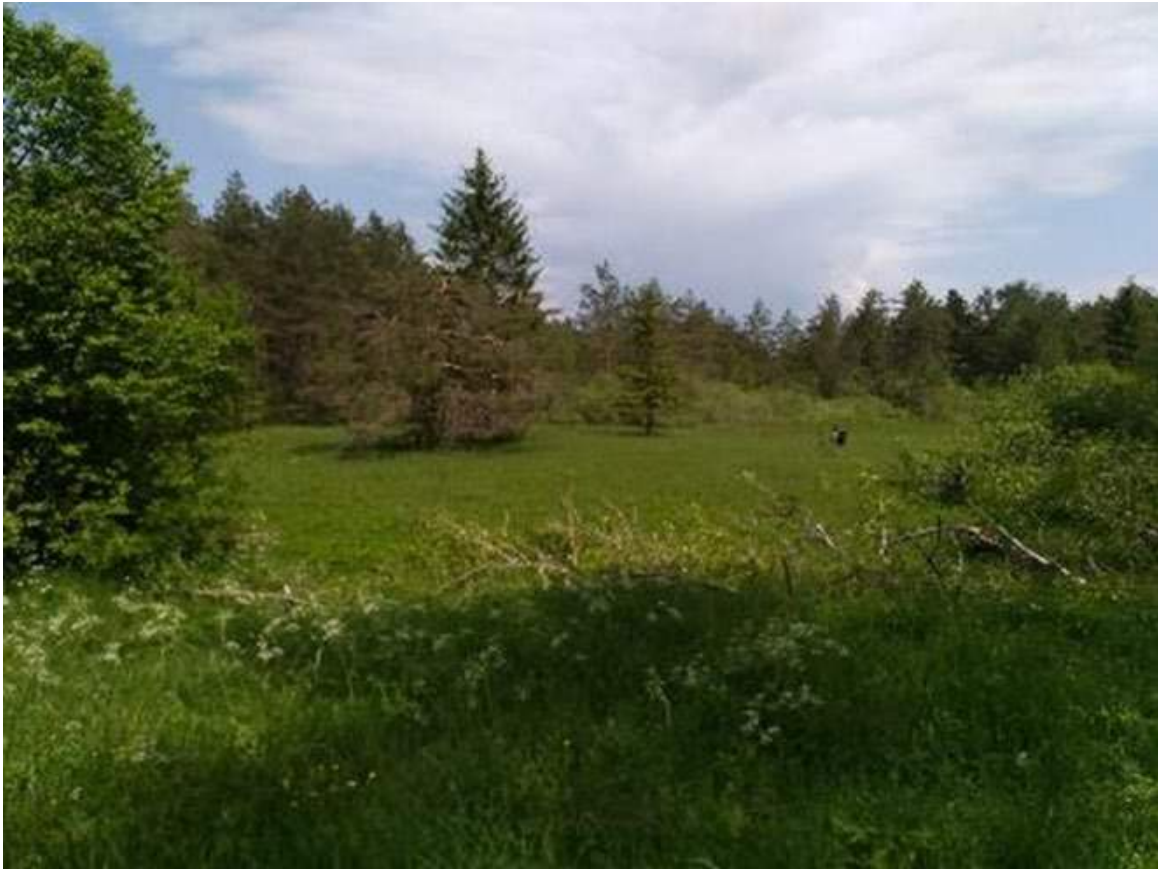
**Figure 1.5:** Sonnegg Fen, overgrown by goldenrod and bushes (Photo: Susanne Glatz-Jorde)

Additionally, the construction of two to four amphibian ponds is important for the protection of the local amphibian and dragonfly species.

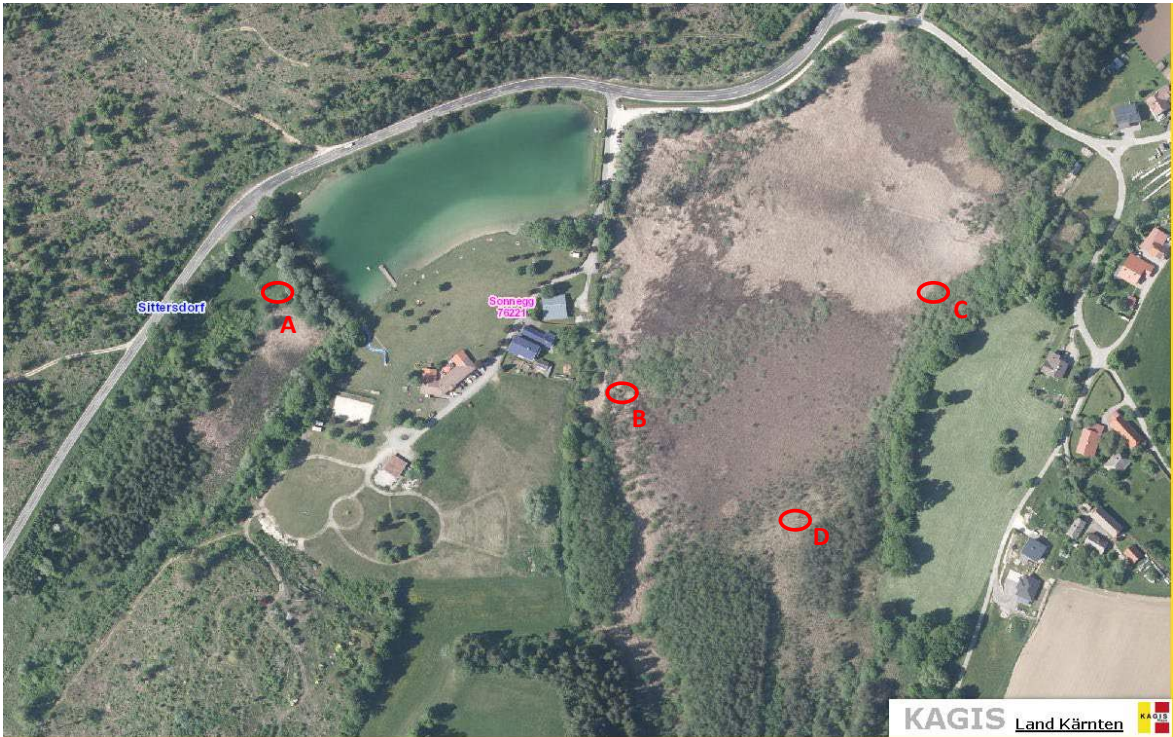
**Figure 1.6:** Establishment of spawning ponds for amphibians. Construction of amphibian ponds, place options A, B, C and D

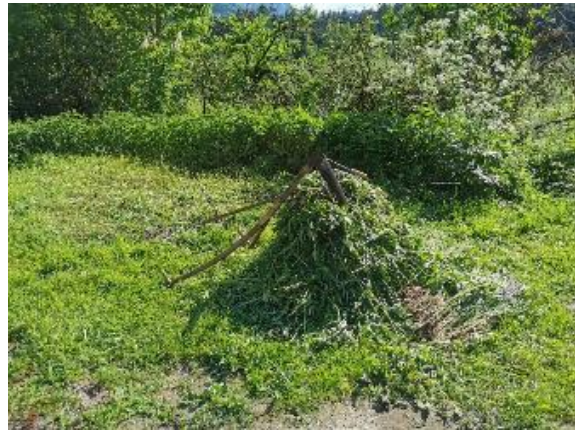
**Figure 1.9:** Neophyte mown material with mown area behind. (photo: Susanne Glatz-Jorde)

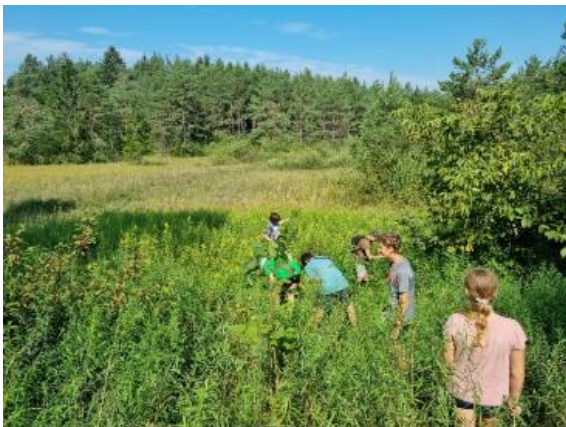
**Figure 1.10:** Targeted removal of invasive vegetation (goldenrod) by forming a human chain (photo: Kathrin Albrecht, Natopia)

In August 2023 the nature conservation and education association Natopia participated in the next pilot measures addressing the invasive species in the fen. The association members (about 10 People) cleared a plot at the edge of the wetland successfully and remove the invasive species there. The plant of interest was goldenrod. **(Figure 1.9)**. During the measures, the danger and impact of the invasive species were explained. The enormous importance of wetlands and fens was also emphasised during the excursion. The group was invited to have dinner after the volunteering at a nearby restaurant.

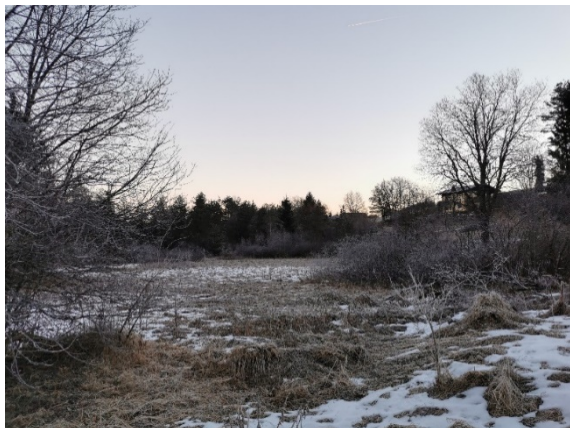
**Figure 1.12:** Sittersdorf fen on January 12<sup>th</sup> before the measures started

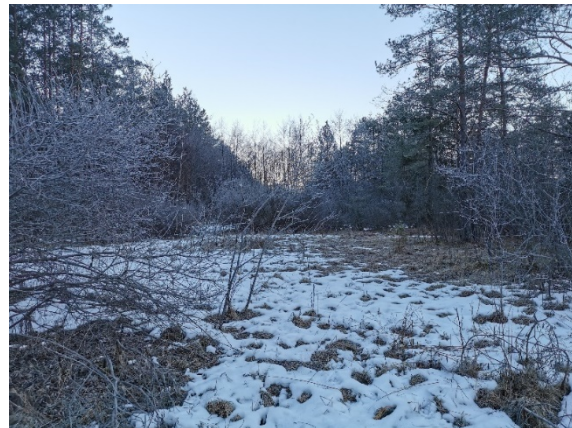
**Figure 1.13:** The Fen is partly overgrown by bushes

On January 12<sup>th</sup> a group of the community, E.C.O. Institute of Ecology and the Geopark staff cleared the bushes in the southern part of the Sonnegg fen (in total 9 people). Due to the perfect weather conditions in the morning, the area could be accessed by a tractor for professional timber removal. Willows and spruce were removed. Bigger trees and some of the bushes were left as structure for birds and other species. After implementation the area is more open, and the dryer part can be mowed again. It was ensured also by the ecological supervision, that very wet parts and areas with rare species like *Salix repens angustifolia* were not harmed.

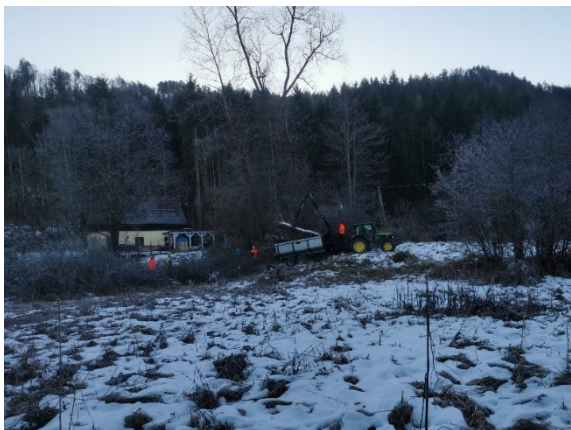
**Figure 1.14:** Fallen Trees were removed with the help of a Tractor

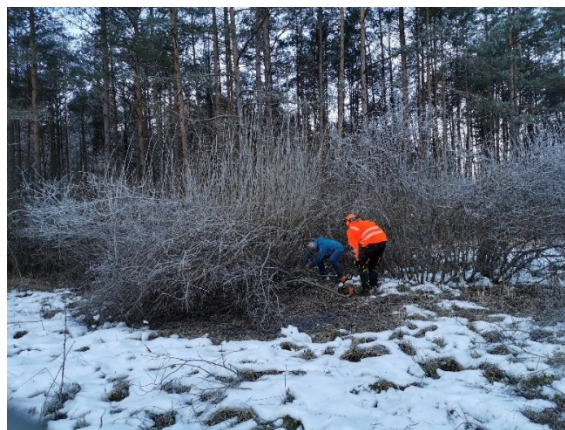
**Figure 1.15:** Especially willows (*Salix cinerea*) were removed

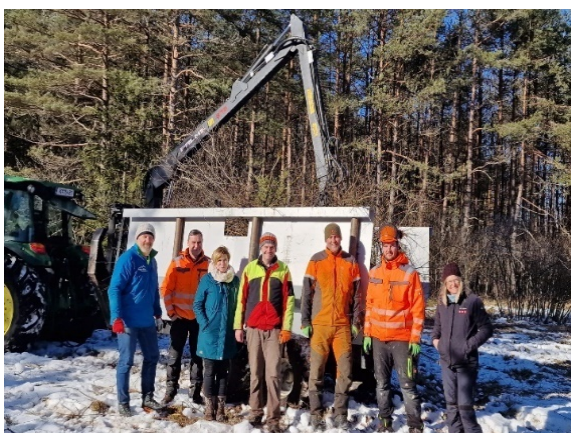
**Figure 1.16:** The soil was frozen and could bear the tractor

A problem was also so wait for the right weather conditions, because for working in the middle of the fen the soil needs to be frozen, but there should be no snow. So, there is just a short time window when measures can be set.

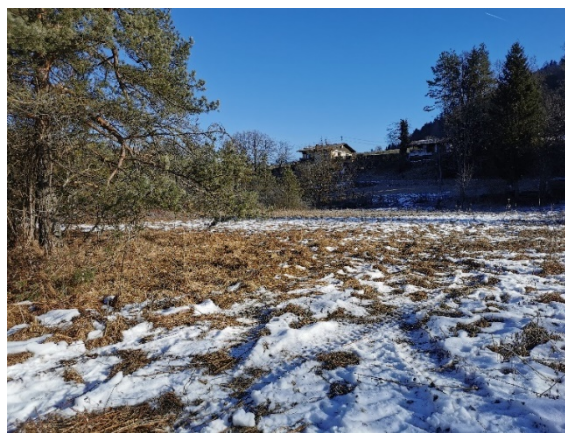
**Figure 1.17:** As a next step the milling machine can prepare the area for mowing

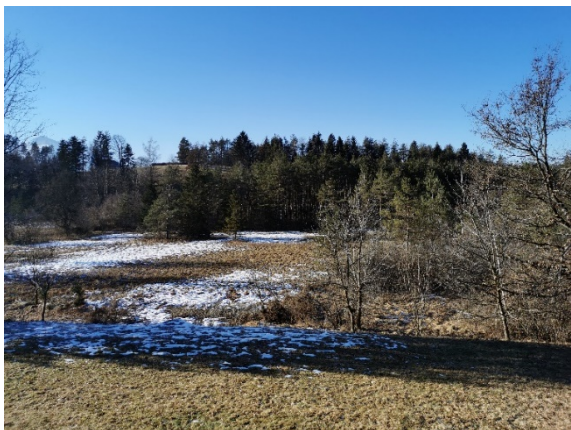
**Figure 1.18:** After the measure the area is more open

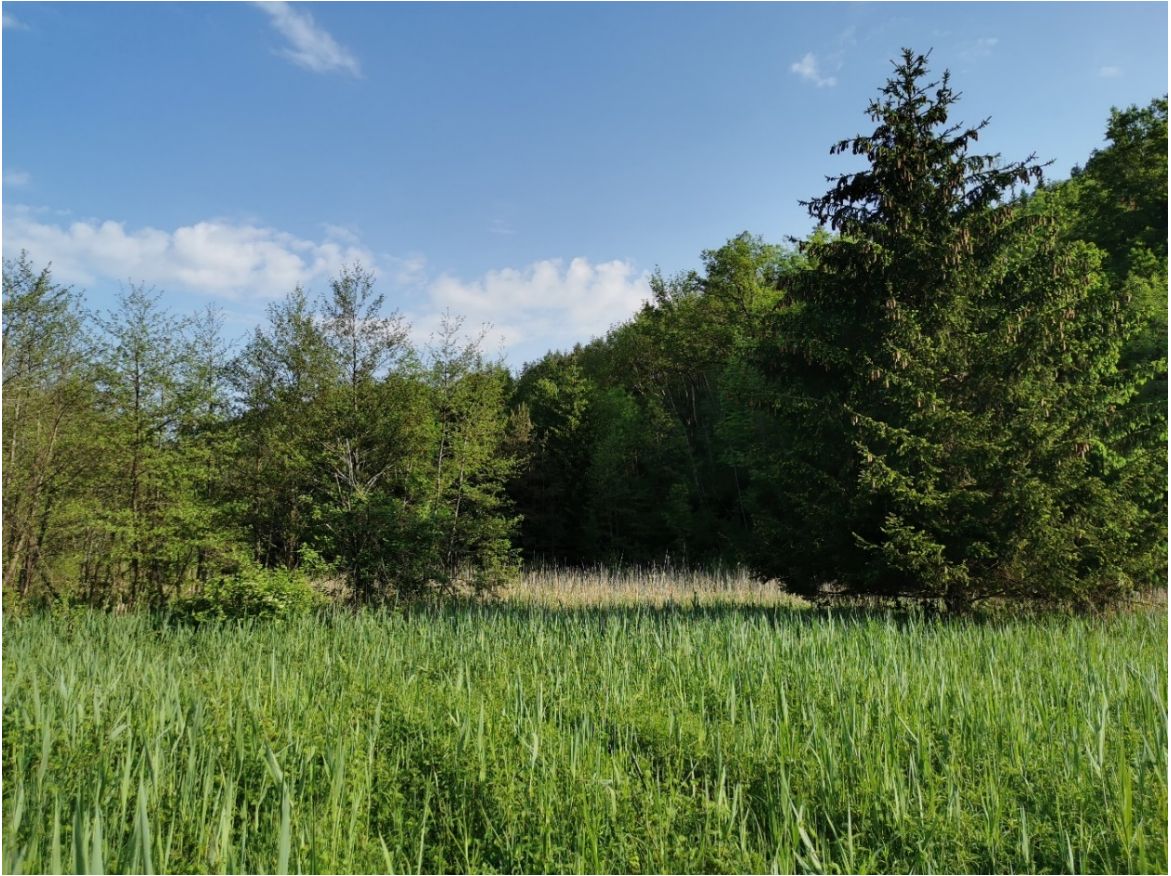
Due to the stopping of maintenance around 10 years ago, the most significant impairment in Kleinzapfen is the proliferation of bushes, which inhibits the undergrowth. Additionally, the extensive stands of the invasive goldenrod *Solidago gigantea* causes impairments to site specific species.

**Figure 1.19:** Fallow *Molinia* meadow Kleinzapfen (behind the trees), overgrown by goldenrod and bushes in front (Photo: Susanne Glatz-Jorde)

Therefore, the proposed measures include regularly mowing of the goldenrod *Solidago gigantea*, to hinder the invasion into the *Molinia* meadow. The emerging bushes within the *Molinia* meadow should be removed, to prevent the inhibition of site-specific species.

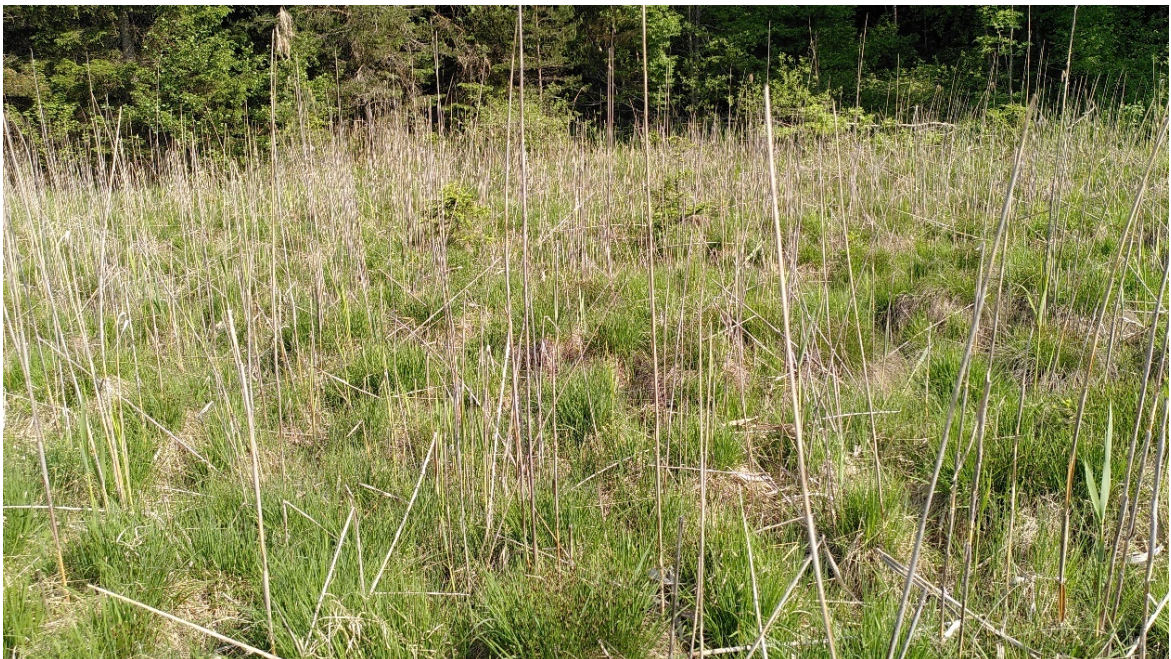
**Figure 1.20:** Fallow *Molinia* meadow – bringing back a mowing regime would allow rare species to grow

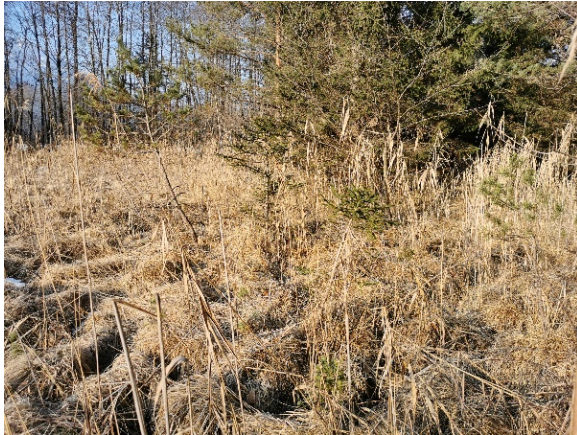
**Figure 1.21:** Young Spruce trees are growing into the area

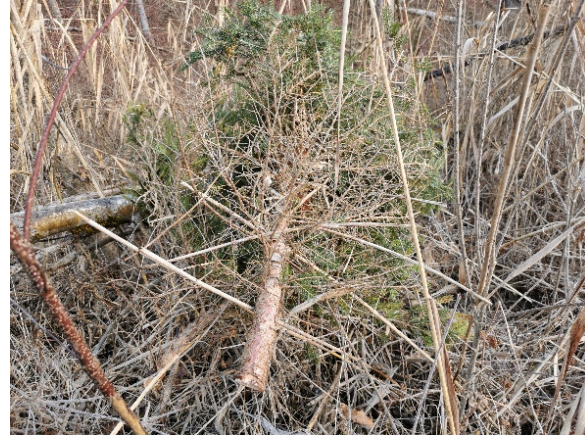
**Figure 1.22:** Spruce and pine were cut by volunteers in February 2024

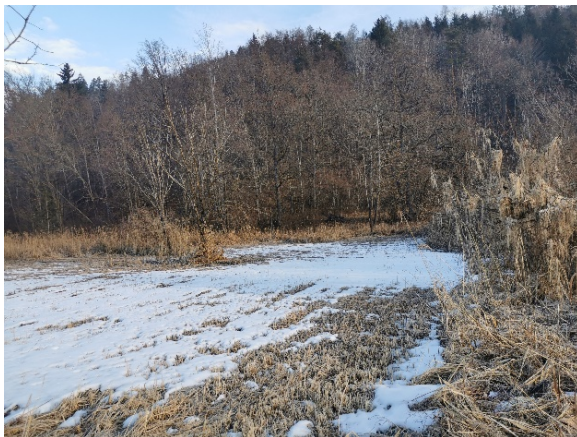
**Figure 1.23:** The part which was overgrown by goldenrod was mowed by the nature conservation agency to avoid spreading in August 2023

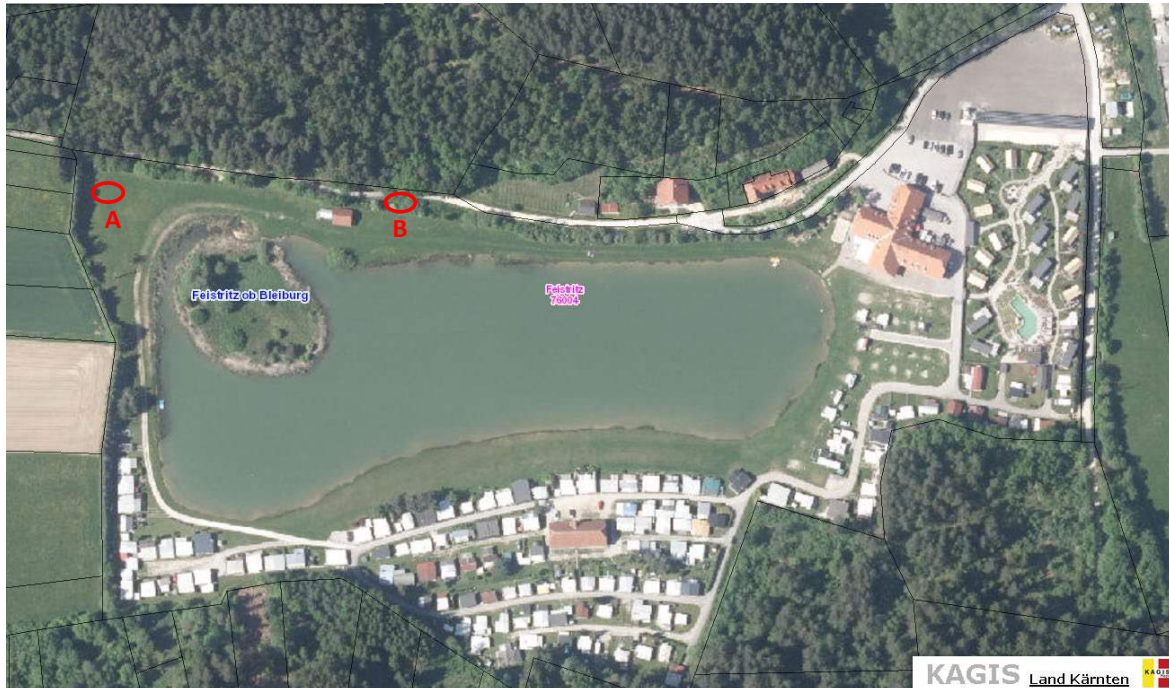
**Figure 1.25:** Site plan of the proposed measures. Establishment of amphibian breeding ponds at location A and B

To protect the amphibians, the establishment of two ponds (**Figure 1.25**, A and B) is proposed. These should remain free of fish to provide spawning grounds for amphibians with higher demand on the habitat conditions.

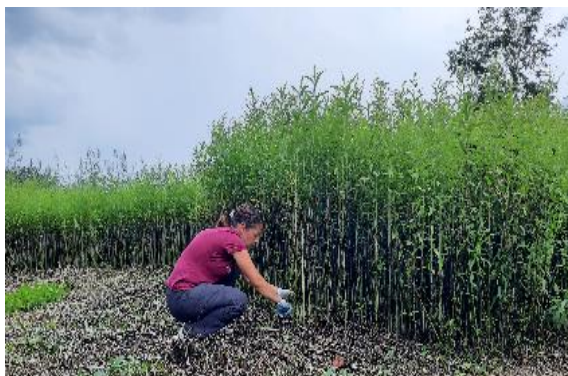
**Figure 1.26:** Participant cutting back goldenrod (photo: Urosh Grabner)

Pilot measures to remove neophytes were carried out by volunteers and Geopark staff during the summer months (June – August 2023). Reduced mowing was also observed in the northern area. People of the Geopark and some tourist supported the measure. The removal was also documented in a short video, available at the following link: <https://youtu.be/TGsnEedusTU?si=BIFrfjYlgKRdOvqX>

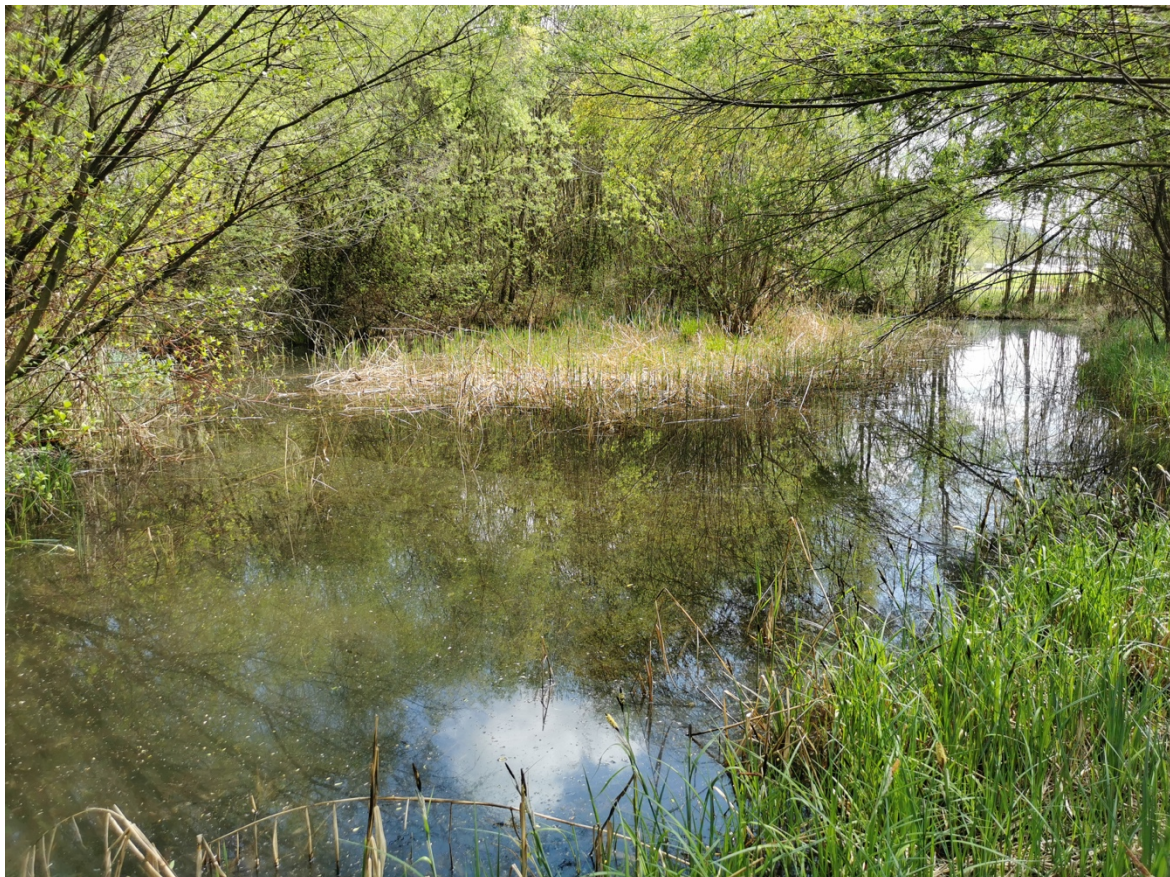
**Figure 1.28:** Natural pond behind the swimming lake

To preserve this habitat, regular measures are required, such as the removal of invasive plants and shrubs. Willow and ashes are hanging above the Water, which causes shading. These and the invasive species (Bamboo tubes, *Solidago canadensis*) should be removed in recurring interventions.

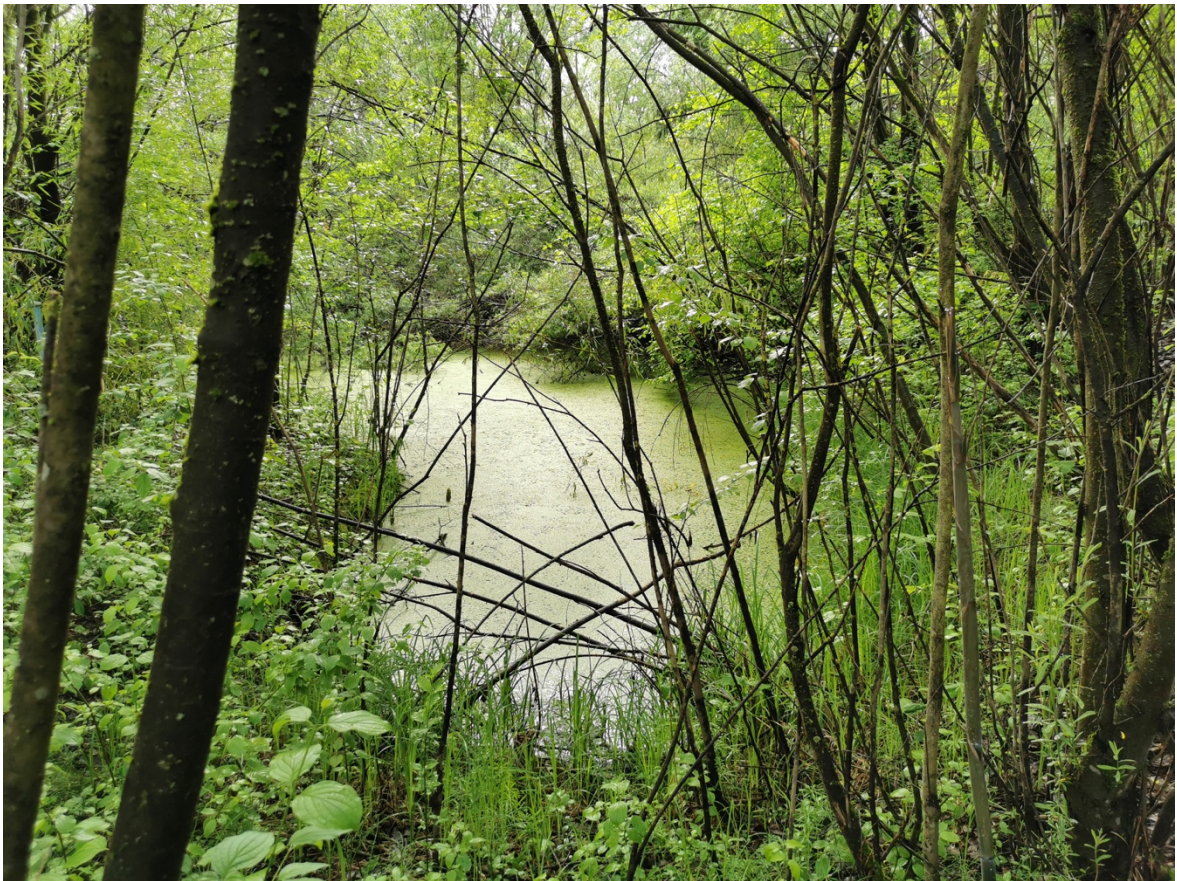
**Figure 1.29:** Bamboo vegetation spreading at natural pond (photo: Susanne Glatz-Jorde)

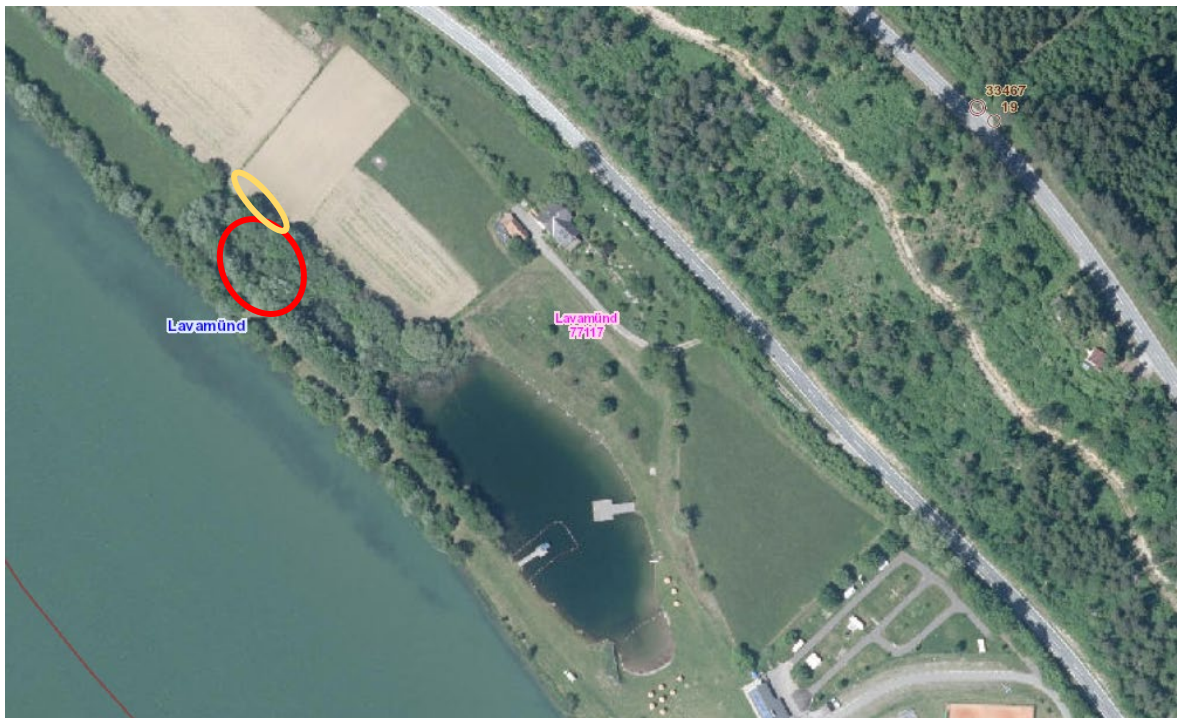
**Figure 1.30:** Proposed measures: removing dense vegetation and invasive species control

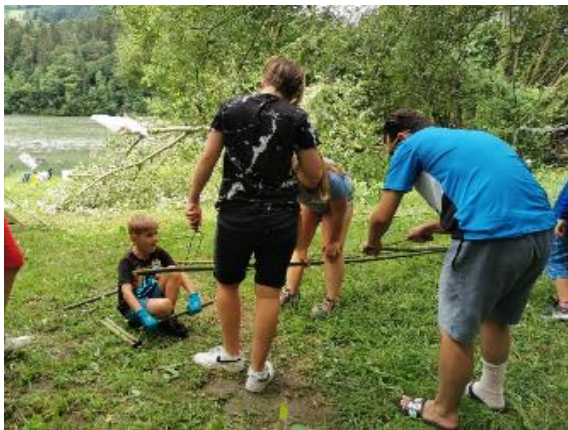
**Figure 1.31:** The participants to the summer school cutting bamboo stems together (photo Susanne Glatz-Jorde)

In July 2023 committed pupils (around 15 pupils and one teacher) of the summer school cut back the bamboo vegetation. The children were very motivated and learned the handling with the saw during this exercise. The pupils were also sensitized on the habitat and species in the ponds. A small insect monitoring programme was elaborated and explained to them. The importance of combating invasive species were explained and carried out several times during summer school.

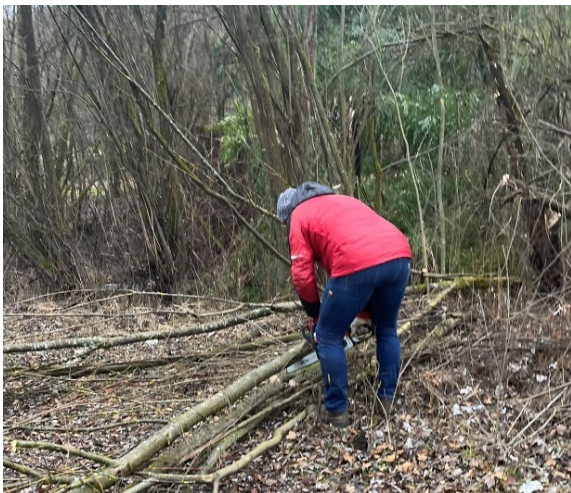
**Figure 1.41:** Cutting of willows close to the pond

In February 2024 a small group of Geopark staff, Community workers and E.C.O. staff removed the bushes leaning into the waters to allow more light falling into the ponds. This will make it more attractive as spawning ground for dragonflies and amphibians. The wood was placed next to the pond to avoid visitors from entering the ponds. This is necessary to keep up the attractive for breeding birds, which act sensitively to disturbance.

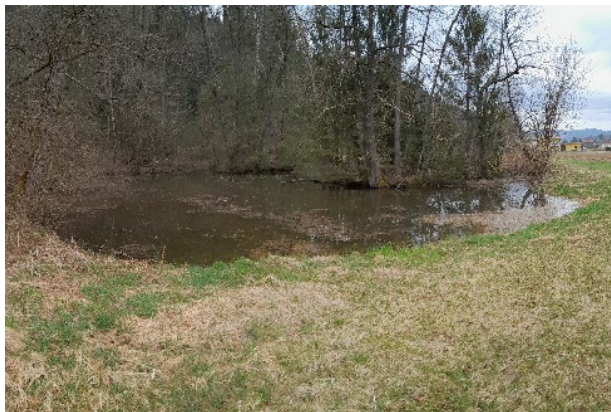
**Figure 1.45:** Pond full of water in March 2023

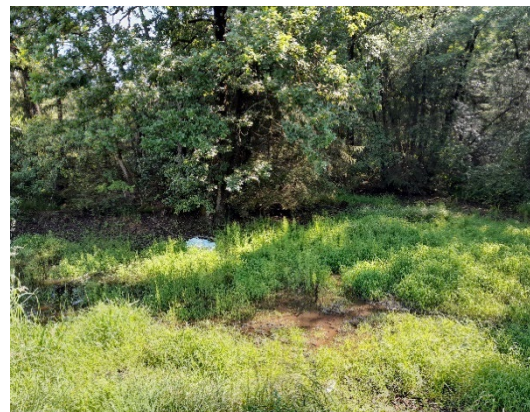
**Figure 1.46:** Dried out pond in June 2023

In the frame of this project no other feasible pilot measures can be implemented. The pond is privately owned and not used by the community of Einersdorf. However, it is a valuable spawning ground for amphibians like agile frog and common toad and could be used in future for sensitization. The loss of water would need further investigation and restoration measures turned out to be quite complex in this case. To enable and carry out these implementations, it is necessary to develop a follow-up project.

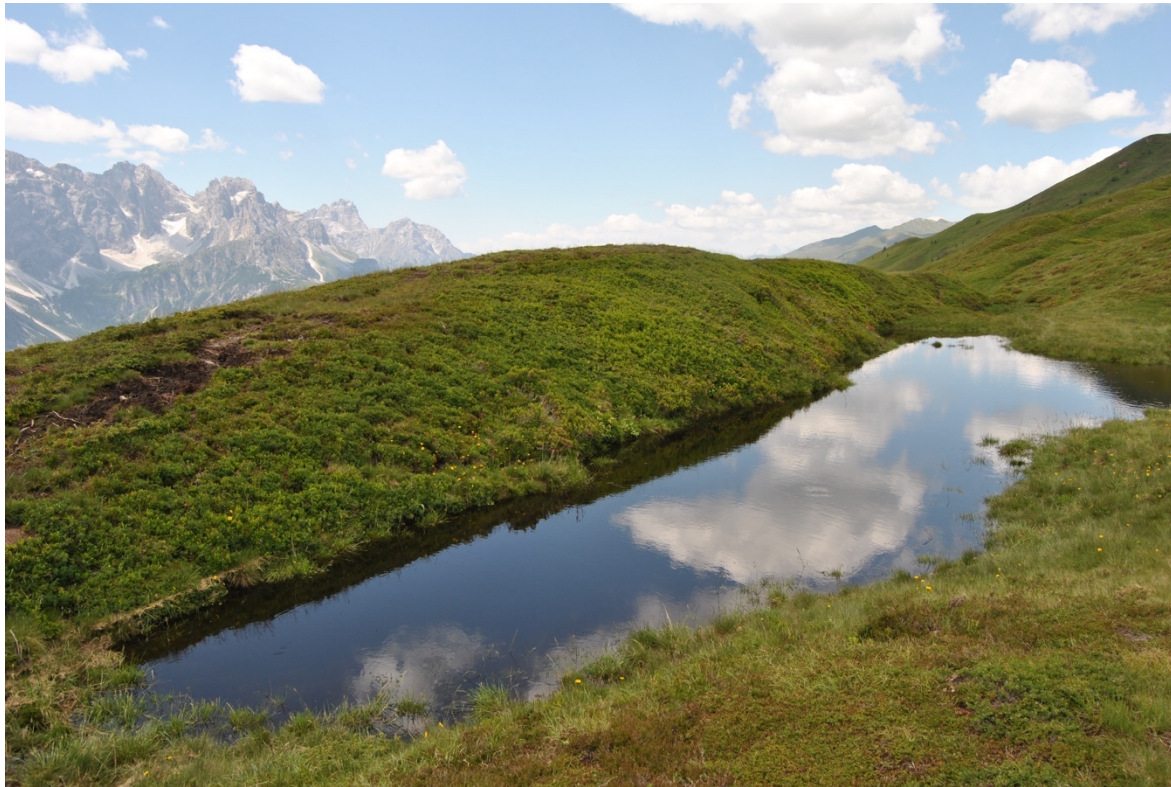
**Figure 2.1:** Pond in Costa della Spina. Many of these elongated ponds originated from bombings during World War I; all the ponds are eutrophicated and show signs of trampling along their banks (07.07.2023, photo by Giulio Menegus)

The pressure exerted by cattle and horses on the ponds of Costa della Spina (Comelico Superiore, Italy, see **Figure 2.1**) was previously documented (Bonometto, 2020) and confirmed during our site visit on 22.10.2022. As a result, we recommended protecting a small number of ponds distributed across the area.

To carry out this plan, the most effective approach is to choose an electric fence. It should be set up before the arrival of cattle and dismantled when they depart at the end of the season. This measure helps minimize the impact of cattle trampling on the vegetation along the pond banks, thereby reducing damage to plants and damage affecting immature emerging dragonflies.

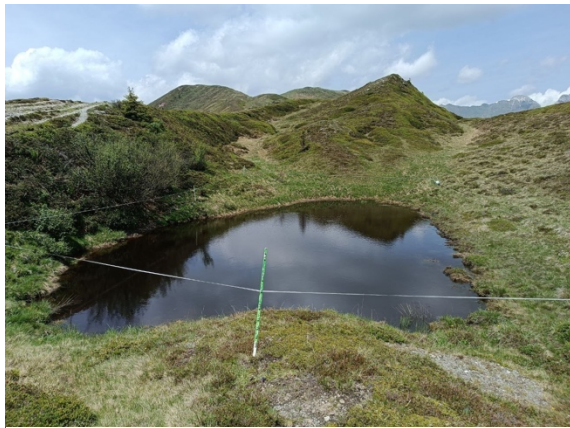
**Figure 2.3:** Pond P15 has a natural shape; the fence encircled the pond, its banks and part of the prairie (20.06.2023, photo by Giulio Menegus)

and P28 are clearly originated from World War I bombings, while P15 retains a more natural shape (see **Figure 2.3**). The straight-line distance between P6 and P15 is approximately 250 meters, and between P15 and P28, it extends to about 570 meters. In the case of P28 (see **Figure 2.5**), its water source is partly derived from the discharge waters of a small system comprising three temporary ponds upstream (P30, P31, P32, see **Figure 2.4**), prompting our decision to enclose this group of ponds as well. The initial fencing, carried out on 20.06.2023, was without electrification, and general maintenance was done with the collaboration of the Regola.

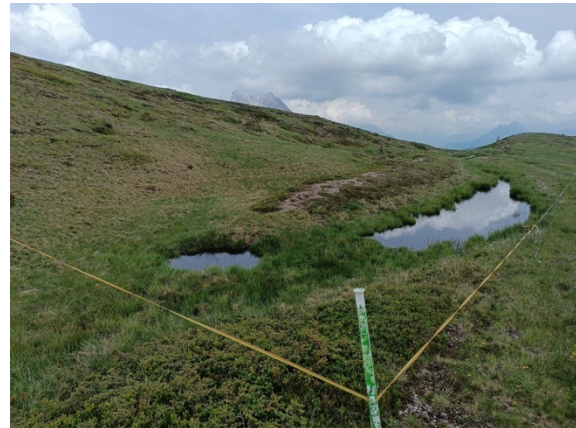
**Figure 2.4:** P31 and P32 were fenced, along with P30, in order to protect the source of water feeding P28 (20.06.2023, photo by Giulio Menegus)

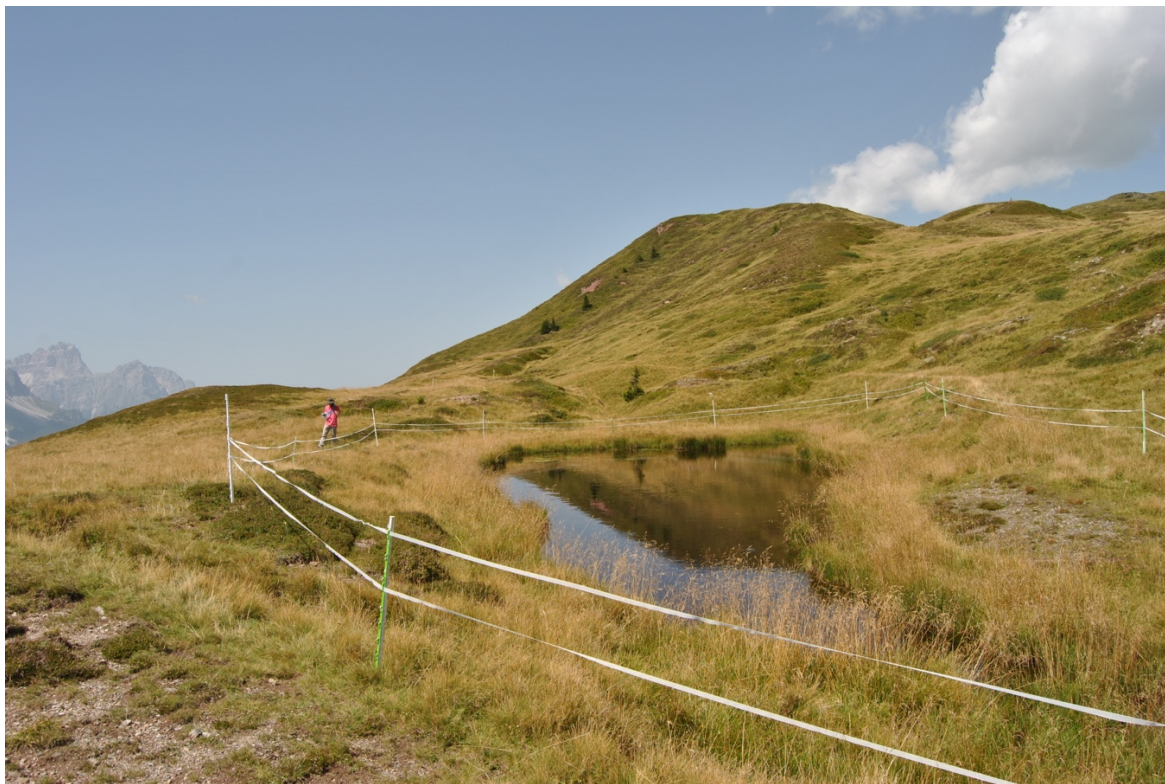
**Figure 2.5:** TESAF personnel enclosing pond P28 with an electric fence (24.08.2023, photo by Giulio Menegus)

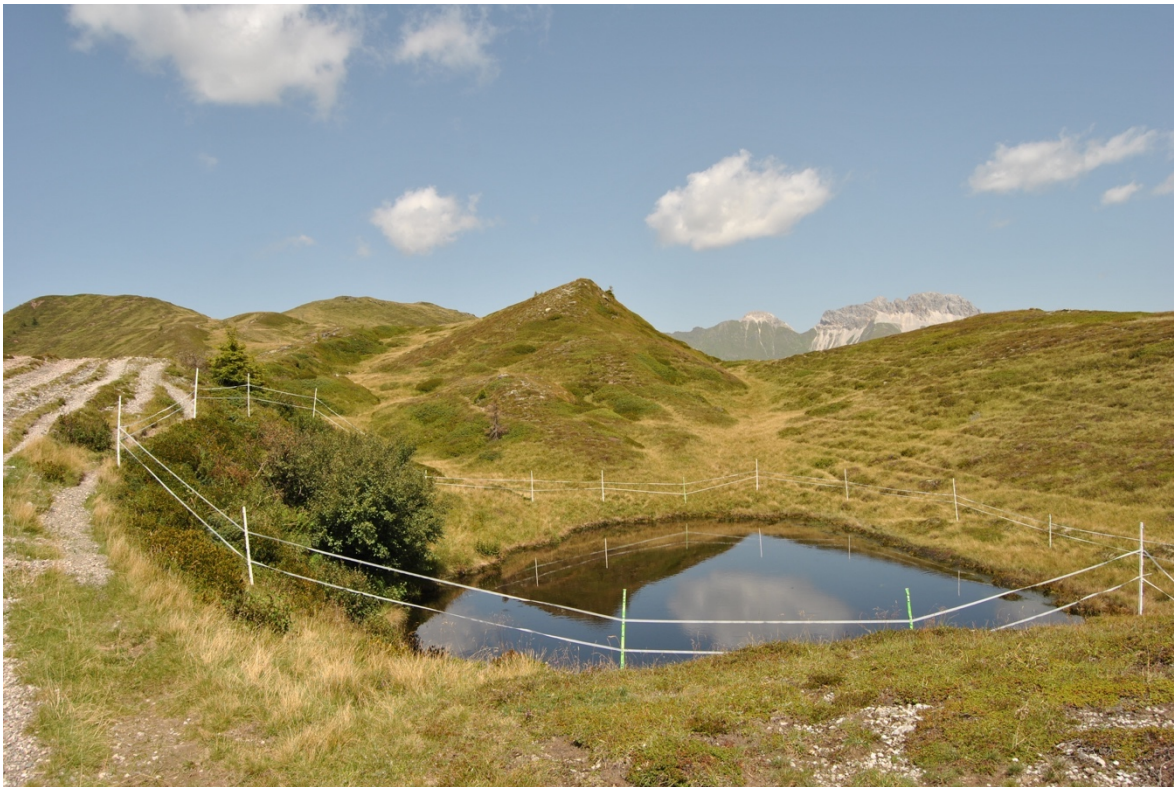
**Figure 2.6:** Pond P15, enclosed by the electric fence (24.08.2023, photo by Giulio Menegus)

The protective measures spanned the majority of the season, encompassing the entire duration of cattle presence on the pastures and coinciding with the critical emergence period of certain dragonfly species, such as *Aeshna juncea* (immature individuals were observed at P28, while a mating couple was observed at P15). This approach ensured the safeguarding of reproductive populations during this vulnerable stage.

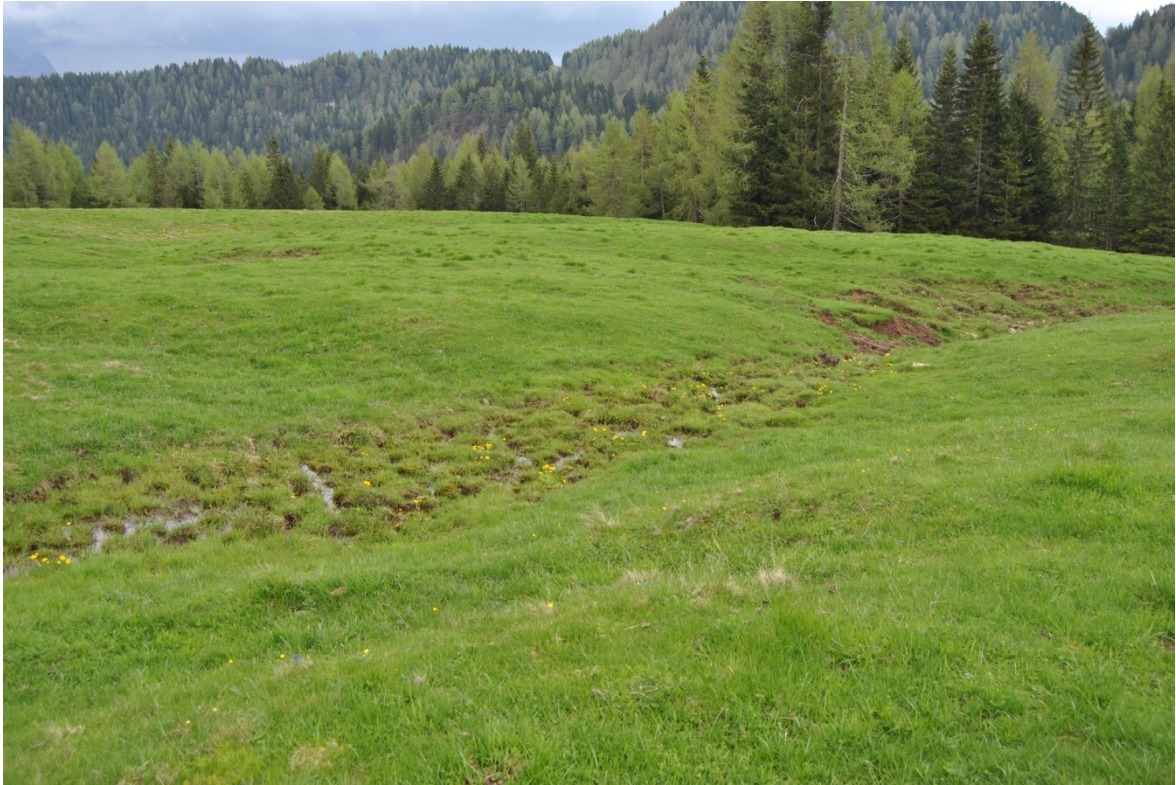
**Figure 2.7:** Drainage ditch in Polget; most of the wetland is now a wet meadow (29.05.2023, photo by Giulio Menegus)

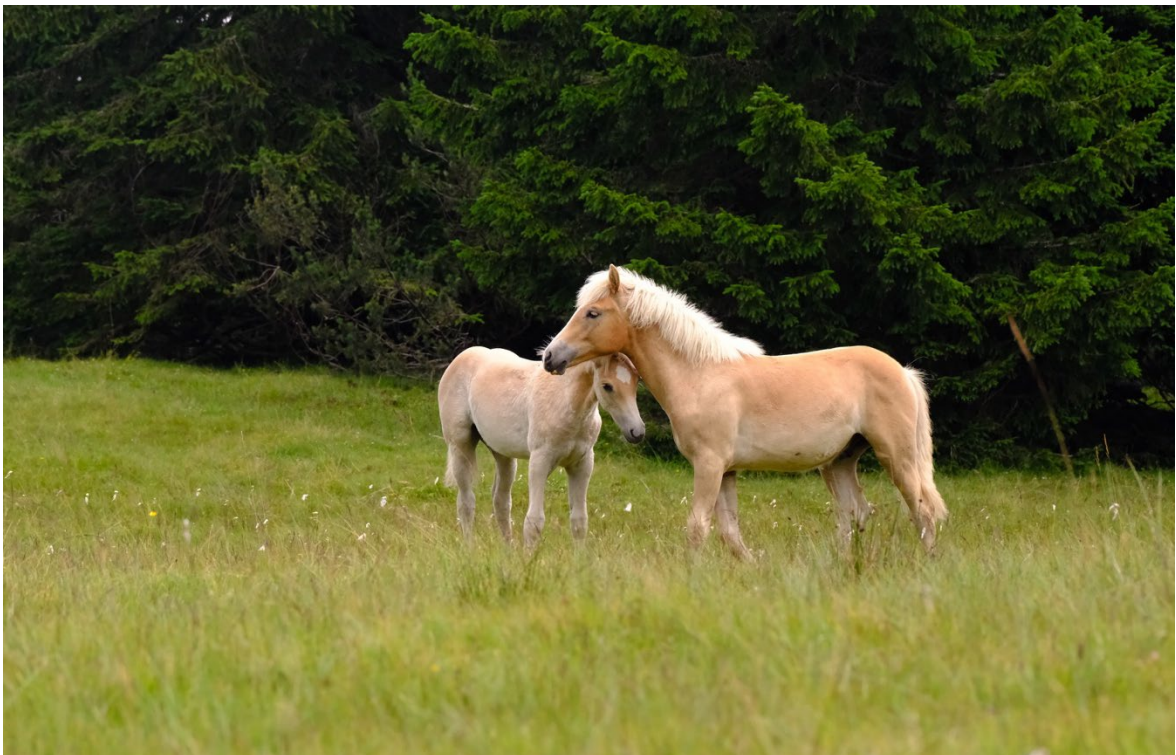
**Figure 2.8:** Horses in grazing in Polget (03.08.2023, photo by Athanasios Fitsios)

The area serves as grazing land for both cattle and horses (see **Figure 2.8**), exposing it to the pressures of trampling, herbivory, and the release of excreta. Despite these challenges, the peatland remains ecologically significant.

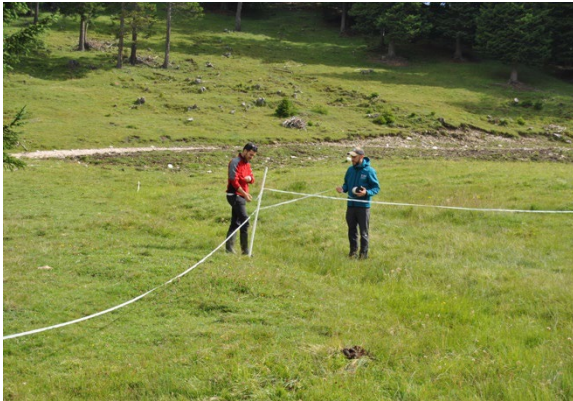
**Figure 2.9:** TESAF personnel fencing a part of the Polget peatland with *Carex rostrata* and *Menyanthes trifoliata* (03.08.2023, photo by Athanasios Fitsios)

We decided to fence off the higher portion of the peatland (see **Figure 2.10**), protecting the more preserved and upstream section, as well as a portion of the drained area (see **Figure 2.9**). Two strategically positioned fences were deployed to shield the most preserved zones and simultaneously discourage animal movement across the peatland (see **Figure 2.11**). Both fences protected about 500 m<sup>2</sup> of habitat.

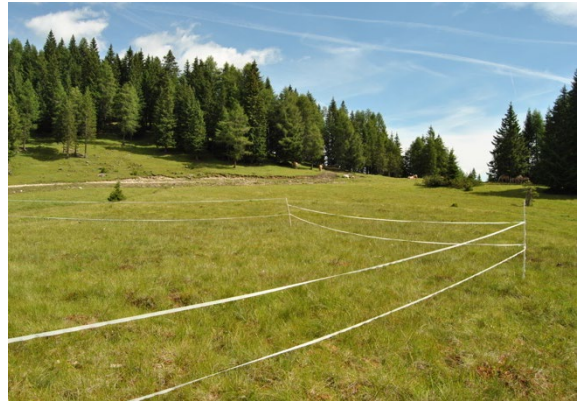
**Figure 2.10:** the fence encircling the best-preserved part of the bog remnant in Polget (08.08.2023, photo by Giulio Menegus)

The fences were installed on 03.10.2023, with the help of a volunteer, and remained in place until 17.10.2023, effectively safeguarding these two core habitat areas for over two months.
