I-SWAMP

# Deliverable 1.4.1: Conservation report

This document represents the **Deliverable 1.4.1: Conservation Report** of I-SWAMP (Integrated Small Wetlands of the Alps Monitoring and Protection). The project is co-funded by the European Union in the frame of Interreg Alpine Space.

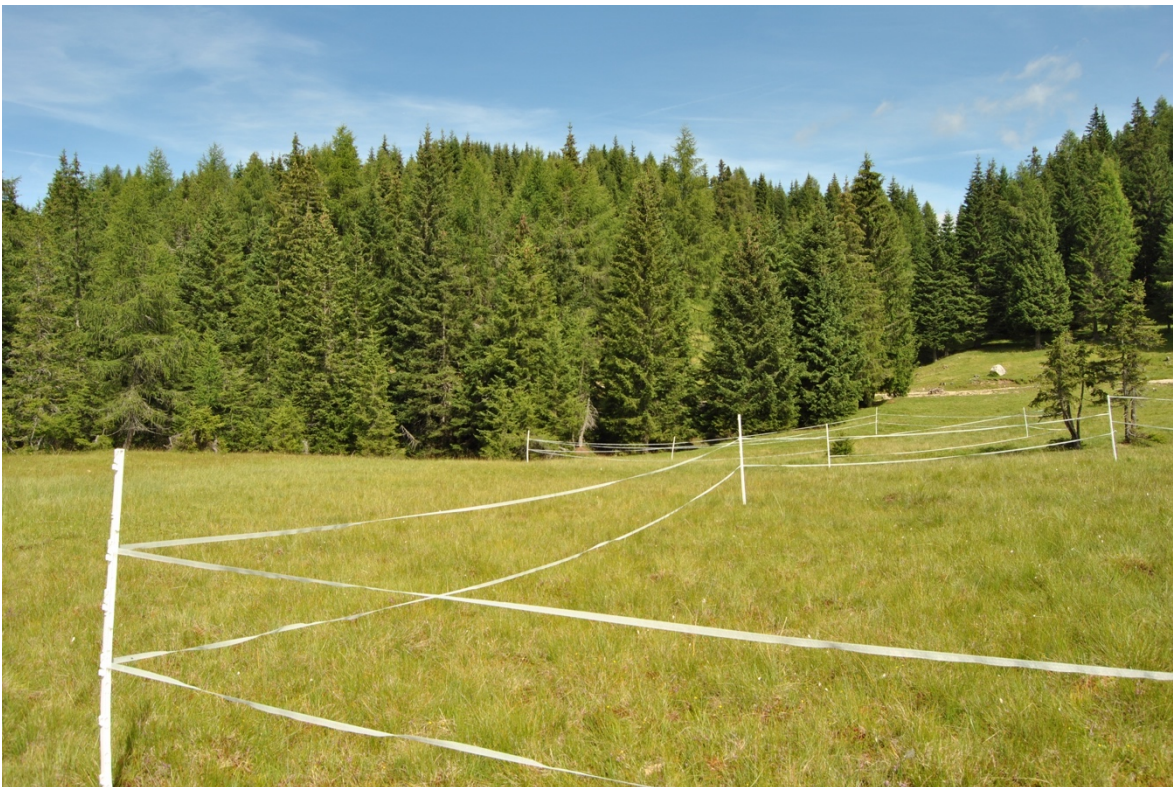
**Figure 2.11:** overview of the two fences in Polget (08.08.2023, photo by Giulio Menegus)

Once in place, the fencing proved effective in restricting access to the two sensitive areas by animals. The area suffered some minor damages because of the presence of livestock in the first half of the season.

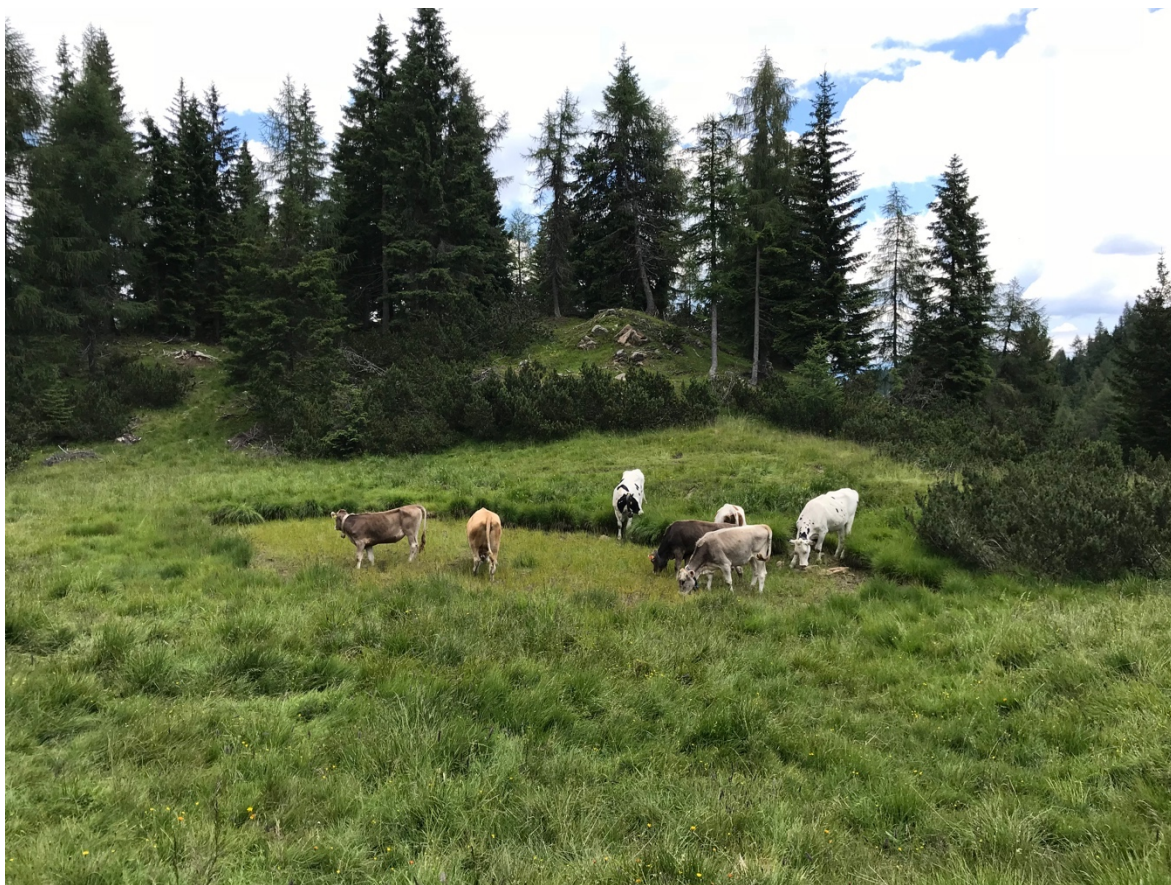
**Figure 2.12:** Cattle trampling on a dry Laghetto delle Sepolture in 2018 (photo by Lorenzo Bonometto)

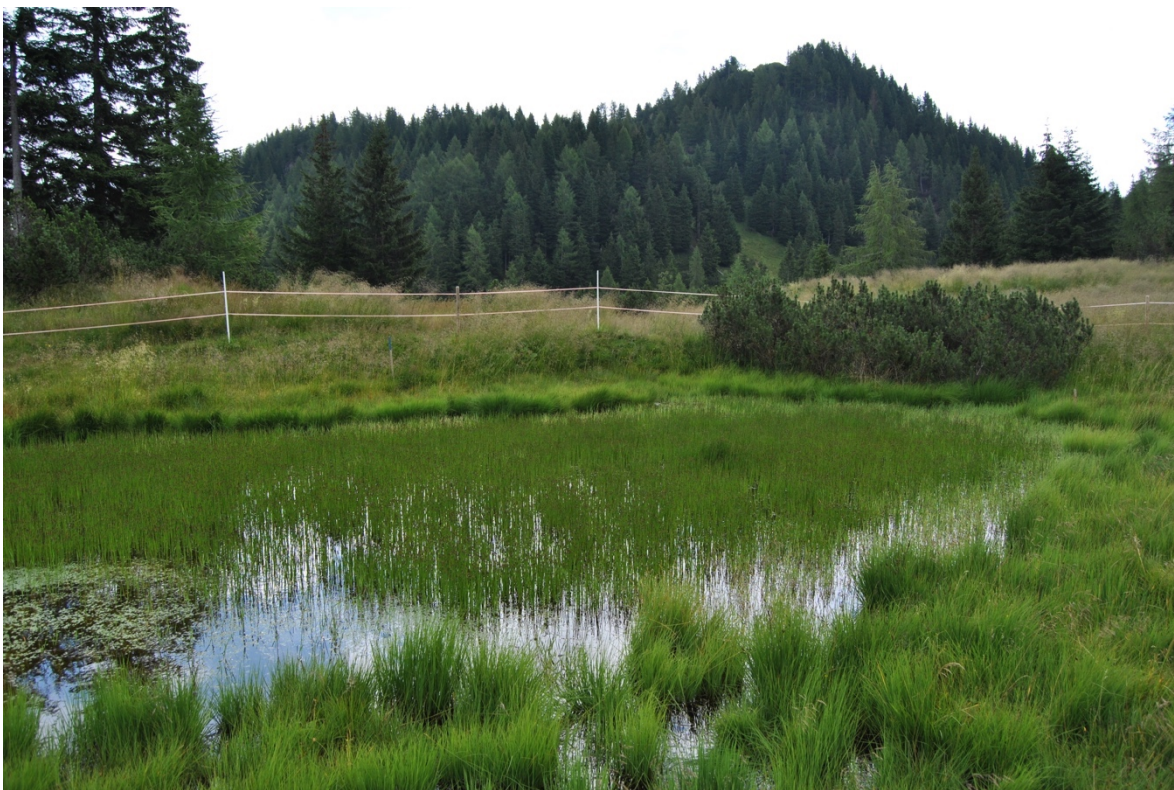
**Figure 2.13:** Laghetto delle Sepolture with *Eleocharis palustris* (03.08.2023, photo by Athanasios Fitsios)

Menegus et al., 2021). Furthermore, conservation management efforts were undertaken in 2021 and 2022. Located within a pasture regularly utilised by cattle, the pond and the surrounding wet meadow exhibit various signs of the effects of their use as pasture and water trough, such as trampling, herbivory, and eutrophication. Additionally, the pond, once permanent, has transitioned to a temporary state, often drying up in the latter half of the season or during particularly dry periods, as it relies solely on precipitation for water input (Menegus et al., 2021). In the summer of 2018, a drought event led to intense cattle trampling on the pond floor (see **Figure 2.12**). To address these challenges, an electrified fence, supported by wooden and plastic posts, was positioned around the site in 2021, encompassing both the pond and a portion of the wet meadow; the same area was fenced in 2022. Each of these two years, the wet meadow has been mowed at the end of the summer season, and sedges along the bankside have also been partially mowed or reduced. Observations in 2023 suggest that these management interventions are yielding positive outcomes, with aquatic vegetation reverting to a pre-2018 state (see **Figure 2.13**). The presence of indicators of eutrophication and trampling, such as *D. cespitosa*, appears to have diminished, at least in certain parts of the enclosed area. Some positive signs emerge from the dragonfly community, indicating the presence of new species, including one of conservation interest such as *Coenagrion hastulatum*, alongside stable populations of other relatively sensitive species like *Libellula quadrimaculata* and *Coenagrion puella*.

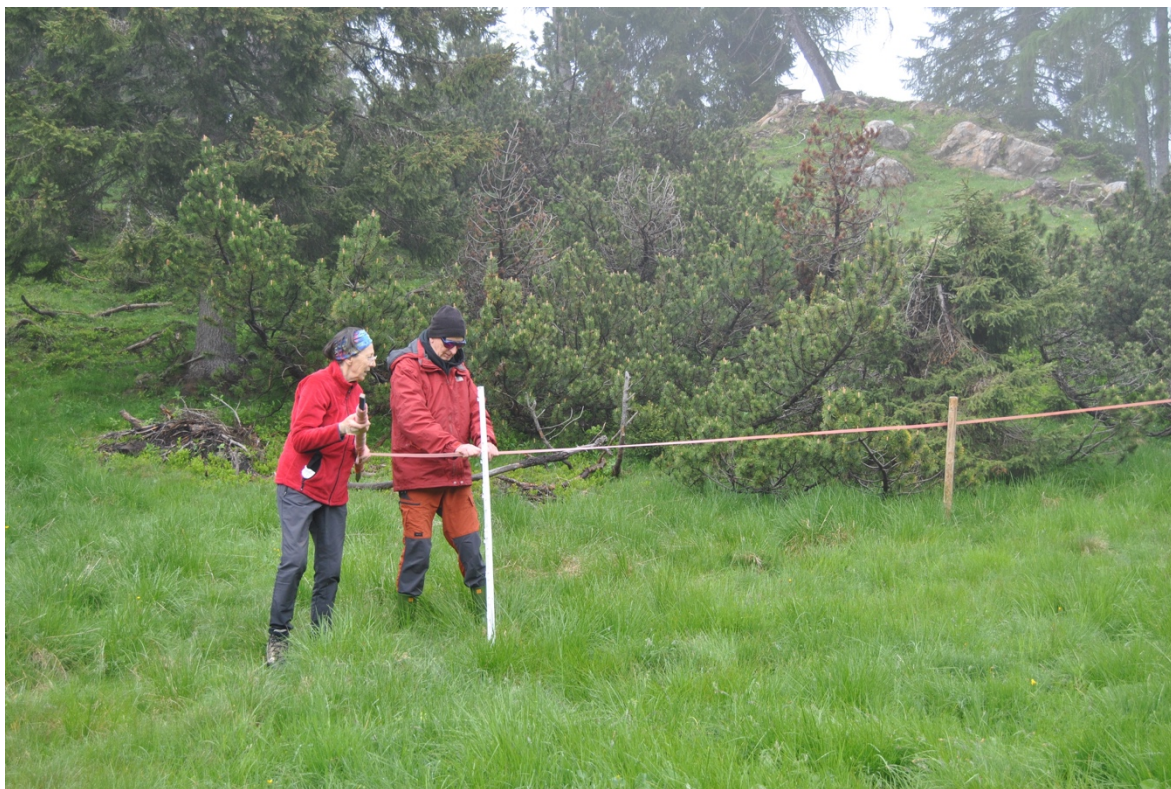
**Figure 2.14:** volunteers fencing the area of Laghetto delle Sepolture and the surrounding wet meadow (13.06.2023, photo by Francesca Minucci)

In order to protect the pond and the wet meadow from the impact of cattle presence, we decided to fence the area at the beginning of the season. The fence was installed along the same perimeter as in previous years on 13.06.2023, with the assistance of two

volunteers from the environmentalist group Gruppo promotore del parco delle Marmorole-Antelao-Sorapiss and some students from the CFP Bauer photography school in Milan (see **Figure 2.14**). The electrification of the fence took place on 06.07.2023, with maintenance interventions conducted on 6.07.2023 and 11.07.2023. The fence was subsequently removed on 17.10.2023 by personnel from the TESAF department.

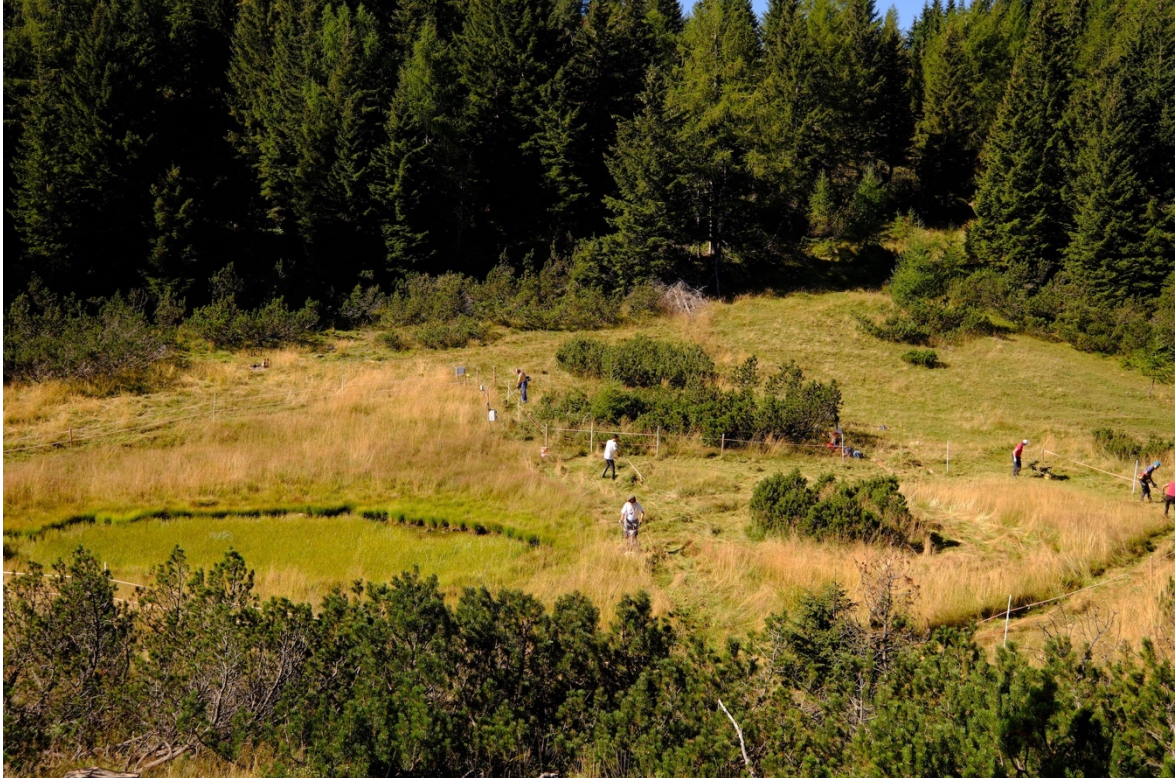
**Figure 2.15:** Volunteers and TESAF personnel mowing the wet meadow surrounding Laghetto delle Sepolture (08.09.2023, photo by Athanasios Fitsios)

including a motor mower, two disc-mowers, and sickles (see **Figure 2.15** and **Figure 2.18**). Clippings were moved downstream using rakes and traditional sheets known as mantui or varote (see **Figure 2.16**). Approximately one-third of the sedge belt was mowed, and aquatic vegetation consisting of *Callitriche palustris* and *A. aequalis* was cleared from an area of approximately 4 m<sup>2</sup>. These activities engaged two representatives from the TESAF department and six volunteers (see **Figure 2.17**).

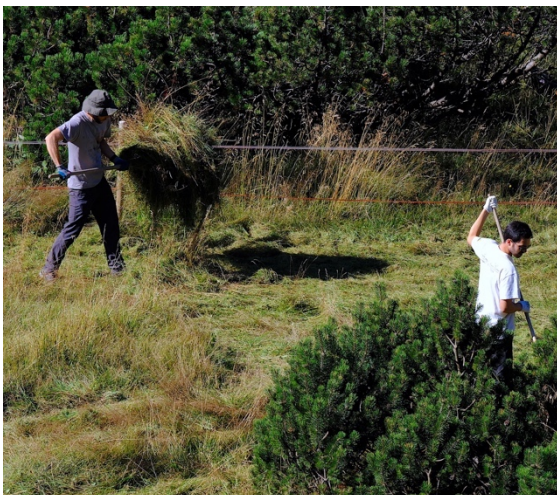
**Figure 2.17:** participants removing the clippings with rakes and forks (08.09.2023, photo by Athanasios Fitsios)

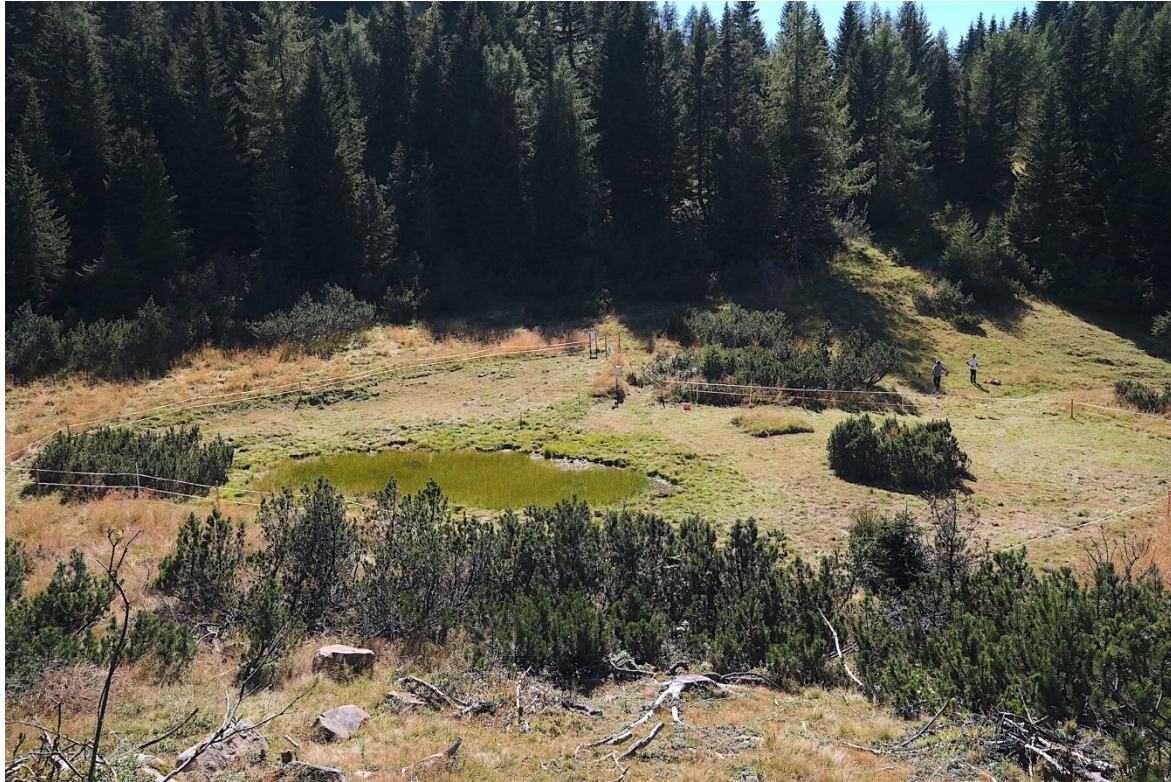
**Figure 2.18:** the area after the mowing; note that some parts of the sedge bank were mowed and that we left a 3x3 m<sup>2</sup> part unmowed (08.09.2023, photo by Athanasios Fitsios)

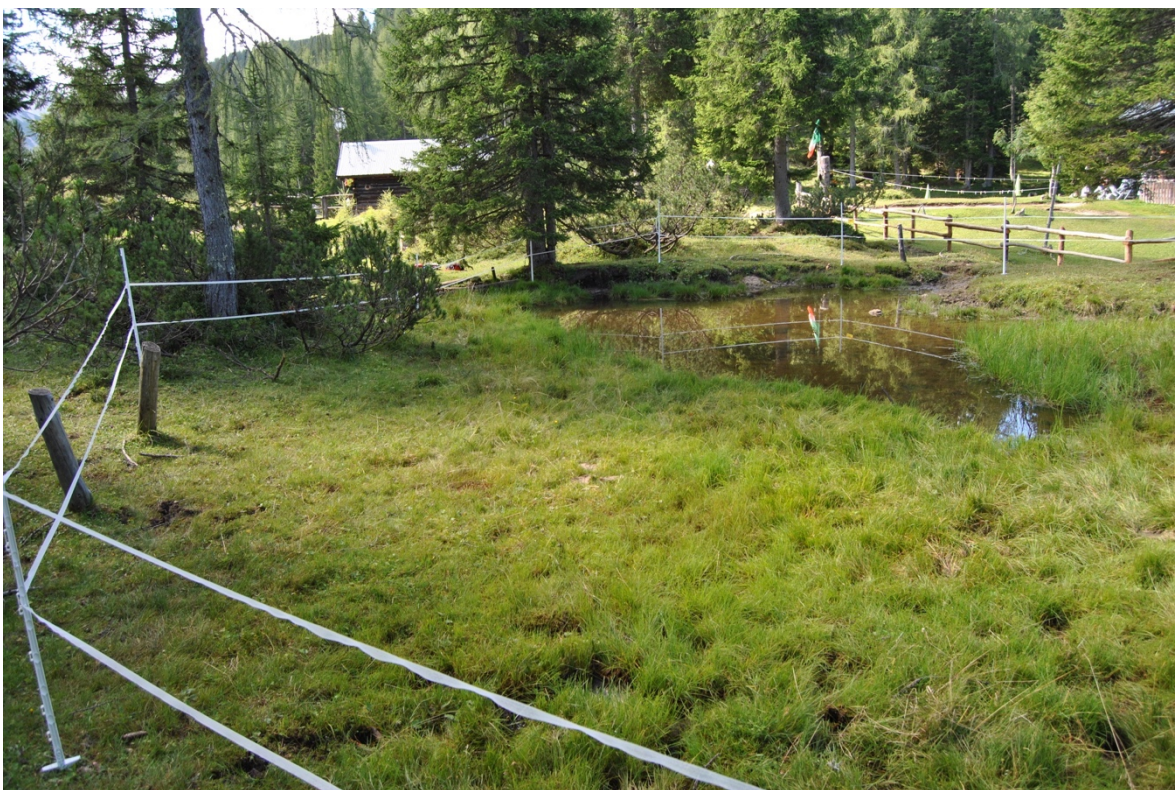
**Figure 2.19:** the electric fence enclosing Laghetto di Vedorcia and the surrounding wet meadow (10.08.2023, photo by Giulio Menegus)

The electrified fence was positioned, encircling the pond and the small upstream wet meadow to the edge of the clearing. In the southern part of the pond, where pond waters discharge into a degraded wet meadow, an access point for cows was left open in agreement with the pasture managers and the owner of the Rifugio Tita Barba. The fence protected an area of about 500 m<sup>2</sup>.

The delayed installation of the fence allowed cattle access for the initial part of the season, potentially impacting vegetation and dragonflies. Nonetheless, stable populations for several dragonfly species were observed, and no significant damage to the sedge belt was found.

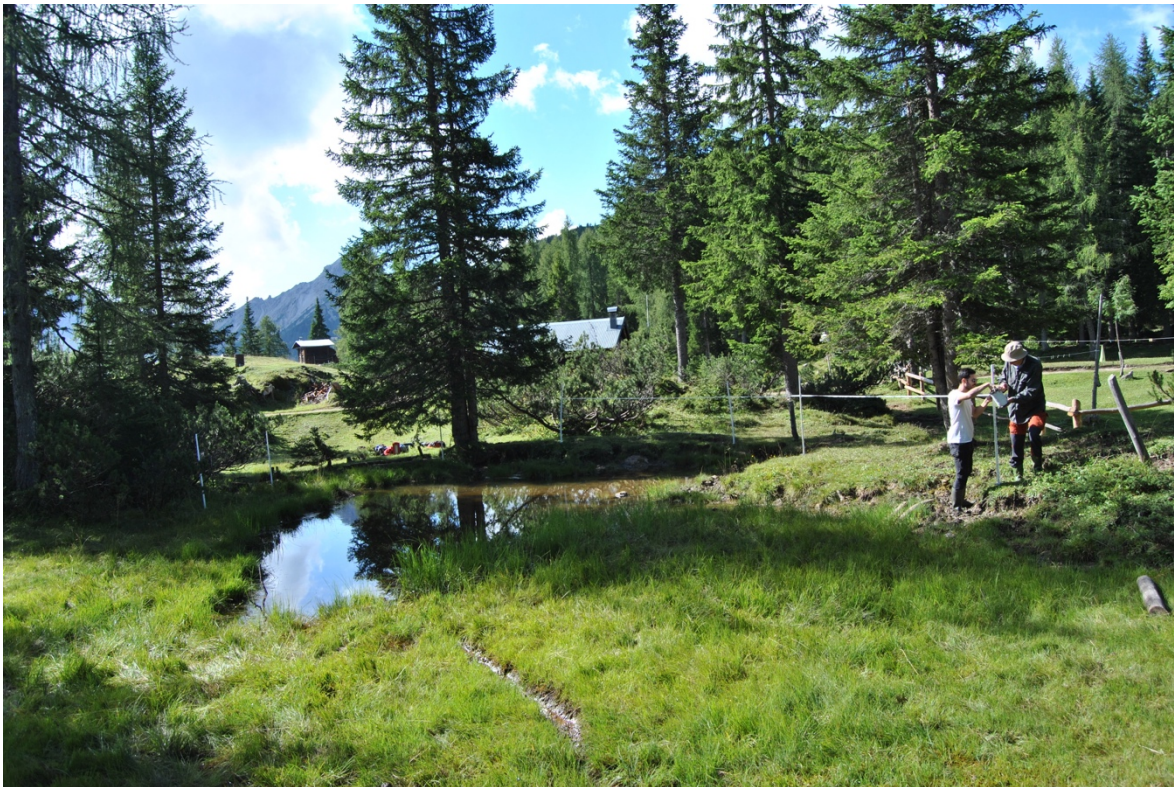
**Figure 2.20:** TESAF staff and a volunteer fencing the pond in Vedorcia (10.08.2023)

We opted to install an electrified fence to protect the area from cattle. Initially scheduled for end of July, following our initial site inspection, inclement weather forced multiple postponements. The intervention was eventually carried out on 10.08.2023, with the assistance of two volunteers from the Gruppo Promotore del Parco delle Marmarole-Antelao-Sorapiss (see **Figure 2.20**).

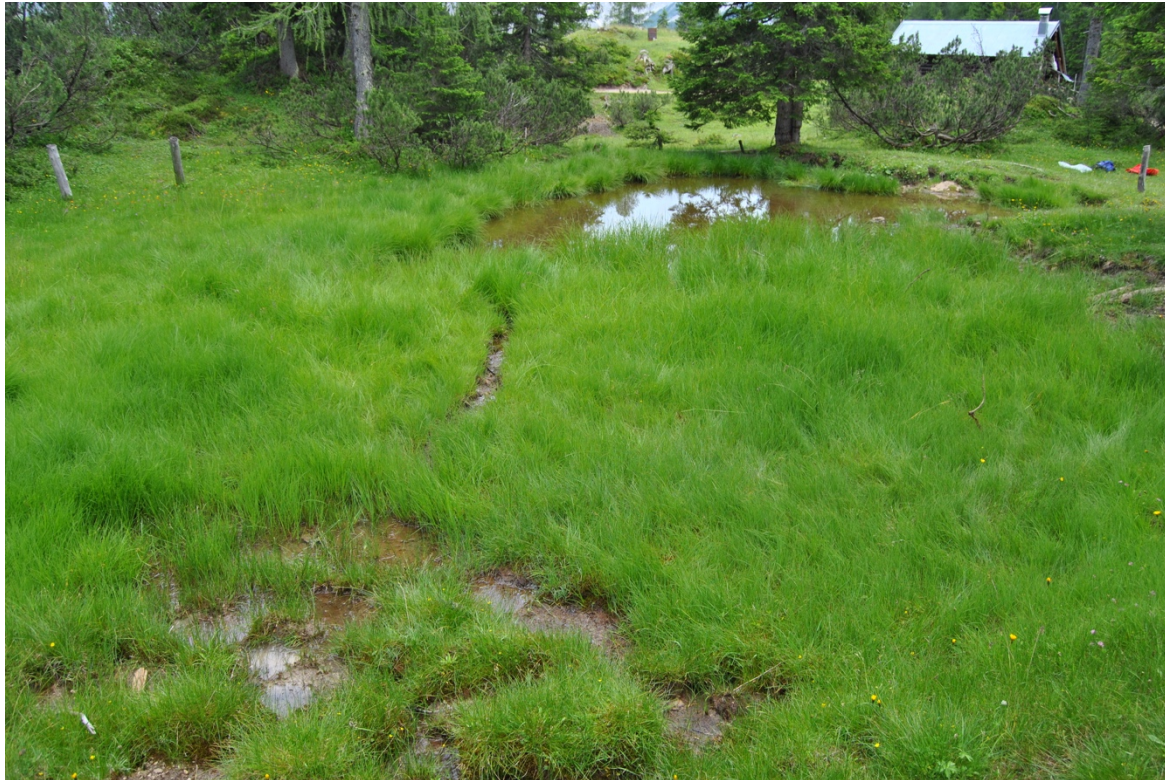
**Figure 2.21:** excavating the upstream part of the habitat could help reclaim some aquatic environment (10.08.2023, photo by Giulio Menegus)

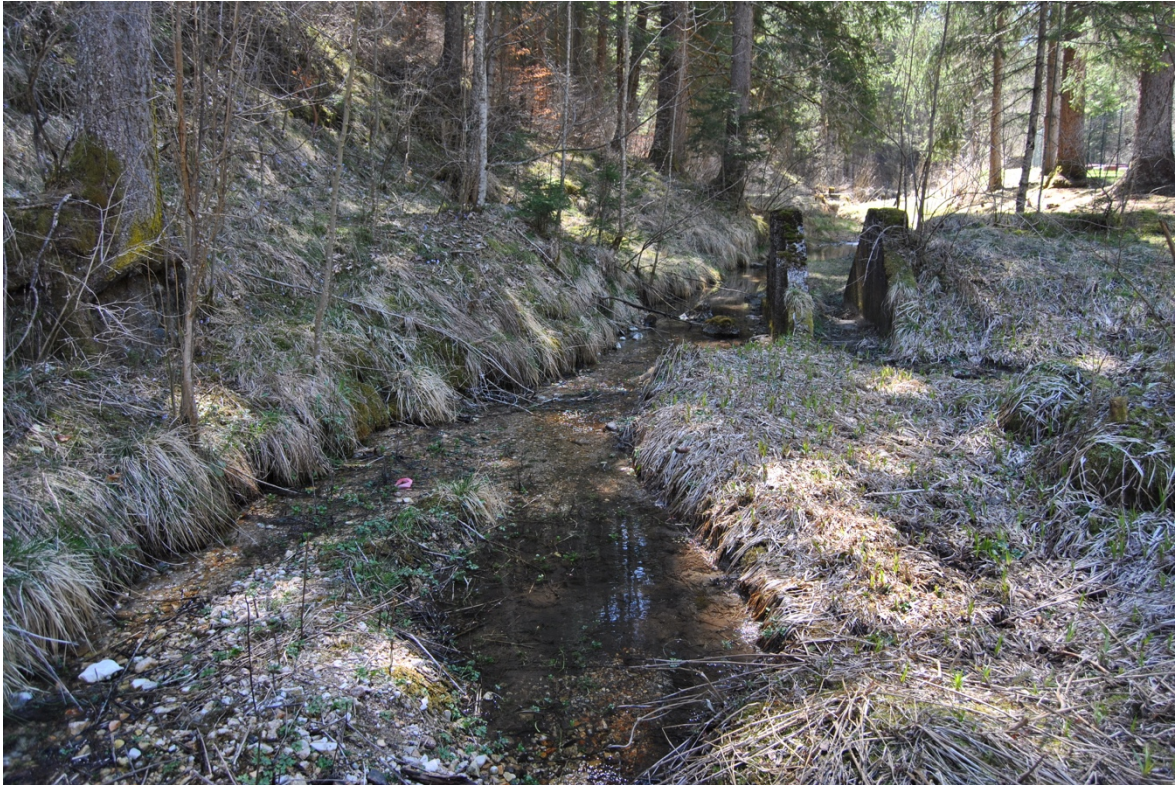
**Figure 2.22:** the resurgence stream in Mosigo, with abandoned concrete structures (06.04.2023, photo by Giulio Menegus)

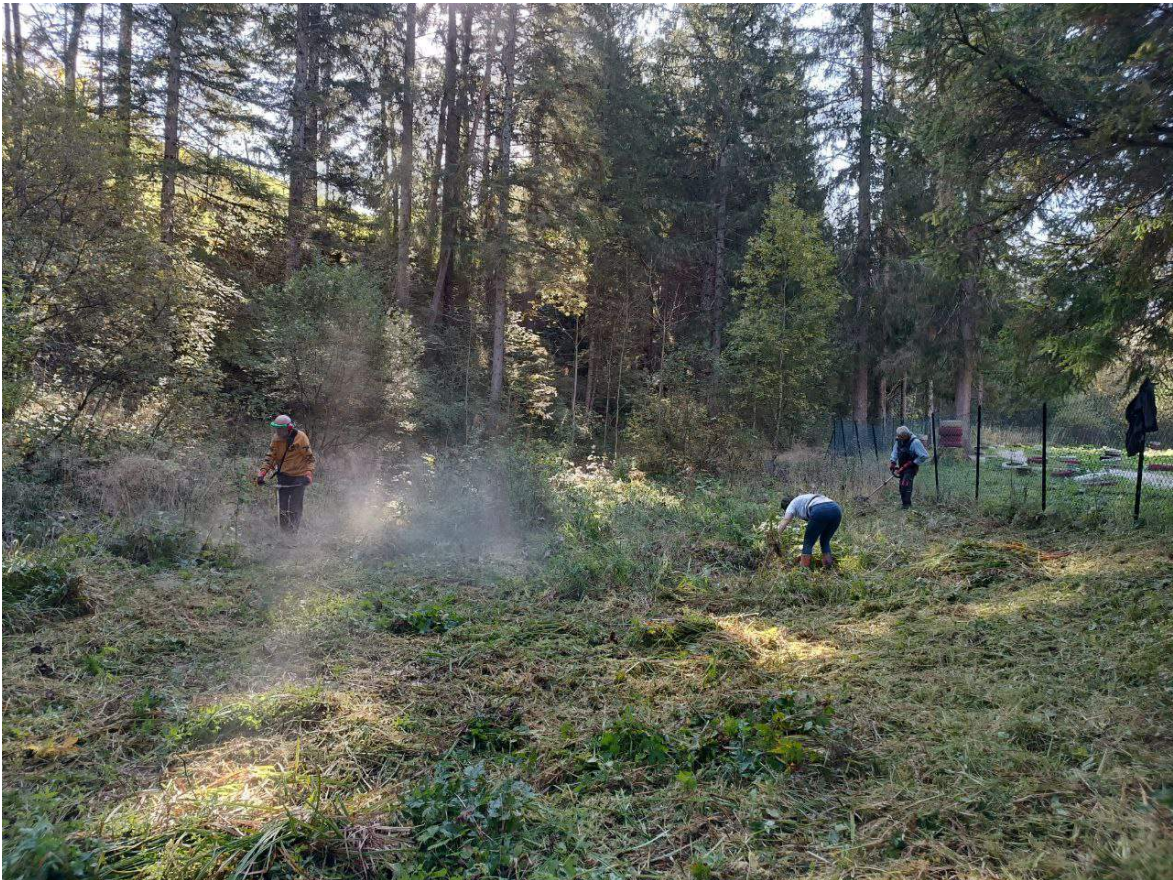
**Figure 2.23:** volunteers mowing the wet meadow in Mosigo (13.10.2023, photo by Giulio Menegus)

To avoid any potential impacts on butterfly larvae, selective mowing practices were adopted. Areas with marginally wet conditions, especially those regularly subjected to flooding and monospecific stands of *Urtica dioica*, were targeted. Many areas were left intact. The cutting was conducted at a height of approximately 15-20 cm above the ground, avoiding the destruction of basal plant parts and particularly the tussocks providing refuge for caterpillars.

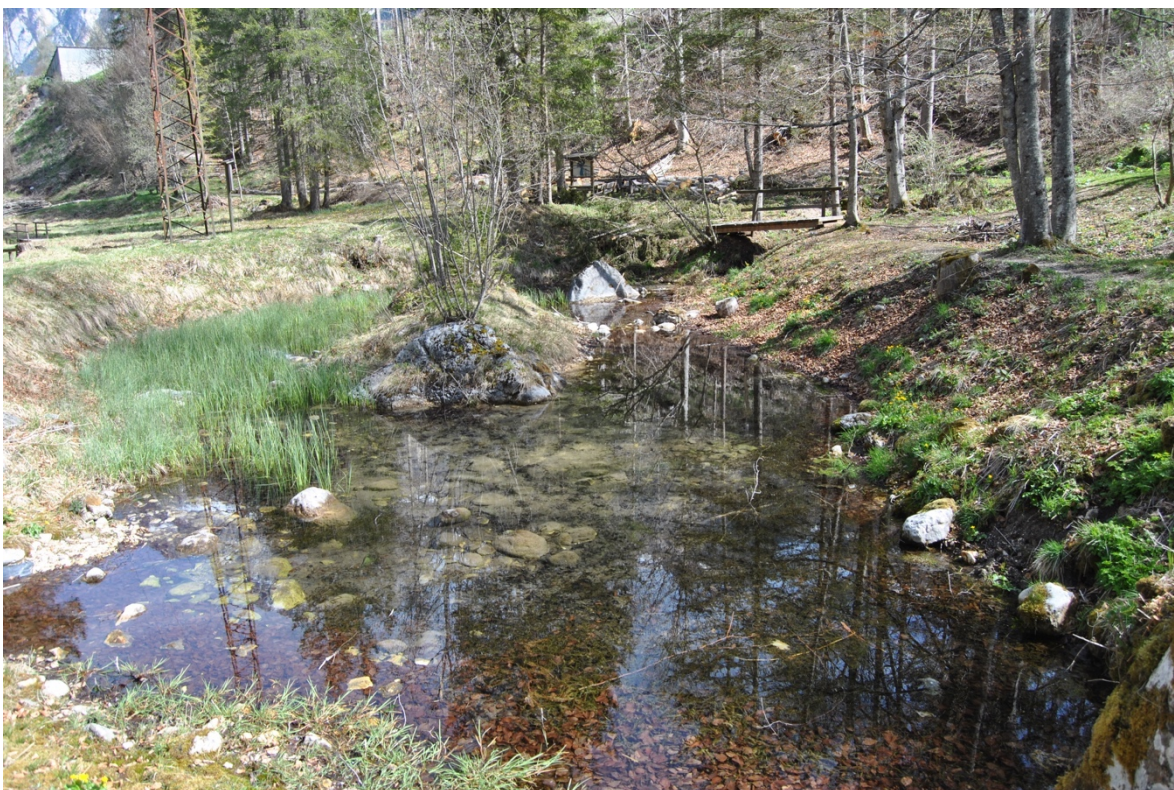
**Figure 2.25:** part of P3 in La Zopa is occupied by a stand of *Elodea canadensis* (29.04.2023, photo by Giulio Menegus)

The pond environments, relatively well-preserved and exhibiting typical communities associated with lowland marshy areas (e.g., *Carex rostrata* stands), are deemed to require minimal interventions. However, a targeted removal of *Elodea canadensis* was planned to address the presence of this invasive species. The same applied for rare *I. glandulifera* plants in the *Petasites* meadow.

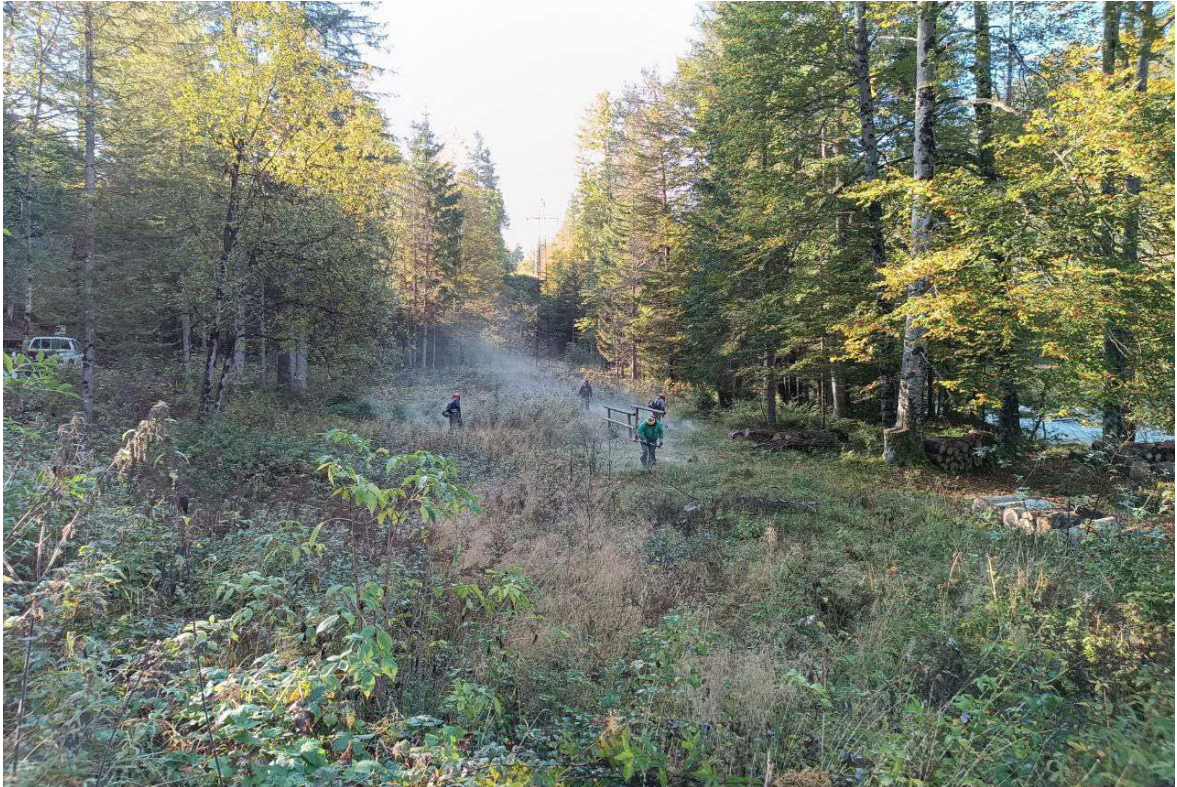
**Figure 2.26:** volunteers mowing La Zopa wet meadow with lightweight equipment (07.10.2023, photo by Giulio Menegus)

The considerations regarding the conservation of the *L. achine* during interventions mirror those outlined for the Risorgive di Mosigo site (see **2.5.2**). The mowing intervention was carried out on 07.10.2023, employing lightweight equipment such as string trimmers (see **Figure 2.26**). Clippings were collected using rakes and forks, then disposed of in the section of the meadow closest to the Boite River. The mowing specifically targeted the *Filipendula* meadow, focusing on the wettest environments while avoiding margin zones and shrubs to prevent accidental damage to the overwintering larvae of *L. achine*. The cutting height was maintained at 15-20 cm above the ground to minimize any potential harm to the basal portions of the vegetation tussocks. An area of about 1200 m<sup>2</sup> (about a quarter of the habitat) was mowed (see **Figure 2.27**).

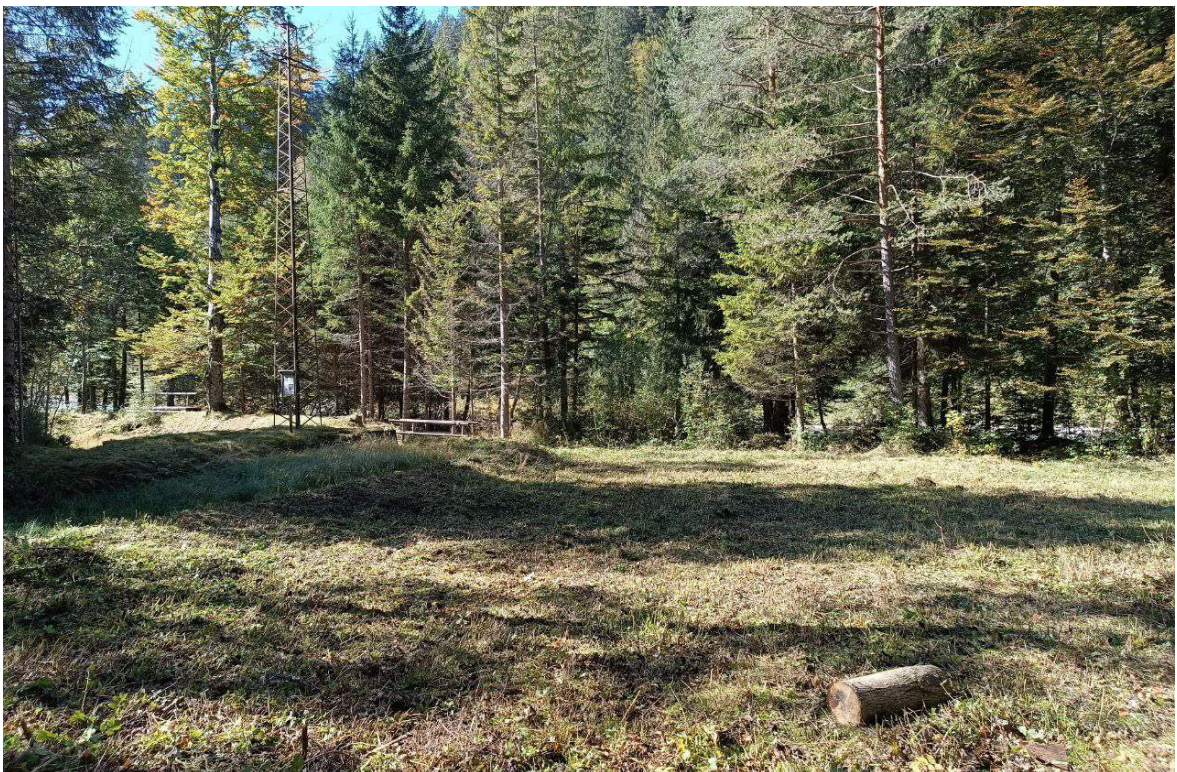
**Figure 2.27:** the wet meadow of La Zopa after mowing (07.10.2023, photo by Giulio Menegus)

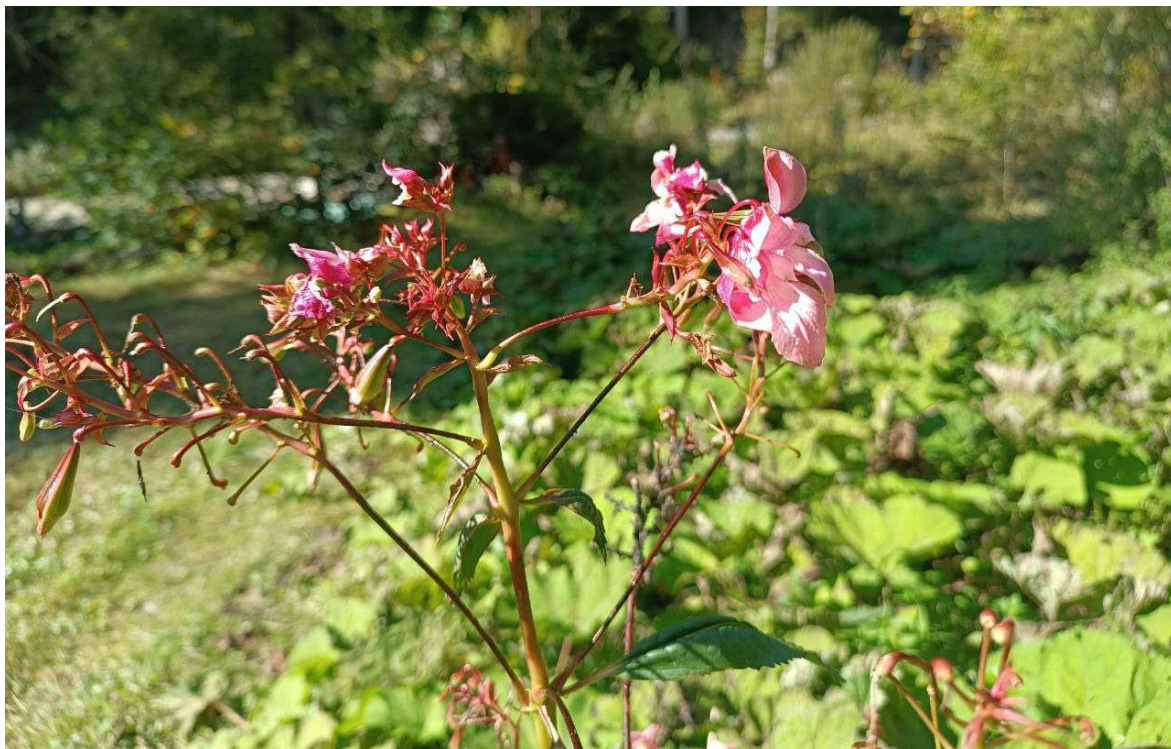
**Figure 2.28:** The invasive species *Impatiens glandulifera* in La Zopa (07.10.2023, photo by Giulio Menegus)

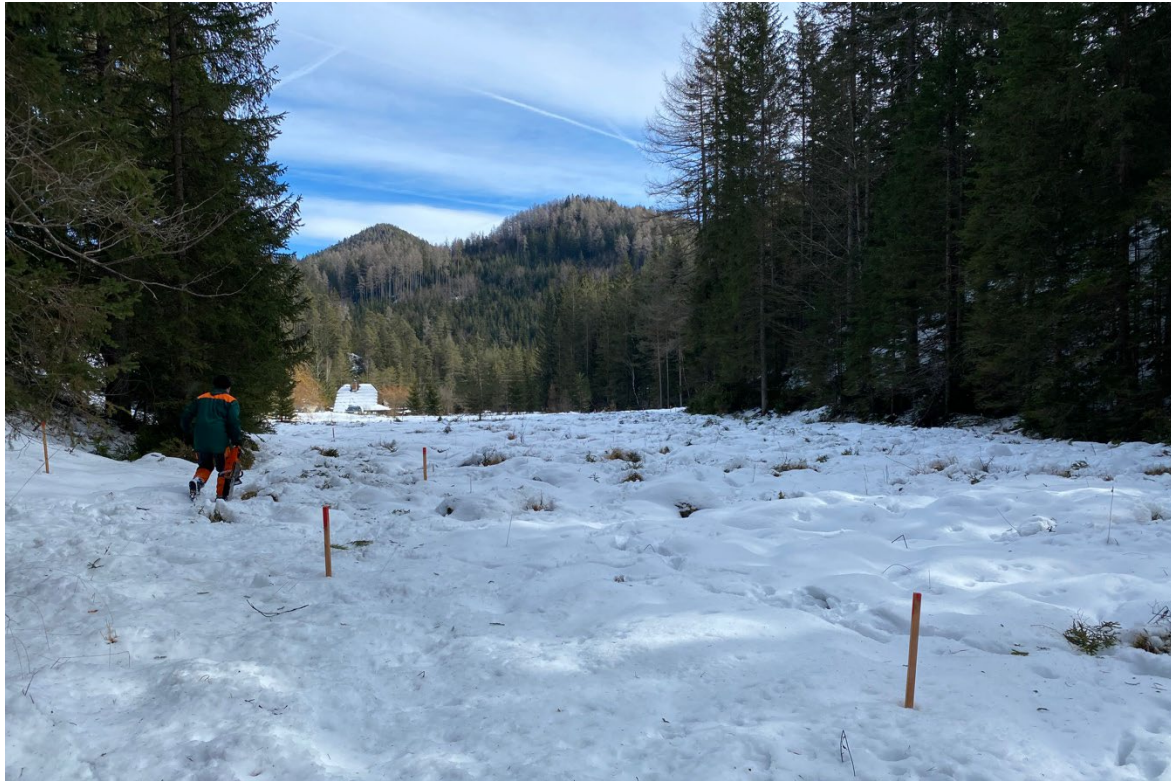
**Figure 3.4:** Removing woody vegetation

execution of the works was tied to the final report of the the Slovenian Center for the Cartography of Fauna and Flora. The report could only be completed when the butterfly nests were inventoried and marked. The butterfly develops nests in autumn (2. 10. 2023 Označevanje gnezd travniškega opstavneža). The removal was carried out in the area where the highest density of the butterfly Marsh Fritillary.

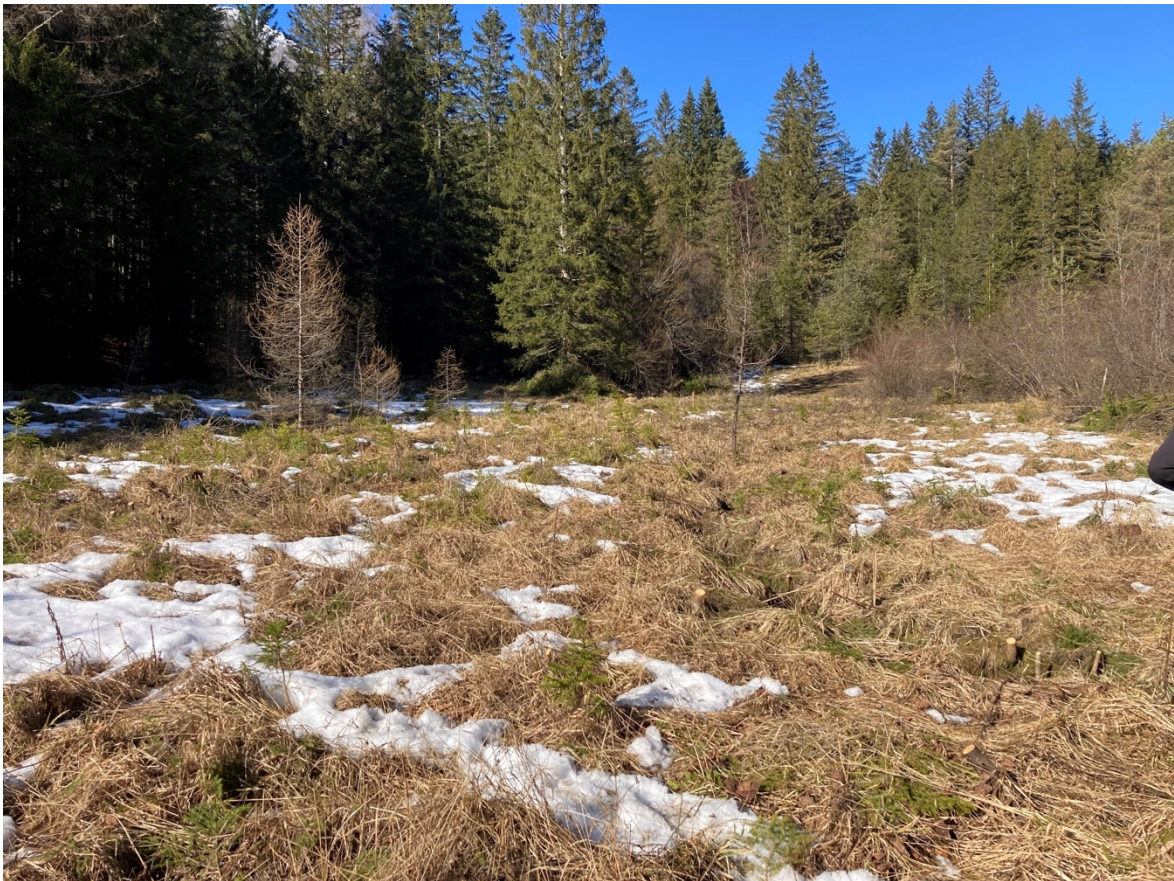
**Figure 3.6:** The cleared area after shrub removal

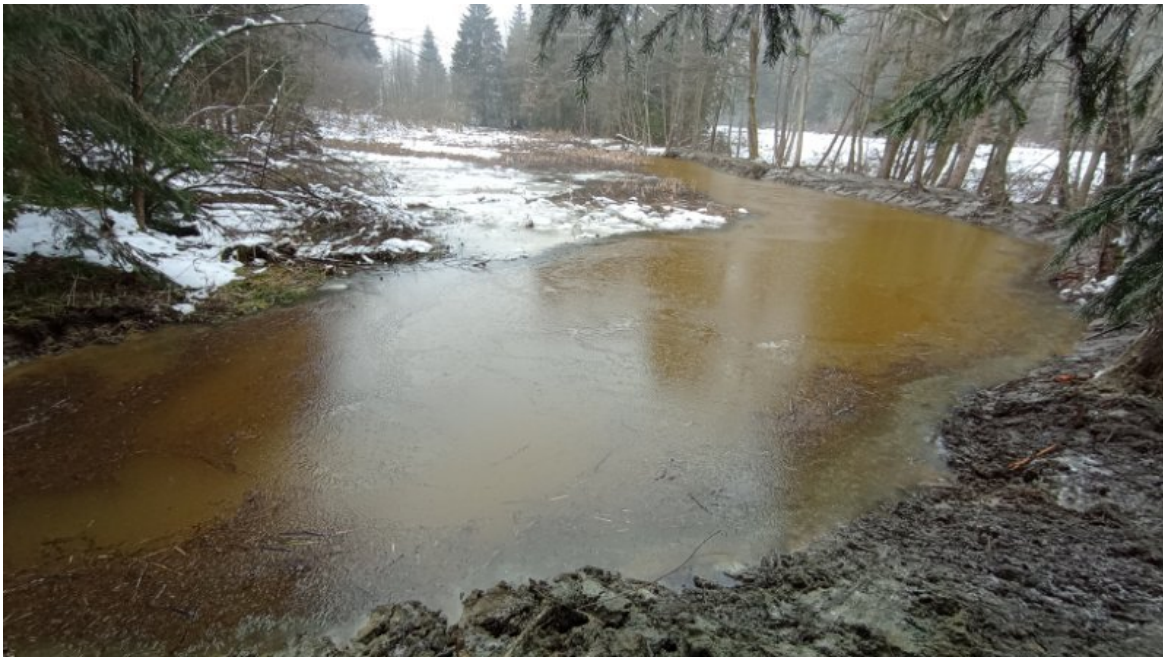
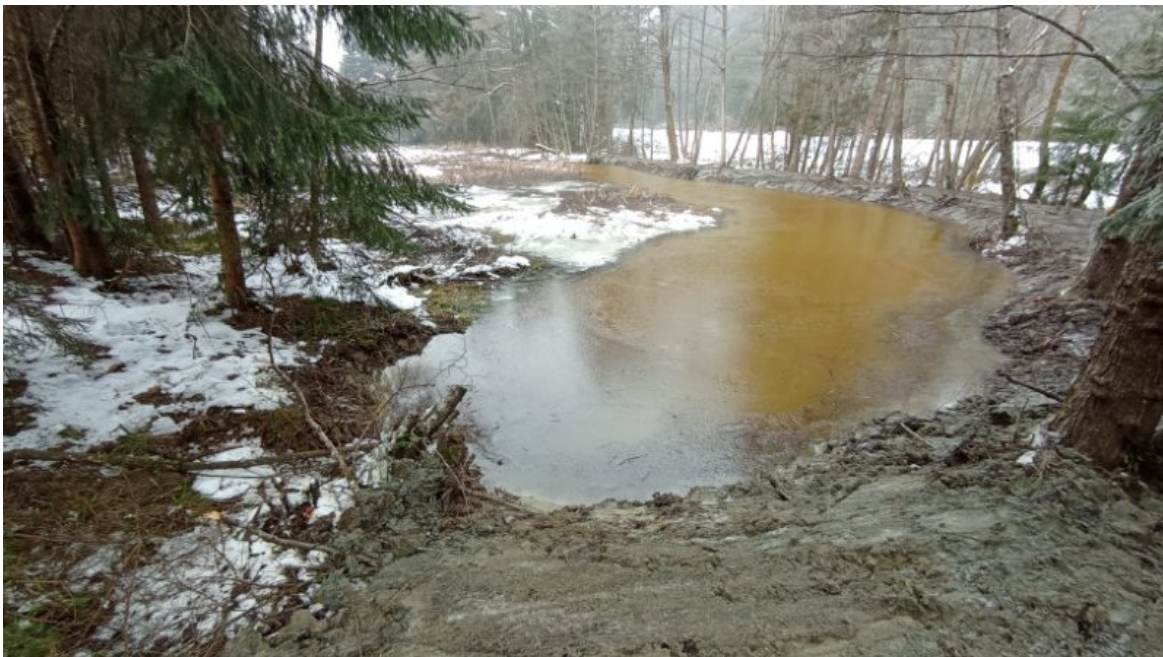
**Figure 3.11 (top and bottom):** Control of work performance

<b>18.10.2023</b>	field visit and the presentation of the actions	The contractor, This local official, and forester
<b>07.12.2023</b>	field visit and the presentation of the actions	The contractor, the excavator driver, local forester
<b>15.-18.12.2024</b>	execution of works	The contractor, the excavator driver,
<b>11.01.2024, 20.12.2023</b>	control of work performance	IRSNC and forestry service

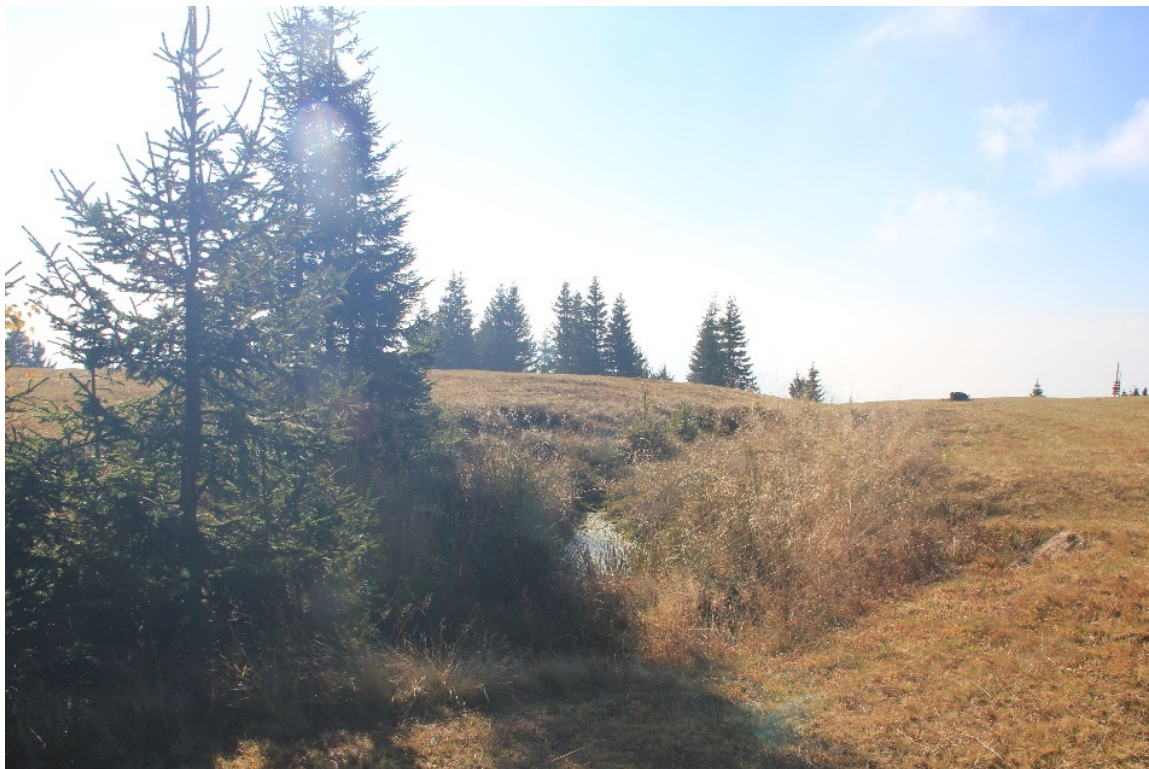
**Figure 3.21:** Bog Krnes I

Two small bog areas located on top of the ridge of Smrekovec. The surrounding area of the bogs is a high mountain meadow, which is grazed and mowed once a year at the end of August. Around the first bog 10 spruce trees grow on the north side. The size of the trees is on average below 2 m. Some trees have already grown over 3m in height. Trees provide shelter from the sun and retain moisture, thus creating a unique microclimate. The southern part of the bog is devoid of tree vegetation, and as a result is somewhat drier. In this place, mossy vegetation appears in smaller patches. Around the second bog there is no vegetation. The footprints of cattle that are drinking water from the bog are visible.
